(1984) - First International Conference on Case Histories in Geotechnical Engineering

India's First Venture Relating to Subsurface Drainage by Horizontal Drains

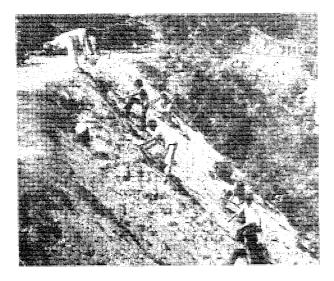
Fig.6 Planting of kikiyu grass on the hill slope

Along with the horizontal drains, vegetative turfing was also implemented for controlling the surface erosion of the hill slope due to run off water. A mixture of assorted seeds of the promising species of the local grasses, shrubs were broadcast over the entire slide of denuded zone in three applications, mixed with sand to facilitate easy handling and for broad er coverage. In addition to this, locally available kikiyu grass was planted flat on the slide slopes, Fig.6 to control the surface erosion.
