Distress to Structures on Loose Ash and Cinder Fills

Moustafa A. Gouda
Chief Geotechnical Engineer, Lippincott Engineering Associates,
USA

ABSTRACT

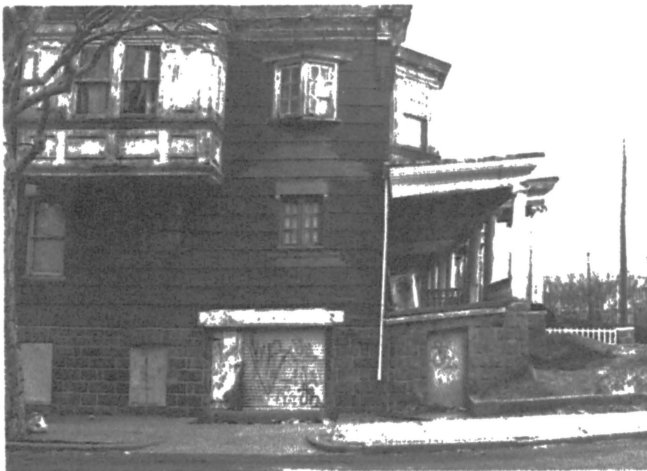
Lippincott Engineering Associates (LEA) was retained by the City of Philadelphia, in the Spring of 1986, to investigate the settlement problems of the Logan Section of Philadelphia. The purposes of the investigation were to determine the causes of settlement, to make recommendations to arrest the settlement, and to provide remedial measures to rehabilitate the structural distress. (Figure 1 indicates type of differential settlement)

Figure 1 - House located at 920 Wyoming Avenue

The two to three feet of total settlement and the one to two feet of differential settlement in the Logan Section has lead to severe damage to properties and has rendered some of the dwellings unsafe for occupancy. Three major types of distress resulted from the severe differential settlement; functional, structural, and architectural.

It is our opinion that ground loss and migration of ash and cinders by piping can be reduced drastically by rehabilitating the underground utilities for all structures in the area. Rehabilitation of the city sewers and an increase in the number of drain inlets in the streets would reduce the potential for flooding and greatly reduce runoff infiltration. However, due to the increase in seismic activities in the Philadelphia area in the recent past, and due to unforeseeable weather conditions, recommendations were given to underpin all the houses that will be rehabilitated using pinpiles extending to bedrock surface.

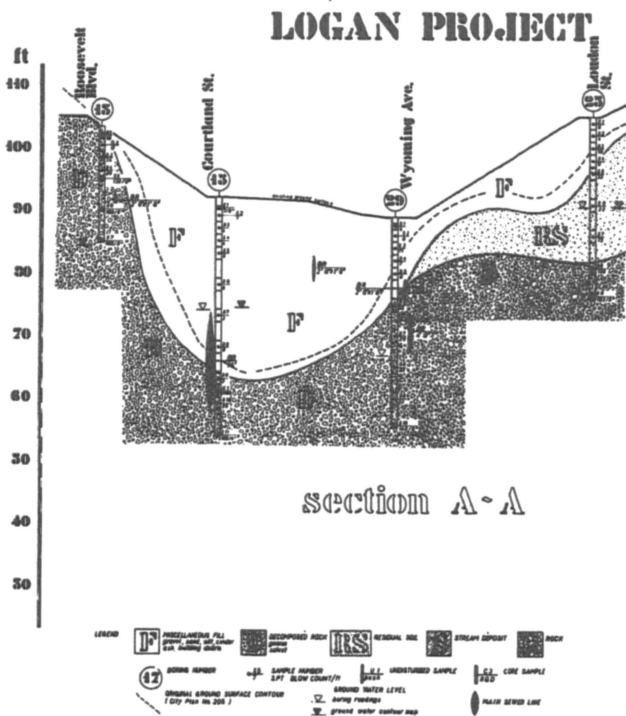
Figure 2 - Geologic Section

A total of 38 test borings were advanced at the site. The SPT's was performed continuously through the fill. All borings were extended to or into the surface of bedrock. The boring results indicated that the site is covered with as much as 40 feet of loose ash and cinders overlying residual soil and decomposed mica schist. Based on test boring results, the following describes the on-site materials.

These were the last formations encountered in the borings. RQD of mica schist bedrock ranged from 7 to 30% in the areas where rock cores were recovered. (Figure 2 presents a general geologic section across the valley)

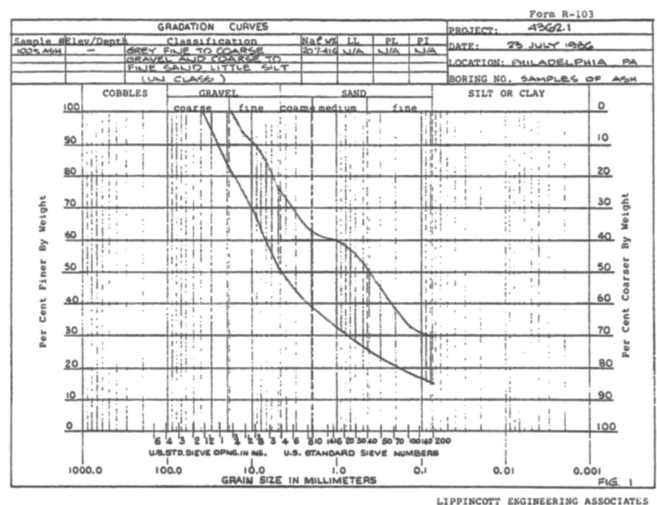
Figure 3 - Envelope of gradation analysis on Ash and Cinders

- 1 - The grain-size of ash and cinders resemble well graded sand and gravel with 17 to 30% fines. (See Figure 3.)

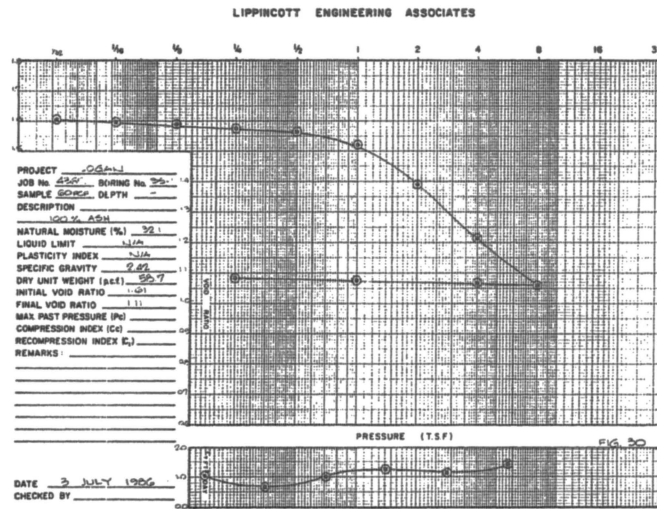
Figure 4 - Typical consolidation curve on Ash and Cinders near minimum density.

1 - Primary consolidation of the loose ash and cinders probably resulted in four to twelve inches of settlement; however, settlement was completed within 12 to 24 months.
