## Study of Ground Movement in a Mining Area

## STUDY OF GROUND MOVEMENT IN A MINING AREA

### ABSTRACT

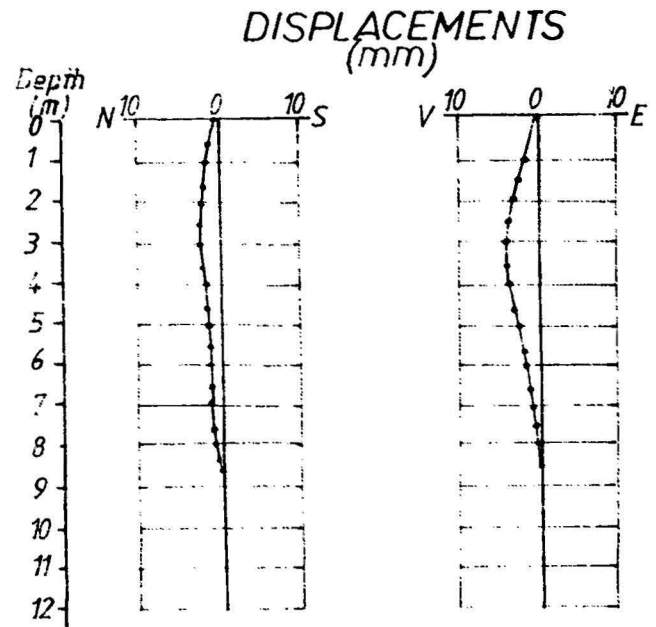
After performing 15 drilled -- holes, those were equipped as inclinometric well. A set of 5 inclinometric measurements was performed during the interval of May 22 ÷ October 15, 1996. The deformation registrations were made by SINCO digital device having an accuracy of 0.25 mm /m. A number of 6 inclinometric wells locations are pointed out in Fig. 1. A special highlighting refers to the inclinometric F 1.1 and F 2.1 located in the relative plate zone, on the alluvial plain. The representatives of company that made the inclinometers were amazed when we designed the above mentioned locations, because they had used the methodology only in order to point out the ground movement in the slope area. We did not abandon the idea explaining them that is necessary to place a row of inclinometers parallel with the dump slope foot in order to verify if any eventual influence of the fill in ground movement exists. The lack of deformation registered in the above mentioned devices strongly confirmed that no influences of dump exist in constructed area. Even the case there was no influence of a mining work highlighted by inclinometric measurements. Only two inclinometers (F 1.2 and F 1.4) pointed out some displacements of the shallow part of colluvial deposits (Fig.2 and Fig.3). However, in the zones were inclinometers F 1.2 and F 1.4 were placed, our field investigations localised shallow landslides pointed out by specific morphological features as described in chapter 2.

Fig. 2 Inclinometric measurements in the drilling F 1.2

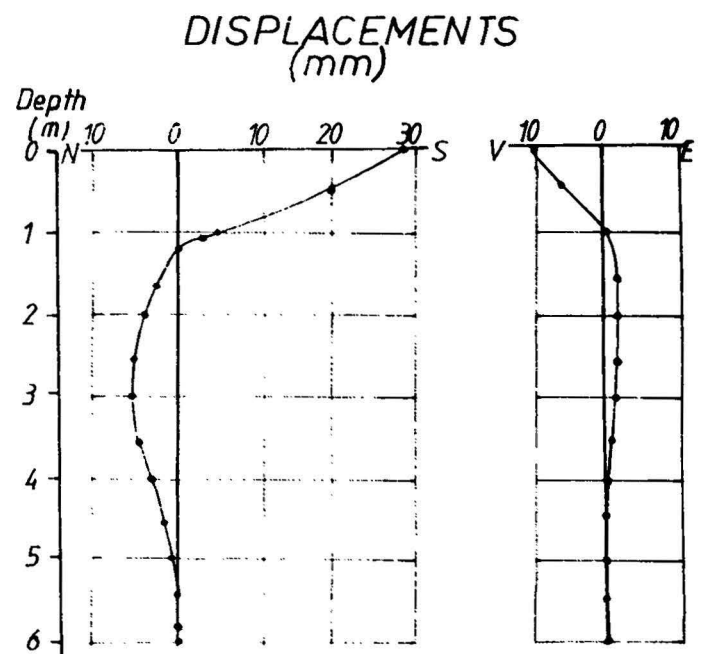
Fig. 3 Inclinometric measurements in the drilling F 1.4

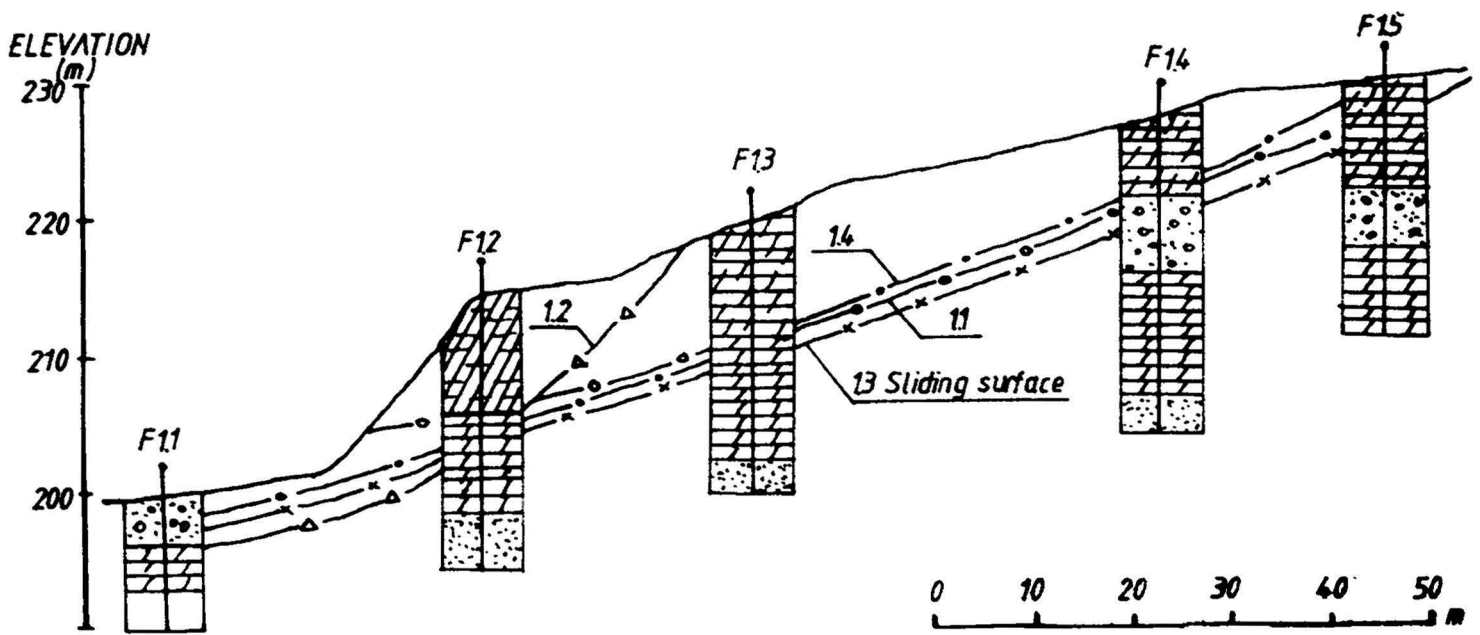
Fig. 4 Stability calculus profile 1-1

The analysis clearly emphasis that the studied slope are characterised by a natural instability potential.

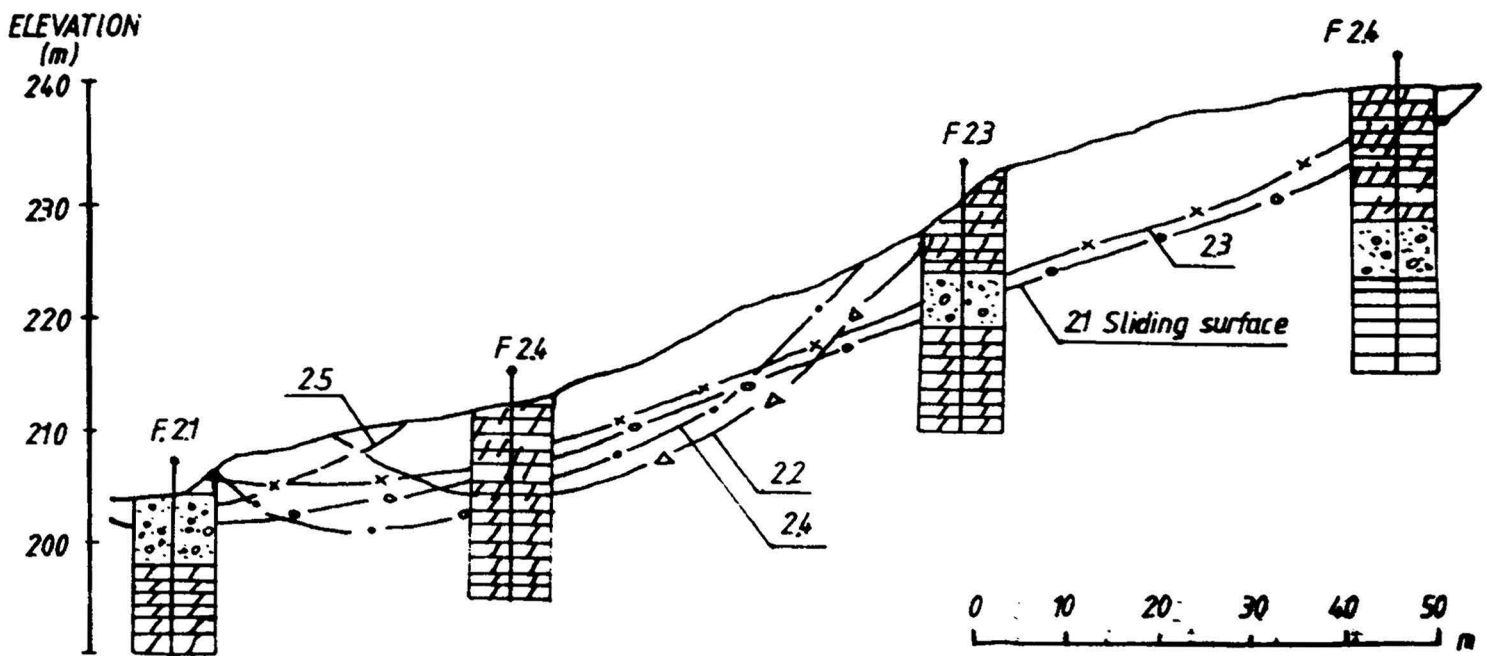
Fig. 5 Stability calculus profile 2-2

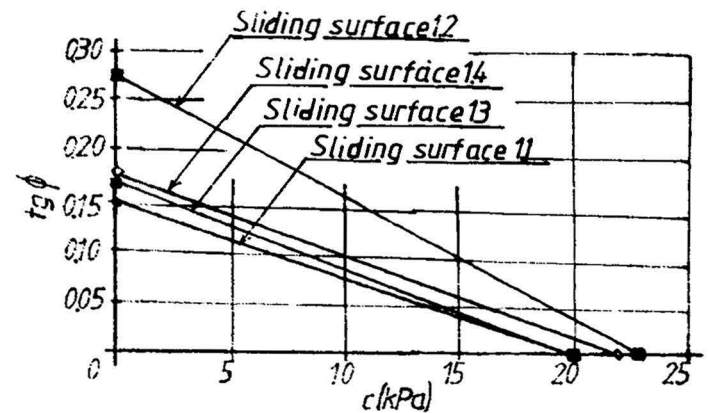
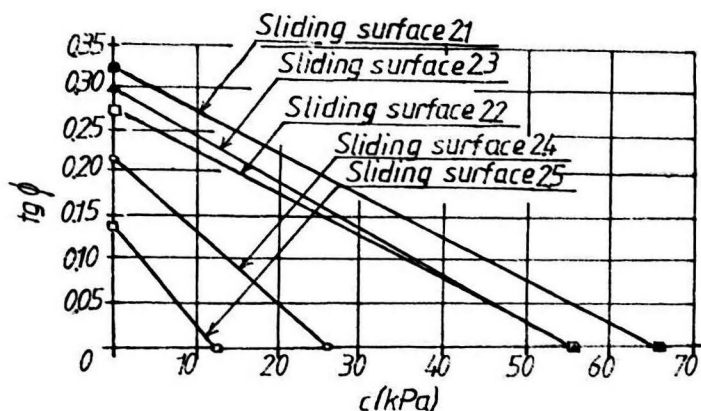
The most probable values of shear strength parameters are confined in the interval  $10^\circ \div 17^\circ$  for the friction angle and  $0 \div 10$  kPa for the cohesion. We also observed, from the diagrams presented in Fig. 6 and Fig. 7 that the long length sliding surfaces, characterised by the smallest values of shear strength parameters, are the most dangerous.

Fig. 6 Results of back analysis for the profile 1-1

Fig. 7 Results of back analysis for the profile 2 - 2

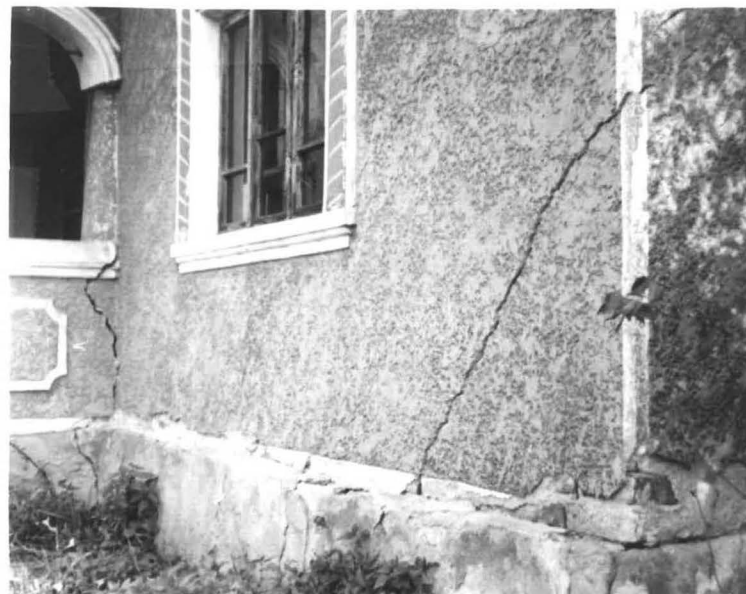
- cracks in walls, having inclined directions at the corners of the buildings, produced by local settlements of the foundation ground; the cracks are spreading becoming even wider and deeper in the foundations;
- breaks of walls and foundations due to global bending of the building, as a consequence of differential settlements,

Photo 2. Damages registered at building No. 14

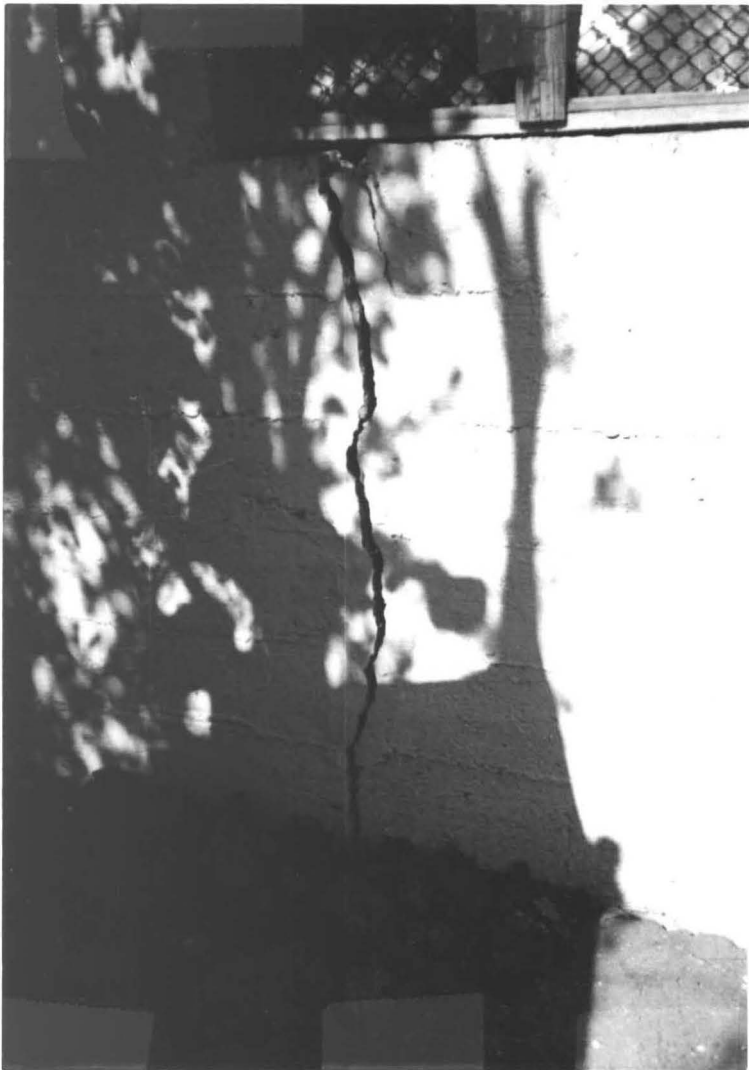
*Photo 3. Damages registered at building No. 53*

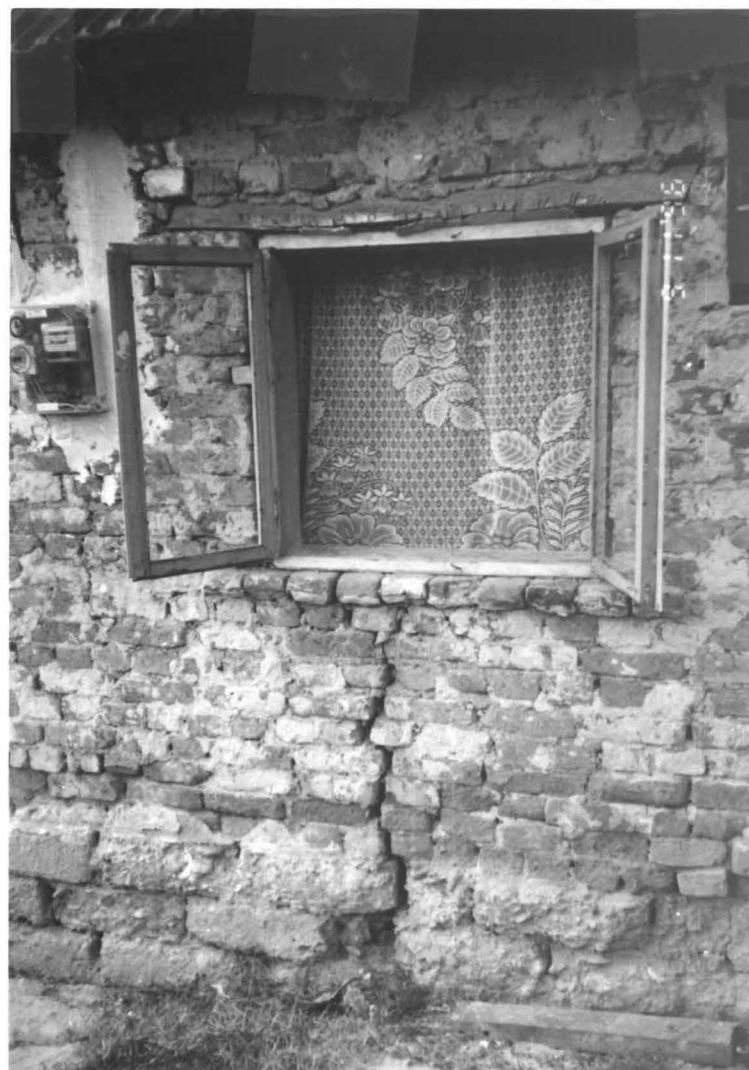
- the utilised bricks are characterised by low quality being hand made and insufficiently burnt; moreover, the masonry is poorly executed, presenting regions with non interlaced joints partially filled with mortar (Photo 4);

*Photo 4. Construction defects at the building No.49*
