Rock Borer Attack on Juaymah Trestle Concrete Piles

SYNOPSIS Rock boring mollusks and sponges are infesting the concrete cylinder piles supporting the Juaymah NGL Trestle located in the western Arabian Gulf. The calcareous aggregate used in pile fabrication provides a favorable substrate for borer activity. Rock boring organisms are common in the Arabian Gulf and typically inhabit nearshore reefs and exposed limestone bottom areas. Although the entire trestle wetted area is subject to attack, infestation is concentrated in the area adjacent to reefs and limestone, on the down current pile face and near the water surface. Boring organisms pose a significant threat to the trestle structural integrity, in that boreholes will deteriorate concrete and expose outer pile reinforcement to corrosive sea water. Serious pile damage is imminent. The entire submerged portion of the structure will be adversely effected if repairs are not performed. Pile deterioration to date has been retarded by the excellent durability of the concrete cylinder piles. Several pile repair systems have been evaluated. Molded fiberglass jackets with epoxy grout fill were selected on the basis of borer and abrasion

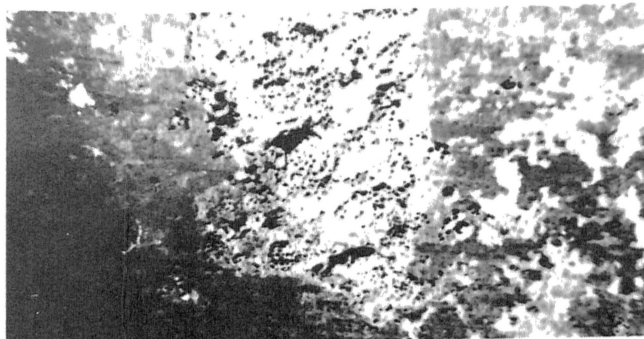
Generally, inspection records indicate surficial marine growth consisting of white coral, barnacles, red coral and sponges. Cleaned pile surfaces contained small cracks, closely spaced shallow holes and more widely spaced deeper holes (See Figures 5 and 6). Cracks were usually faced with a hard white substance, indicative of calcium carbonate efflorescence (autogenous healing). Closely spaced sponge holes were observed at one location on the 19 piles inspected. Measurements indicated upto 1600 holes per 0.1 square meter, averaging about 15mm in depth. The pile surface in this area was reported to be slightly depressed as a result of surface slaking.

Figure 5 Pile Surface With Closely Spaced Sponge Boreholes

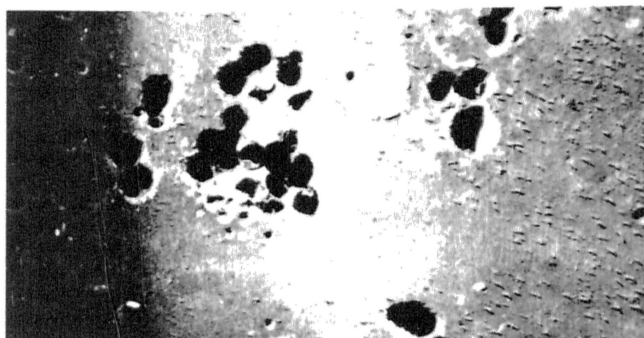
The more widely spaced holes were occupied by small mollusks. Spot measurements recorded concentrations of up to 200 holes per 0.1 square meter with an average count of about 5 to 10 holes per 0.1 square meter on the down current pile face. The measured holes ranged up to 35mm deep and 13mm diameter, but average infestation was about 20mm deep by 6mm diameter. For the most part, borer attack was

concentrated on the down current side of the piles, on the south through west quadrant. Mollusk and sponge specimens were retrieved for identification and study.

Figure 6 Pile Surface With Mollusk Boreholes

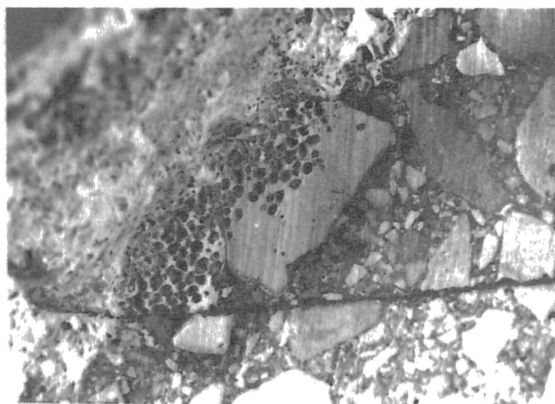
Concrete adjacent to the sample surfaces contained numerous small holes and several large holes. Small clustered holes were identified as sponge attack (See Figure 7). This form of infestation was limited to aggregate in the outer concrete surface. Aggregate exposed to sponge were perforated with holes averaging 1mm in diameter and extending to 15mm. Larger mollusk boreholes were up to 15mm deep and 5mm in diameter. Generally, mollusk holes extended through both aggregate and cement, and were coated on the interior with a thin calcareous film (See Figure 8).

Figure 7 Sawcut Pile Section showing Sponge Infestation in Concrete Aggregate

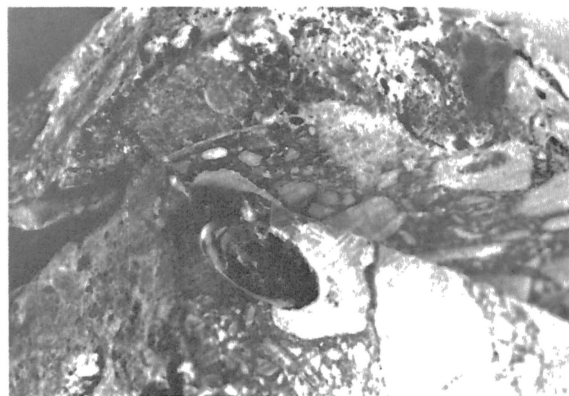
Figure 8 Mollusk Borehole In Sawcut Pile Section

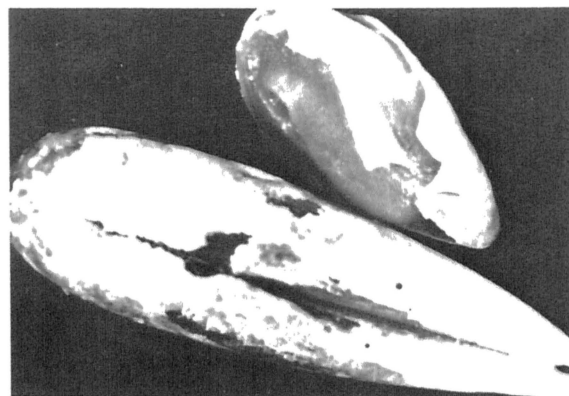
Specimens of the rock borers have been identified as genus *Lithophaga*, rock boring mollusk, (See Figure 9) and genus *Cliona*, rock boring sponge. Their existence in the Arabian Gulf is well documented in marine biological literature (Vita-Finzi & Cornelius and Thomassin 1973). Both organisms are filter feeders, deriving nutrients and oxygen from surrounding water. Both bore primarily by chemical action, favoring calcareous substrates. The pattern of infestation differs markedly between the organisms. The mollusk attack is widespread and relatively deep, while the sponge attack is localized and shallow.

figure 9 Rock Boring Mollusk-Genus *Lithophaga*
