International Conference on Case Histories in
Geotechnical Engineering

Landslides in Shale-Derived Glacial Till

LANDSLIDES IN SHALE-DERIVED GLACIAL TILL

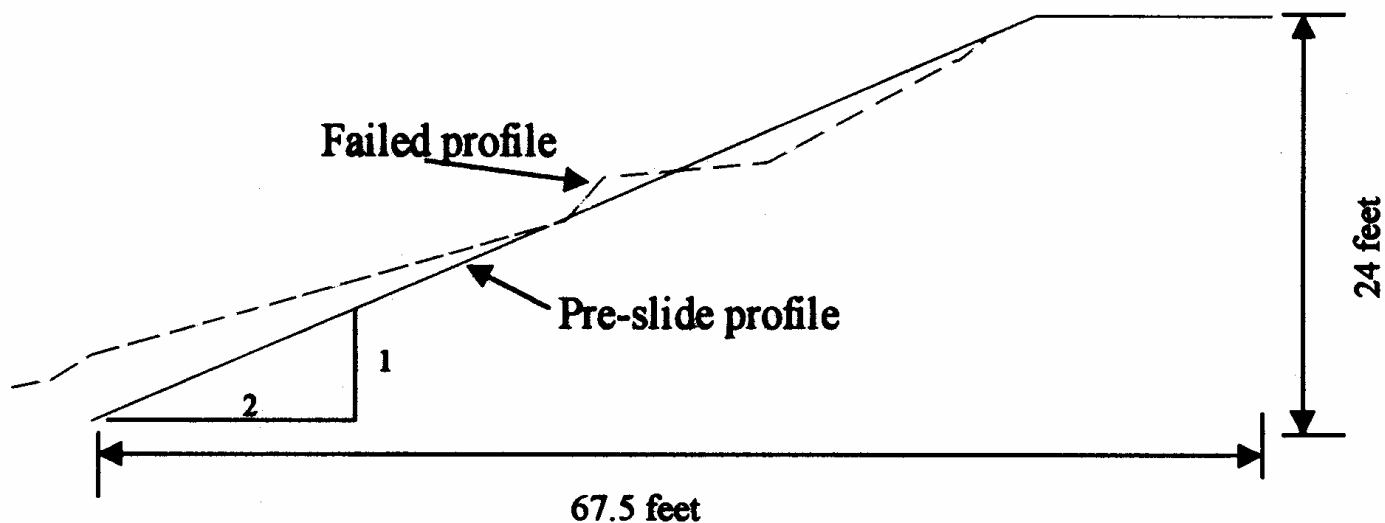
The foreslope, shown in Fig. 1, is 24 ft (8 m) high at a 2:1 slope and on the north side of the embankment. The slide is classified as a translational slide in which a few blocks of fine-grained soil have failed along a shallow failure plane approximately 2.5 feet (0.75 m) deep. The failure plane is approximately parallel to the slope of the existing embankment. During fieldwork in April 1999, it was observed that the soil in the failure zone appeared wetter and with an aggregated structure that differed from the soil samples collected from the borings and the soil on the surface adjacent to the slide. A similar landslide existed on the south side of the roadway but was not studied in detail.

Fig. 1. Typical cross section of U.S. Highway 34 slide, Monroe County, Iowa.

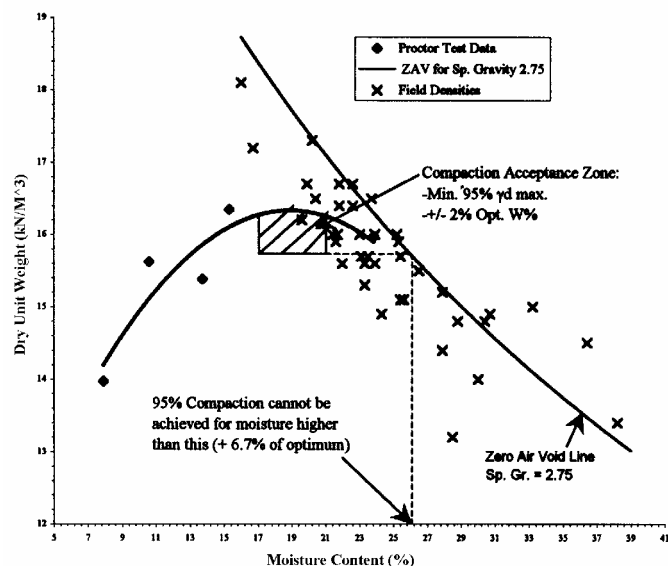
Standard Proctor tests conducted on composite samples determined a maximum dry unit weight of 105 pcf (16.5 kN/m³) at an optimum moisture content of 19%. The unit weights of compacted embankment soil, determined from 37 Shelby tube samples, were compared with present day recommended specifications of a minimum compacted soil density of 95% of γ_{dmax} and a moisture content of $\pm 2\%$ of OMC. The dry unit weights of the compacted samples range from 87.8 pcf (13.8 kN/m³) to 115 pcf (18.1 kN/m³) with field moisture contents from 14% to 38.5%. Nearly 42 % of the samples from the interior of the embankment are below 95% relative compaction that is recommended (Bergeson et al. 1998); however only 13% have unit weights below 90% maximum dry unit weight. The field moisture contents of 81% of the samples are higher than the optimum, suggesting that the soil imbibed moisture subsequent to construction, as can be seen in Fig. 2.

Fig. 2. Standard Proctor density and field density results for embankment soils.

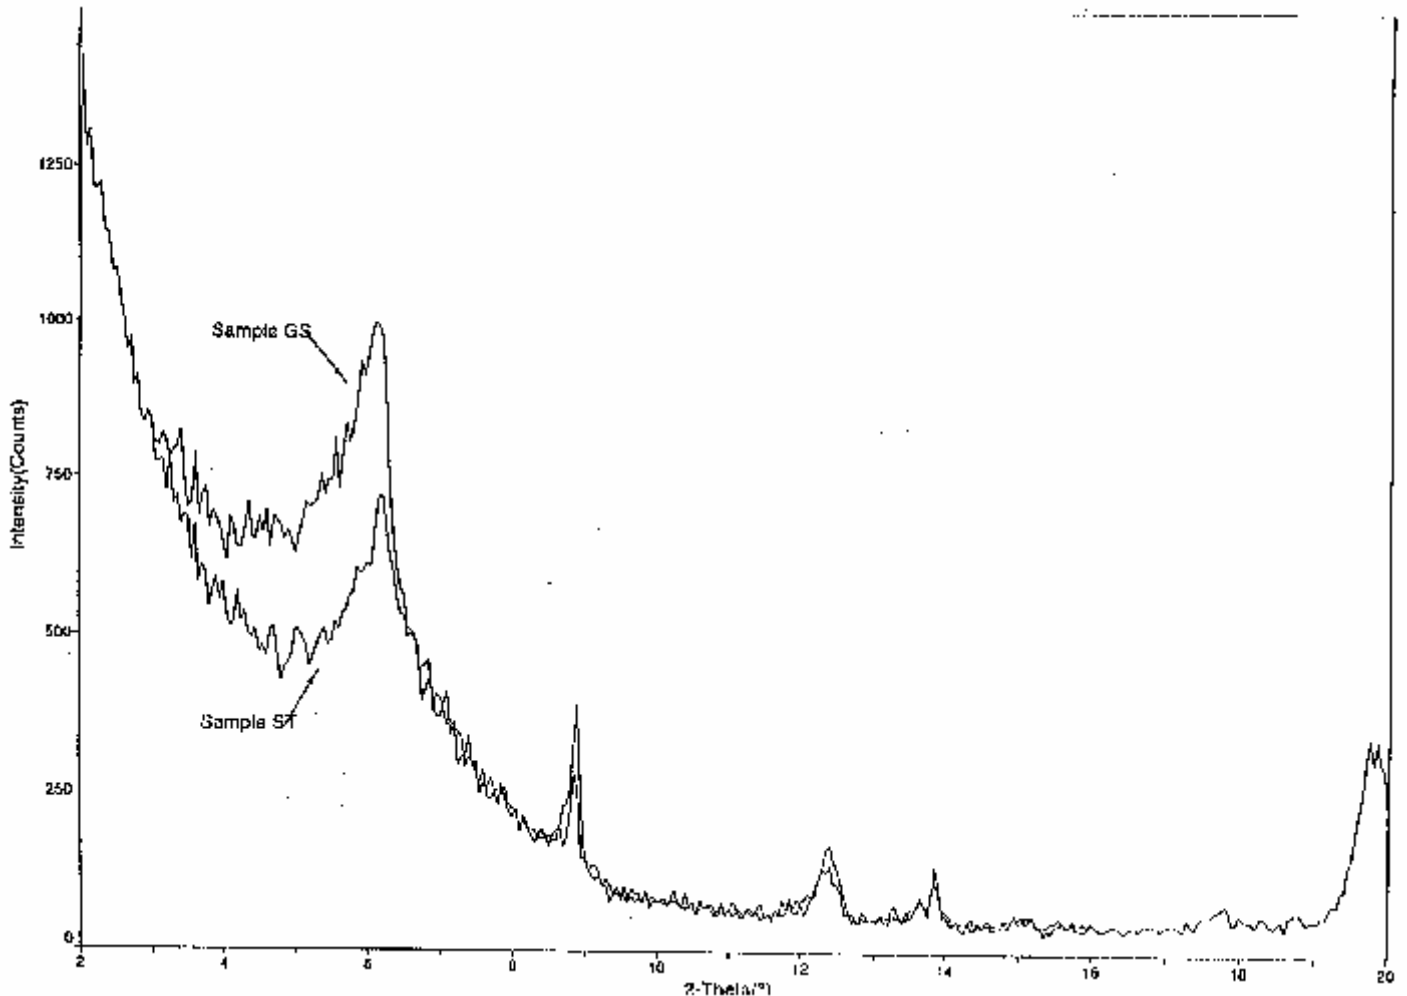
X-ray diffraction tests were carried out on both the grab samples from the failure zone and Shelby tube samples from the interior of the embankment to determine their mineral composition. Fig. 3 shows an overlay of the X-ray diffractograms from the grab samples from the surface and Shelby tube samples. The composite diffractograms show that both soils are similar in mineralogy and composed of clay minerals, quartz and feldspar. The clay minerals were dominated by montmorillonite (Schlorholtz 2000). This supports the description from the soil survey report (Oelmann 1984) of the Gosport soil series having high shrink-swell potential on drying or wetting. The diffractogram from the grab sample shows a slightly broader montmorillonite peak, which may indicate the presence of intracrystalline moisture and perhaps a different exchangeable cation in the failure zone soil. This subtle difference could account for a lower shear strength in the soil at the surface of the embankment. The surface clay will swell on coming in contact

Fig. 3. X-ray diffractograms for soil from failure surface and from interior of embankment.
