Failure of a Pipeline in an 800-year Old Debris Fill

FAILURE OF A PIPELINE IN AN 800-YEAR OLD DEBRIS FILL

Paper No. 9.16L

In June of 1994 a 20-m section of 1.4-m diameter, restrained-joint, ductile iron pipe failed during construction of a new section of water pipeline for the city of Cairo in the Arab Republic of Egypt. The failure occurred in an area where the pipe was supported on piles, and compacted silica sand was used as side support for the pipe. Soil above the crown of the failed section of pipe was 6 m or more in thickness. Results of a detailed review of the failure revealed that a number of unique and related factors apparently caused the failure. The most significant of these causes was the native soil surrounding the pipeline, which was formed from an accumulation of 800 years of building and construction debris. At the location of the failure the debris was in excess of 15-m thick. When subjected to water at this location, this debris underwent significant settlement, which eventually led to loss in side support for the pipeline. To repair the pipeline and to avoid future similar failures, a utilidor was used to protect the pipeline in areas where overburden thick

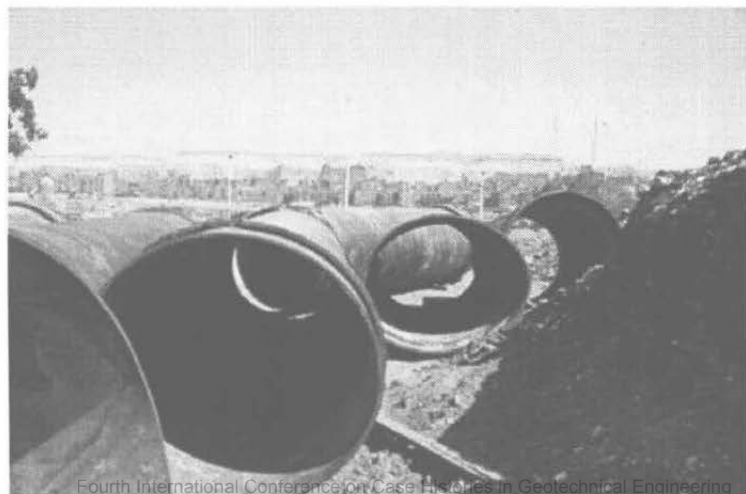
drained and inspected. During that inspection, the engineering staff observed that the diameter of the pipe had deformed downward from 10 to 20%, and the diameter at the springline of the pipe had increased in a similar amount. These measurements indicated that the pipe had ovalled, the extent of which was sufficient to break the seal at the pipe joints.

The ovaling of the pipe at Reservoir 1 was clearly visible when the backfill was removed (Fig. 2). The deformations of the ovalled pipe sections were sufficient to cause the concrete lining of some of the most heavily deformed areas to crack and fall away. The pile cap was also extensively damaged over a 23-m distance, with the Delta piles typically punching up through the pile cap in a number of locations (Fig. 3). The sand fill that was removed in this area was very wet (e.g., moisture contents in excess of 50%), relative to when it was placed and relative to the surrounding Darassa fill.

Fig. 2 Damaged 1.4-m diameter pipes.

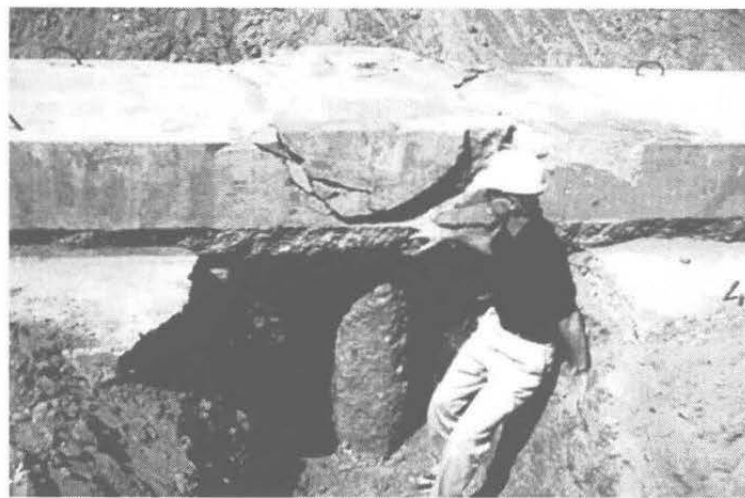
Fig. 3 Punching shear failure of Delta pile through pile cap.

An elevation survey was also conducted on the pile cap after the pipelines were exposed. Results of this survey indicated that the settlement of the pile cap for the undamaged sections of the pile cap was negligible. On-the-other-hand, there was clear evidence of settlement of the pile cap in the areas that had failed. Although the movement of the damaged section was thought to be due to the punching shear failure resulting in the pile cap moving downward relative to the piles and not due to pile movement, the movement did introduce the possibility that the Delta piles might have plunged downward some

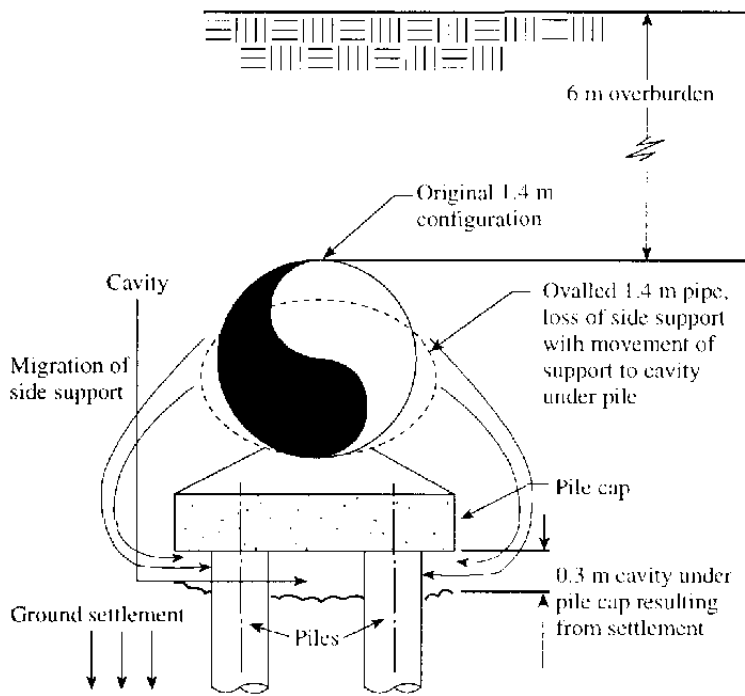
A second revealing observation was also made in the area of the pipe failure. Along with the settlement, there was as much as 17 cm of silica sand between the bottom of the pile cap and the top of the mud slab. This silica sand was the same sand that had originally been placed as trench backfill. Laminations of irregular thickness were visible in the sand, suggesting that the sand had flowed from the trench into the void on more than one occasion. It was later hypothesized that the sand had been washed into the void by water that had accumulated in the trench when a connector pipeline leaked (Fig. 4).

Fig. 4 Hypothesized Pipe Failure Mechanism.

- A water leak at the saddle connection caused significant settlement in the Darassa fill below the base of the pipe trench, resulting in a cavity forming beneath the pile cap.
- The water saturated sand fill surrounding the pipe was slowly washed into the cavity below the pile cap, resulting in a progressive loss of side support along the springline of the pipe.
- As the side support was lost, the pipe deformed, eventually resulting in more water leakage from the water-tight seals at the pipe joints and further flowing of the sand fill into the void.
- The pile cap failed in punching shear when the pile cap-pipeline-soil system adjusted to a new state of equilibrium under the soil and water loads.

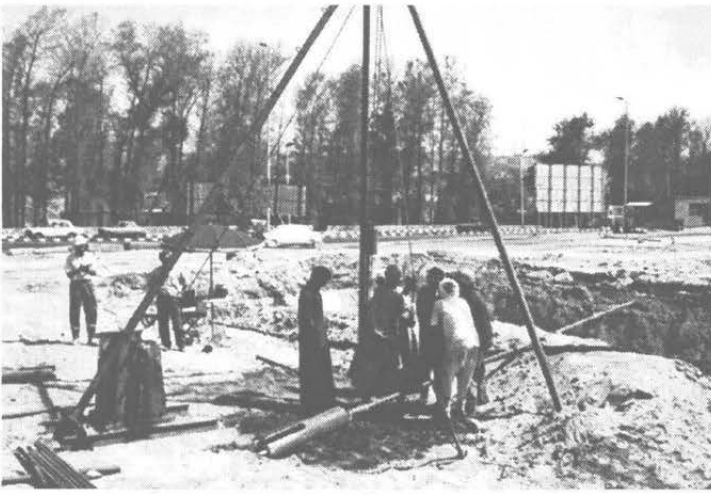
The geotechnical explorations included five borings drilled by hand-auger bucket methods (Fig. 5) through the Darassa fill approximately 1 to 2 m into the underlying dense sand. Modified penetration tests using a 100-mm outer diameter by 83-mm inner diameter split-spoon sampler driven by a 64 kg hammer were conducted at approximately 1-m intervals in the Darassa fill; SPTs were conducted in the dense sand underlying the Darassa fill. The objectives of these explorations were (1) to determine the consistency of the fill and sand in areas where maximum settlement had occurred and (2) to collect representative samples of soil for laboratory classification testing. Undisturbed block samples of the soil were also obtained from the test pits dug below the pile cap.

In general results of these explorations were very consistent with those performed as part of the original design. Blowcounts from the modified penetration tests and the SPTs were similar to those recorded previously. Laboratory tests confirmed that the Darassa fill was a mixture of gravel, sand, silt, and clay-size materials with from 50 to 80% sand-size or coarser. Water contents for samples ranged from less than 10 to as much as 50%, with the highest values being recorded in the vicinity of the pipeline break. Consolidation tests conducted on specimens trimmed from the block samples suggested that vertical strains would be up to 3% when water was added after consolidating the samples to the estimated overburden pressure.

Fig. 5 Hand-auger bucket soil boring.

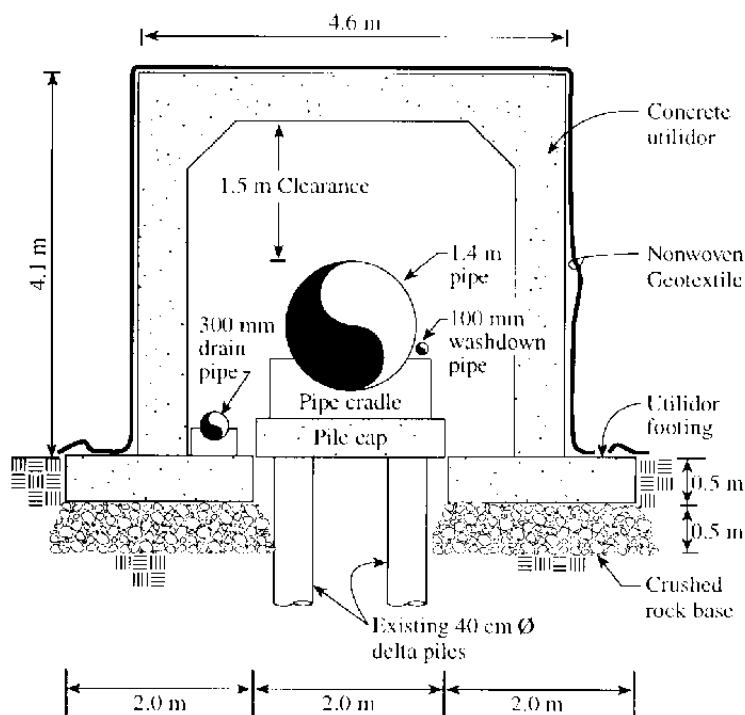
Fig. 7 Reinforced Concrete Utilidor Section.

Utilidor Alternative. The proposed concrete utilidor, Alternative 1, is shown in Fig. 7. The design concept for the utilidor was to use the concrete structure to carry the trench overburden loads around the existing pipe, pile cap, and piles to new strip footings located on either side of the pile cap. The design concept was also to allow the utilidor structure above the pipe to settle independently and articulate according to the ground movement without affecting the pipeline.

The utilidor consisted of precast concrete "U"-shaped sections each approximately 3-m long and each spanning approximately 4.6 m with a height of 4.1 m. The utilidor sections were designed such that they were not connected to the footings nor to each other, allowing differential movement to accommodate ground settlement.

Each utilidor segment was supported by a relatively flexible, lightly reinforced concrete strip footing 2-m wide and 0.5-m thick. To prevent backfill materials from entering between the segments, a loosely laid nonwoven geotextile covered the exterior face of the utilidor. In addition, the utilidor was developed with a manhole entrance at either end for human access to permit long-term visual inspection and maintenance

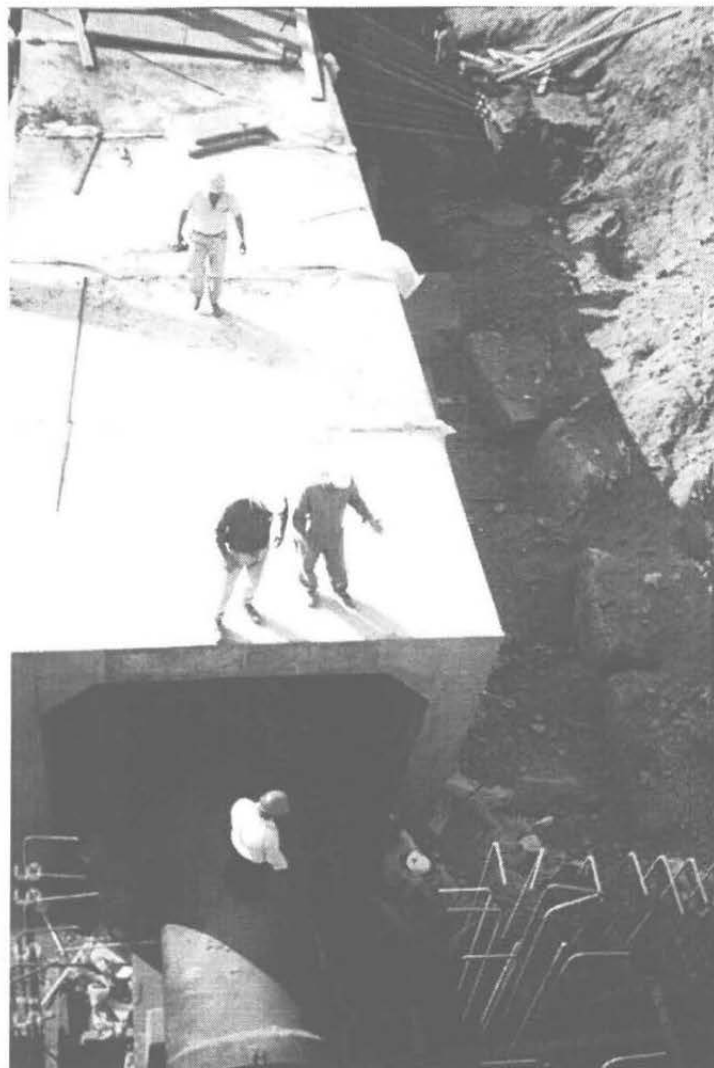
Fig. 8 Utilidor construction over 1.4-m diameter pipe.

During the work, the flooding and monitoring stage occurred within 7 to 10 days, with minor subsurface settlements occurring at Reservoirs 1 and 3 and no settlement at Reservoir 2. The utilidor and pipe encasement construction occurred in stages utilizing re-usable wooden gang forms (Fig. 8). Upon completion of the work and the proper concrete cure period, backfilling over the work took place, and the original construction grades were established. Settlement monitoring of the utilidor structures occurred throughout the backfilling operation.
