Foundation Problems in a Developing City

SYNOPSIS Foundation problems are normally associated with type of sub strata, soil, rock or any other foreign material met with, and/or if choice of foundation is not compatible with them. In developing cities, the development stress is on highly developed congested areas, limiting the sub soil investigation, and plans to have high rise buildings, requiring deep foundations and some times execution of these posing site problems. The collapse of a multi-storeyed structure caused, according to geotechnical engineers due to overlooking the existance of a drain and a few cases of "composite" foundations are described.

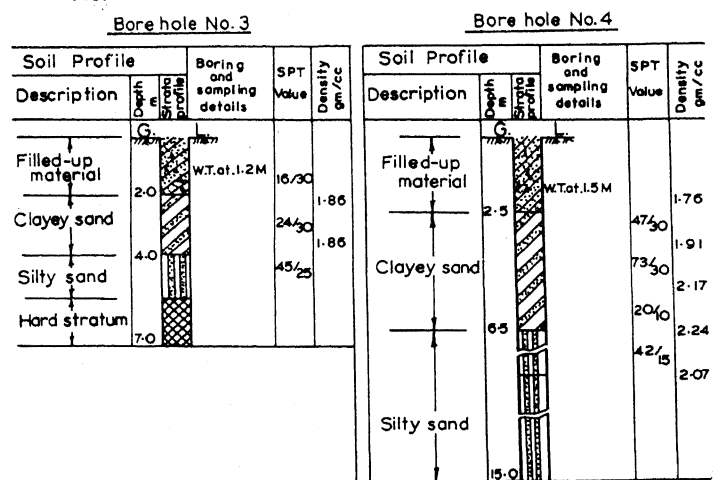
FIGURE 3: TYPICAL LOGS OF BORE HOLES

The complex contained two floor shopping blocks and multi-storeyed buildings with maximum 14 floors. In general for all structures the designers preference was single or a group of piles as foundations, with single or double under reamed bulbs of diameter 37.5 cm and 45 cm diameter, giving reduced load carrying capacity of order of 24 tones and 27 tonnes at 65 % efficiency due to high water table conditions prevailing at site. The Indian Standards Code of Practice (1973) was followed. The heterogeneous filled up or remnants of old structures, as expected in the area, presented lot of difficulties for manual auguring or under-reaming for piles and sometimes the bailing out of the material was done by sending the person inside the bore to remove chunks of hard lime-mortar of old structures. Damage to boring and under-reaming tools was experienced right through. Following three typical situations are presented, which are not common and are difficult to analyse applying geotechnical theories or practices known to the authors.

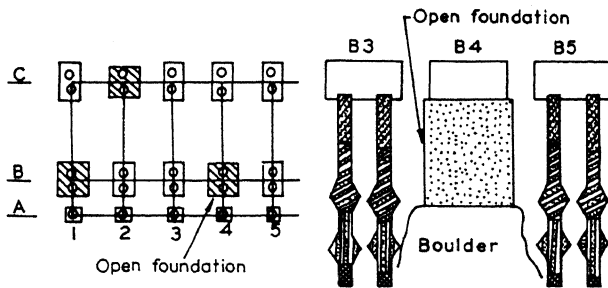
Fig.4: Under reamed piles with open foundations

In the shopping block, where perhaps in general open footings would have taken care of loads of two storeyed complex, a group of two under-reamed piles were adopted under columns. A big boulder of size 2 to 2.5 metre in diameter, extending to more than two metres in depth, obstructing piling operation, left no other alternative except to adopt a "composite" foundation, that

is an open footing of size 1.8m x 2.5m depth under one column resting over the boulder and adjacent columns resting over a group of two under-reamed piles, as shown in Fig.4. Under-reamed piles are the cast-in-situ piles, and the piling was taken up one by one and hence change in design of foundations was not possible. At least for four columns, in the complex, similar "composite" foundations were adopted.

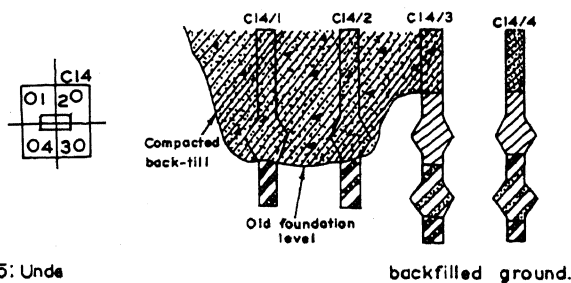
Fig. 5: Under reamed piles with open foundations

In the multi-storeyed housing complex in the same area, a group of four piles was provided for column footings. After two piles were completed namely C 14/3 and C 14/4, as shown in Fig.5, the two piles C 14/1 and C 14/2 could not be driven due to the foundation of an old building obstructing the piling operation. This situation was tackled by removing the old structures by excavating a pit three to four meters deep upto hard strata and back filling it by selected gravelly material belonging to "GC"- "SC" group of soils. The two piles, C 14/1 and C

14/2 of the group, were subsequently completed but could not be driven upto the depth of other two piles C 14/3 and C 14/4 due to the hard strata met with. The piles were left, without under reaming and their bottom tips resting at different elevations. The single piles of different lengths, with and without under-reaming when tested were found to satisfy the designers. But prediction of behaviour of group of four piles, was not possible from the test piles, and even theoretical analysis was not feasible from soil properties. The matter was discussed and opinion of structural designers and geotechnical engineers deferred leaving the owners with no other choice than to stop the construction with four floors against fourteen initially planned and to wait and watch the behaviour of structure. This has been described as case of indiscriminate use of under-reamed piles by Saxena et al (1978).

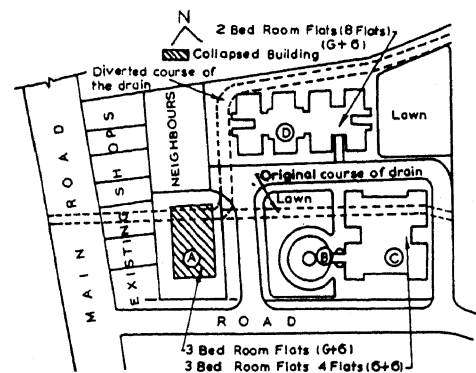
Fig.6: Plan showing collapsed building.

The six storeyed completed but unoccupied building which failed, was one of the seven buildings located in the area of 8000 sq.m as shown in Fig.6. The area was relatively low lying, originally under cultivation collecting drainage water of surrounding areas. A drain about metre and a half deep, originally crossed the area of the collapsed building, but was diverted to pass around the collapsed building in open land. The building rested on columns and transferred load of 50 tonnes through a group fo two under reamed piles of 37.5 cm diameter and 70 to 75 tonnes through a group of three under- reamed piles with rectangular and triangular caps respectively. The columns were not connected through plinth beams. The sub soil investigation report and results of tests on foundations soils and piles were not available. A few open pits and general topography of surrounding rocky and bouldery terrain seams to have guided the designers, and banking more on their experience with under-reamed piles and Codes of Practice.

The collapse occurred in early hours of the day, after heavy rains in the area on the preceding evening. The drain was running full and area was practically submerged. The distress in the building with spalling of plaster in the ground floor partition wells was observed 30 minutes before collapse. As reported, the north western corner of the building sank into the ground with a hissing sound. One of the versions was that soon after

the water storage tanks were filled up in the morning for the first time, the distress was followed and failure took place. The demolition of the building was taken up by the owner-engineer with in 24 hours after the failure and operation was over with in 48 hours giving no time for inspection. The left over was that the North-Western columns were completely sunk in the ground, while on south-eastern side about a metre length of the columns were seen, at an inclination of 10{o} to 15{o}. There was no heaving of the ground around the foundation.

As reported by Ali et al (1982) the examination of full length of pile by open excavation was not possible due to high rate of water inflow from surrounding areas. Two distinct features were noticed with respect to piles. In some cases, the columns had pierced through the pile caps into the soil, in between the pile groups, slanting generally towards north-west. In some other cases, the piles had inclined about 25{o} from vertical towards the drain and it was noticed that bulb were about 75% of the designed diameter and shafts were irregular and number of pile in a group were less than planned.

It is experienced that bias in collecting data and interpreting results is difficult to be avoided or even minimized. Ali et al (1982) considered collapse due to the "progressive shear failure of pile caps" and due to low strength concrete. However, the other buildings, as shown in plan Fig.6 constructed by the same agency and at the same time did not suffer distress. Rao (1987) considered, the primary cause of collapse of the building was due to liquifaction of top "sandy clay" adjoining storm water drain resulting in loss of lateral support of piles. The area was highly congested even about a decade back, with very high commercial value in the new city. The history of the site, that is the once cultivated land, lowest in elevation and serving as a drain of surrounding high rise terrain and further change in urban hydrology due to increase in built up areas was completely over looked by planner and the designer. Experience with engineering is hardly a substitute of these factors.
