A Case History of the Collapse Accident of a Temporary Earth Support Structure

SYNOPSIS: This paper presents a case study on the collapse accident of a temporary earth support structure. The examination of the design plans and investigations of the construction site where the accident occurred has been carried out to throw light on the accident situations. Some causes of the accident occurrence which have been derived from these examinations and countermeasures for prevention of these types of accidents are discussed.

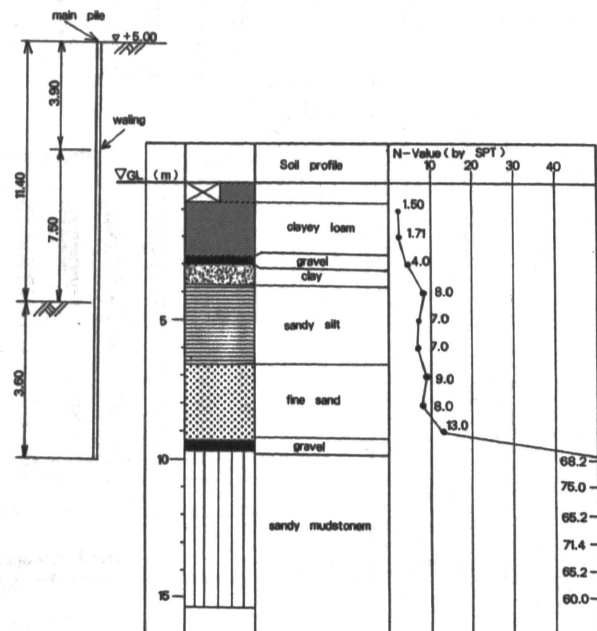
Fig. 2 Boring log of the construction site

Geological survey of A construction site was not performed. However, only one boring investigation had been conducted for the construction of the foundation piles. The location of the boring is shown in Fig. 1. Fig. 2 is the result of the boring investigation. According to this boring log, the ground consisted of cohesive soil (Kanto Loam) from ground level (GL) to -4 meters, sandy silt from -4 to -6.5 meters, fine sand from -6.5 to -9.5 meters and sandy mudstone below -10 meters. The N-value of the sandy mudstone was around 60 and other soil was less than 10. The ground water level was GL-1.5 meters.

According to the calculation sheet, the safety factor for overturning of the main piles was 1.2 and penetration depth of the main pile was 3.6 meters. The greatest part of the penetration portion was the fine sand and only 30 centimeters of the pile toe penetrated into the sandy mudstone (see Fig. 2). Resisting moment due to this 30 centimeters penetration portion covered about 40% of total resisting moment.

Since excavation work is concerned with natural ground, geological surveys and soil investigation which were conducted before the execution of the construction are very important. In this construction site, only one boring investigation for the construction of the foundation piles had been performed. No ground surveys were performed around the area where the collapse occurred. In cases where the ground is of a complex shape or the ground condition is not clear, the preliminary ground surveys should be conducted. Surveys during the construction are as important as the preliminary survey. Detailed changes in ground conditions could not be known by the preliminary survey and the behavior of the ground caused by the execution of excavation could be known, and based on them, if necessary the construction plan should be properly modified and the remedial work should be carried out as soon as possible.

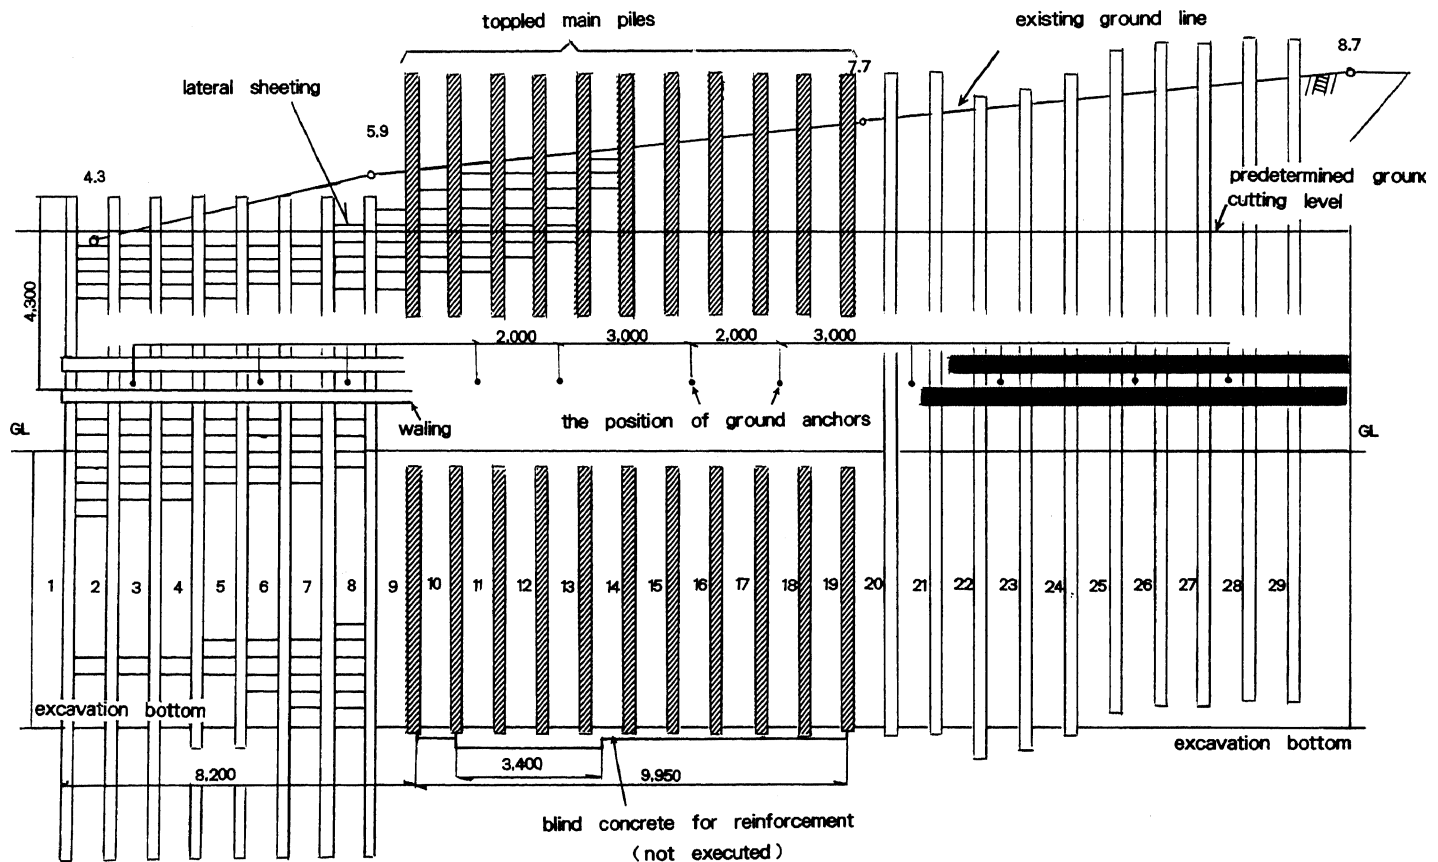
Fig. 3 The elevation of the collapsed earth support structure

At around 1:15 P.M., central 15 meters of the temporary earth support structure on the east side collapsed and 200 cubic meters of earth, 7 ~ 8 meters high and maximum thickness 4 meters, slid into the excavation area. Due to this collapse, 11 of the H-steel piles toppled. Four workers at the bottom of the excavation site were buried alive and three workers were struck by H-steel piles. As a result, five workers were killed and two others were injured. The elevation of the collapsed earth support structure is shown in Fig. 3.

The east side of the construction site where the collapse occurred was a hill shape of GL+5 ~ +10 meters (see Fig. 3). According to the construction plan, after this hill had been cut to GL+5 meters level, then 15 meters main piles would have penetrated the ground. However, the field engineer performed ground cutting without checking the excavated ground level with the assembly diagram, therefore the hill shaped ground was not cut to the designed ground level. In spite of the lack of ground cutting (GL+8 ~ +9 meters), the penetration work of the

main piles were carried out. As a consequence, it follows that 21 of the main piles had not penetrated to the predetermined ground level (except for 8 piles on the north side) as shown in Fig. 3.

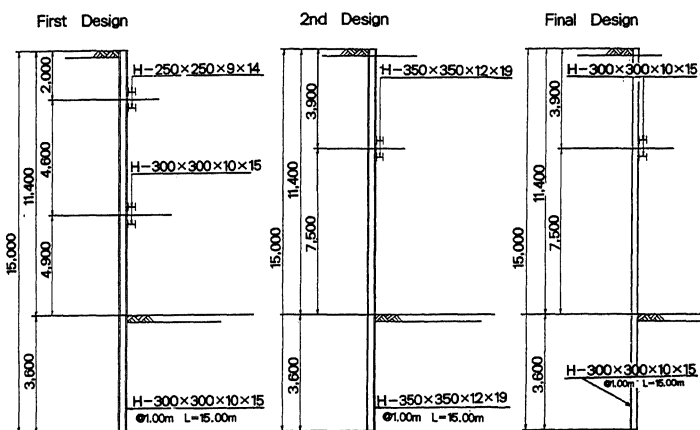
Fig. 4 Designs of main piles and ground anchors

meters and the 2-stage ground anchors were adopted. However, by the judgement of the field engineer, the design plan was changed to use a single-stage ground anchor and a 350*350 H-steel pile. Finally, 300*300 H-steel piles were used as the main pile (see Fig. 4).

In this construction, the temporary earth support structure was designed from the economical point of view or by the reason of material procurement at the site. For example, the 2-stage ground anchors were changed to single-stage anchors and the size of the H-steel piles were reduced (see Fig. 4).

In general, temporary structures are liable to be designed where priority is given to economic restrictions. From an engineering viewpoint, a design which realizes the importance of safety should be used to prevent collapse accidents.

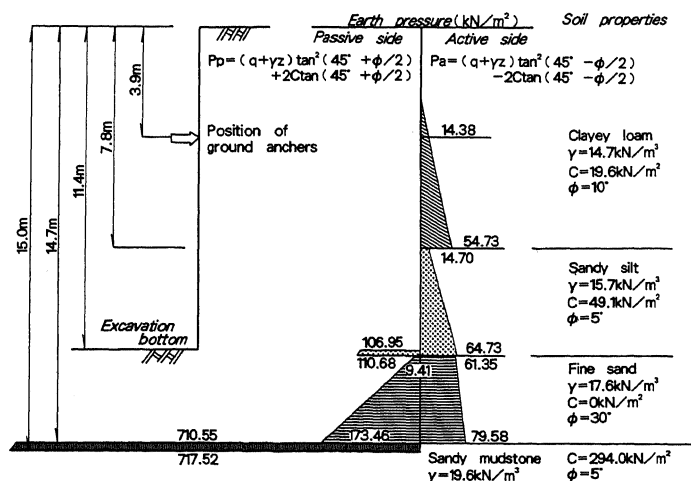
Fig. 5 The earth pressure distributions for the determination of the penetration length of main piles

Earth pressure distributions for determination of the penetration length of the main piles are shown in Fig. 5. If there was a lack of penetration of 30 centimeters, the safety factor for overturning was reduced to 0.7. Considering the accuracy of the penetration work of piles and the uncertainties of the ground conditions in this construction site, these design procedures, in which about 40 % of total resisting moment of the main piles was covered with the lowest 30 centimeters penetration portion, are undesirable.

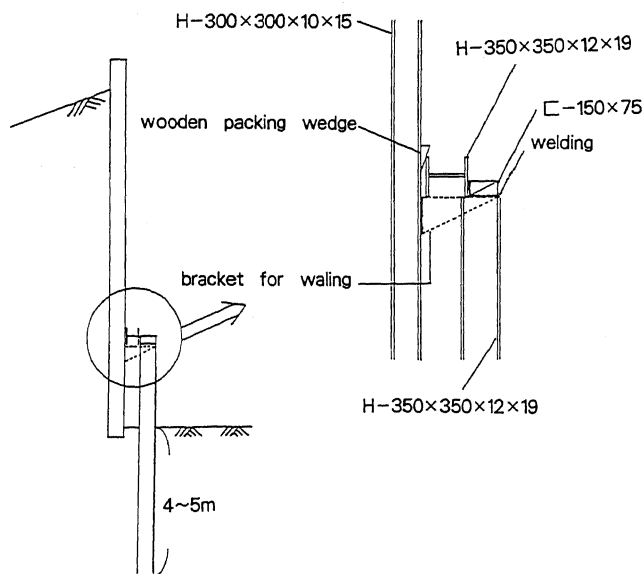
Fig. 6 The schematic diagram of remedial piles

In this construction site, insufficient penetration of the main piles on the east side was found just after the first excavation had finished and the remedial work had been done using H-steel piles available at the site. Additional remedial piles were driven in front of the main piles and the schematic diagram of remedial piles is shown in Fig. 6.

However, the strength of remedial piles had not been examined at all. In cases where such mistakes are recognized during construction, a detailed checking of such mistakes has to be made and effective remedial countermeasures should be taken immediately.
