The Santa Helena Dam on Compressible Foundation

The Paper describes the performance of a 28 m high compacted earthfill dam for water supply in Northeast Brazil. For mainly economic reasons, the dam was founded, in part, over soft to very soft silty clays to a depth exceeding 8 metres. Large diameter sand drains were provided to accelerate consolidation in the foundation during construction. Maximum construction settlements of approximately 240 cm were recorded. Results of settlement of spillway structures, pore pressure measurements in the fill and long term settlements, are described in this paper. Transverse cracking of fill occurred as a result of large deformations in the compressible sediments. The cracks were repaired, and the dam is currently operating satisfactorily.

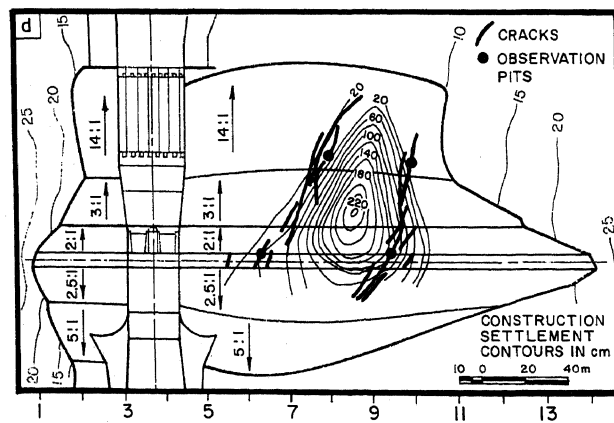
Fig. 5(d) shows the distribution of settlements in the soft clay at the end of the twelve month long construction period. The settlements caused by placement of a 2 m thick sand blanket, which also served as a working platform for installation of sand drains were not recorded.

The settlements shown in Fig. 5(d) were obtained from settlement plates installed on top of the compacted sand blanket. The maximum settlement during construction reached 240 cm at the maximum section at Station 8+10. The settlements generally follow the contours of thickness of soft clay shown in Fig. 5(b).

dam, a new set of nine major cracks was observed (Fig. 5(d)). Three cracks were again located at Station 9+10 m, two of which occurred on the downstream slope while the third was located upstream. Two cracks at Station 6+10 also extended to the upstream side. The crack at Station 8+00 was restricted to lower elevations of the downstream slope. The cracks were a maximum of 3.5 m deep and were generally of hairline width. However, in places, a maximum opening of 20 mm was observed. These cracks were also grouted with a 5-7% bentonite mix. The transverse observation trenches have been backfilled with compacted residual soil alternating between 30 cm thick layers of gravel. PVC pipes for grouting and bleeding have been installed in the gravel layers for any treatment which may be necessary in the future. No additional cracking has been observed since January 1981.

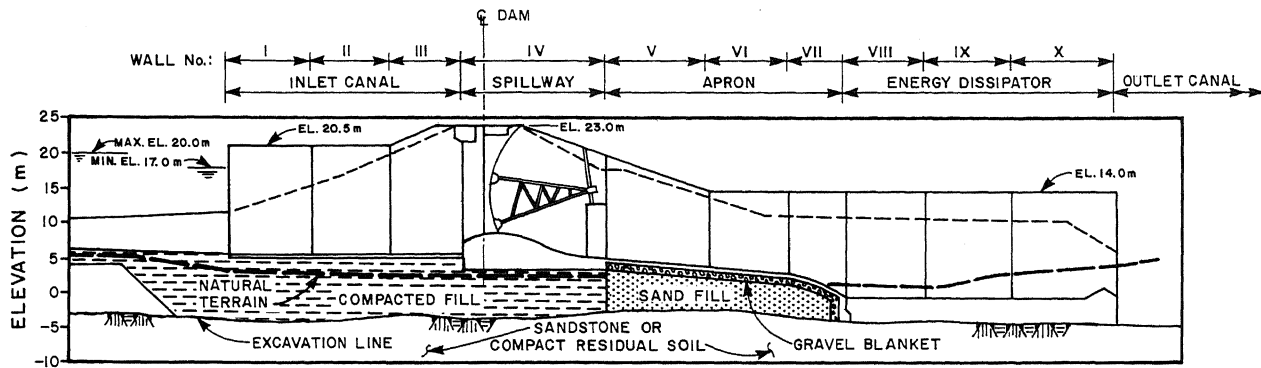
Fig. 6. Foundation Conditions Beneath Spillway Structures

The spillway walls (Fig. 6) suffered differential settlements due to varying foundation conditions. A maximum settlement of over 110 mm was observed on Right Wall II founded on compacted fill. A large proportion of settlements occurred while fill placement in the dam, adjacent to the walls was in progress. During this period a maximum settlement of 0.6 mm/day was observed at Wall II R. Table III summarizes the recorded settlements.

The settlements of the spillway walls on compacted fill were surprisingly almost three times higher than anticipated. The reason may lie in the fill being placed at a water content above the optimum. Also, the flood of October 1977 inundated the compacted fill then in progress. While a substantial volume of upper softened fill was subsequently excavated and replaced, it is possible that the remainder of the fill also experienced some swelling and softening.

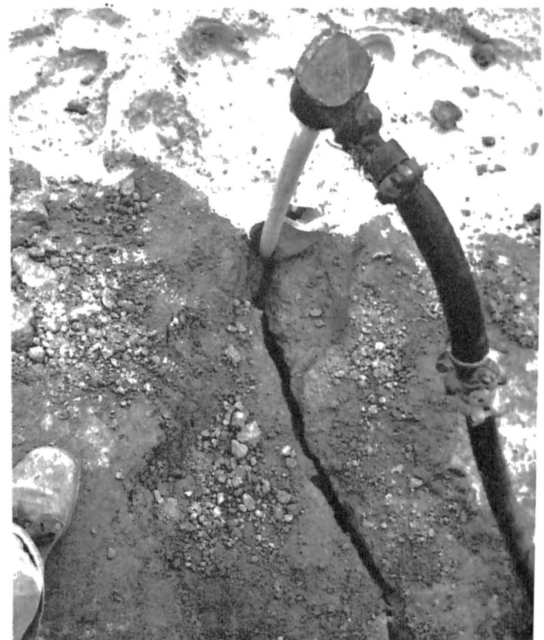
Localized cracking in the fill occurred as the dam height was raised. The first two cracks occurred when the fill was at approximately elevation 10 m. The cracks at Stations 6+10 and 9+10 were parallel to each other at an angle of 70° with the dam axis. It is of interest to note that these first cracks occurred when the fill placement was temporarily suspended as a result of high piezometric readings ($r_u > 0.5$). Narrow trenches transverse to the cracks were excavated to a depth of approximately 3 m. The cracks were cleaned by injecting water under low head and were subsequently filled with a 5% bentonite mix. Fig. 11 shows the treatment of a crack ending at the sand chimney drain.

The next two cracks, both near Station 9+10, were observed when the fill reached El. 18.0 m. The cracks maintained an inclination of 70° to the dam axis. These cracks were located only on the downstream slope, and were treated as described previously. At the completion of the

The first appearance of cracking was probably associated with large shear strains in the foundation, and the simultaneous development of high pore pressures. However, subsequent transverse cracking appears to be related to differential settlements in the fill. Fig. 5(a) and b) show a sharp change in thickness of clay near Stations 9+00 and 6+10 where cracking occurred. It is also of interest to note that high pore pressures in the foundation were observed with cracking at the higher fill elevation. This mechanism of cracking is different from the more common case of squeezing out clay from beneath the embankment to upwards at the toe of the embankment. In the latter case, tension cracks begin at the bottom of the embankment (Chirapuntu and Duncan, 1977). Similar transverse cracking has been observed at Duncan Dam (Gordon and Duguid, 1970) where over 4.3% differential settlements occurred at a distance of less than 120 m from the rock abutment.

Fig. 11. View of a Crack in the Fill.
