Geotechnical Problems of Dam Sites and Their Solution with Reference to the Projects of Eastern India

S. Gangopadhyay
Geological Survey of India, Calcutta, India

SYNOPSIS : Geotechnical problems of dam construction are associated with adverse geological conditions of the dam site like soft rock, fault, shear zone, joints, weathering, permeable bouldery deposit, soluble rocks, ancient slide etc. In many of the dam sites of eastern India where one or more of such adverse conditions exist, the dam could be safely constructed by treatment of foundation defects. In some cases, however, a new site with less geologic problem was chosen with consequent modification in the project scheme.

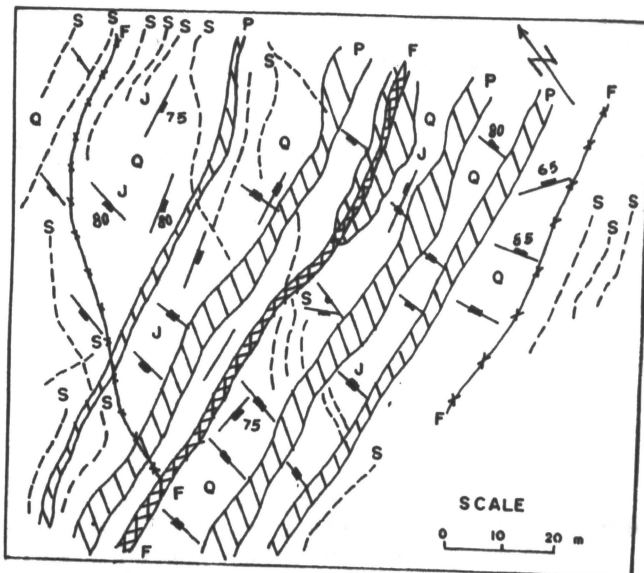
The construction of 71m high and 171m long Umiam dam of Meghalaya faced a multitude of geotechnical problems associated with weak geological features in the dam foundation. The concrete dam is located across the Umiam river in hard quartzite interbanded with soft phyllite, both the rocks being open jointed. After the foundation was opened, a 2m to 3m wide fault zone with soft gougy material was detected at the central part of the dam site aligned across the river (fig 1). Another fault was identified at the upstream end. The fault zones posed problems of differential settlement, development of cracks and leakage of stored water.

Fig.1 : Umiam Dam foundation with fault(F) shear zone(S), joint(J) and soft Phyllite(P) with quartzite(Q).

As remedial measures, the design of the dam was modified specially to accommodate the spillway structure mainly on hard bands of quartzitic rocks and matting was provided in parts of the soft phyllite. A 4-6m deep trench (twice the width of the fault) was excavated along the fault zone, the gougy and shattered material was scooped out and the trench was back-filled with lean concrete. The affected rocks on either sides of the fault were grouted by the cross-holes of 9m. Curtain grouting was provided for the upstream fault.

Foundation treatment by vertical grout holes at 3m intervals did not help for any grout-intake though the joints were open. The grout holes were then made inclined by 50° - 70° and oriented normal to strike direction. Consolidation of jointed rock down to 6m was then fully achieved. Due to the high seismicity of the area a very high seismic factor (0.18g) was incorporated in the design of the dam. The dam constructed nearly three decades back is functioning till date without any trouble.

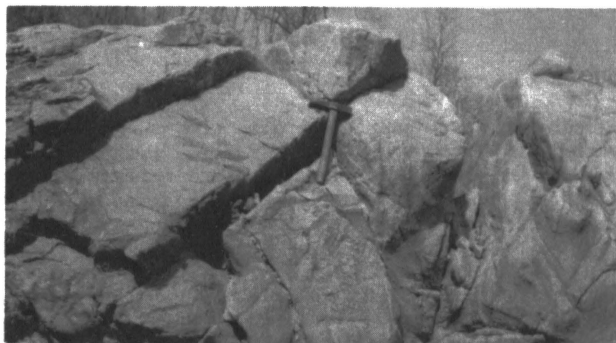
The site of the recently completed 70m high and 762m long concrete dam across the North Koel river of Bihar consists of granite gneiss affected by extensive joints and innumerable shear zones. The joints are close spaced, wide-open at the surface (fig 2) but less open downward. Foundation treatment included removal of these highly jointed rocks followed by cement grouting. Curtain grouting (Three rows of staggered holes at 6m intervals) and consolidation cement grouting by inclined holes down to 6m were very effectively carried out to strengthen the foundation.

Fig.2 : Open-jointed rock with dislodged blocks in North Koel dam foundation.

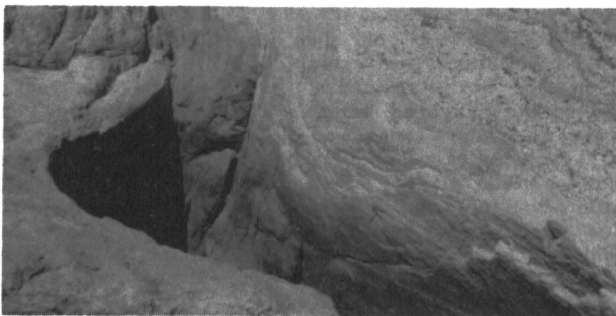
River action on a fault at the downstream has given rise to 'trench' (fig 3) of 2-3m wide, 3-6m deep and 80m length. During dam site selection, the dam axis was fixed as far as practicable towards the upstream so that this trench can be avoided from coming within dam foundation. But a portion still comes at the left bank toe portion of the dam. As a precautionary measures after excavating out the in-filled material from the trench, it was treated with concrete plug.

Fig.3 : A deep trench (3mx6mx80m) formed by the stream action along a fault at the downstream (toe) part of the North Koel dam site.

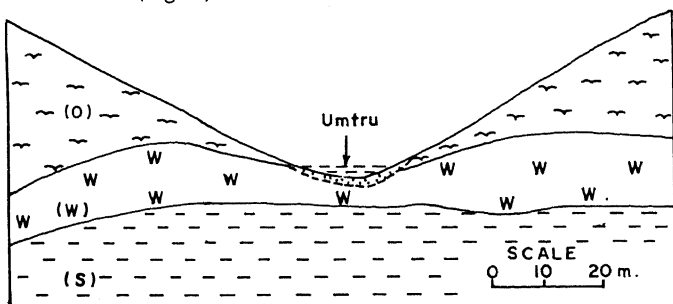
The site for the proposed 45m high and 198m long concrete dam at Kyrdemkulai in Meghalaya is a morphologically good site. But, exploratory drill holes indicated that the lower parts of the two abutments have 10m to 15m thick overburden comprising permeable sandy and micaceous soil. At further higher reaches the overburden mantle is 21m to 28m in thickness. The bed rock and fresh rock profiles are almost flat or curve downward (fig 4).

Fig.4 : A geological section along Kyrdemkulai dam axis showing thick mantle of overburden(O) and weathering(W) of mica schist(S).

Due to such deep zone of overburden compared to the dam height, construction of the proposed dam was not found to be economically feasible at this site. The dam was ultimately constructed in a new site nearly 50m upstream which was not topographically a good site but with less overburden cover.

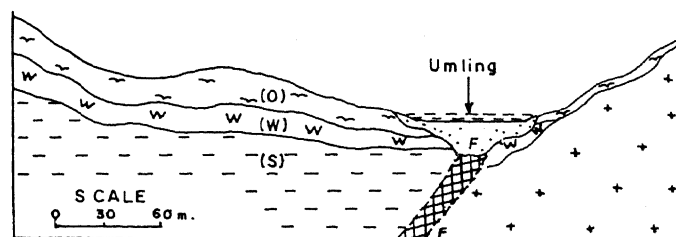
The central part of the river has also 10m to 20m thick deposit of riverine material and below this there is a 6m to 10m wide fault (fig 5) proved by drilling and water pumping test (Gangopadhyay, 1981). Extensive leakage is anticipated through this fault zone under reservoir condition. The construction of the dam at this site was found to be uneconomic due to the high cost involved in foundation treatment.

Fig.5 : Section along Umling dam axis portraying thick overburden(O), deep weathering(W), soft schist(S) in the left bank and hard gneiss(G) in the right bank with a major fault(F) in the river section.

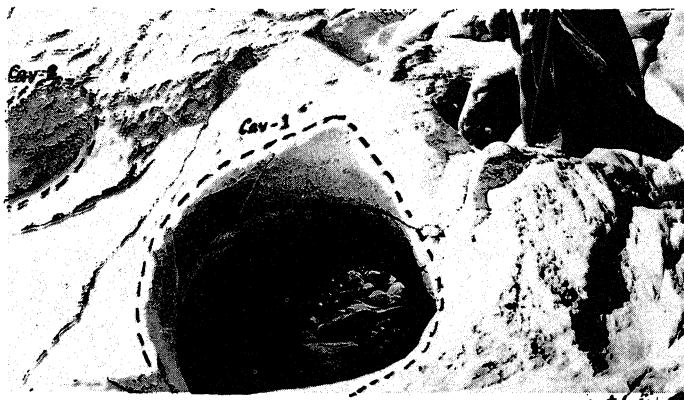
The dam foundation had got also several pot holes, one of which was nearly 10m deep having a circular cross section of 1.5m dia. This consumed huge quantity of cement to plug this by concrete. All these foundation treatment undertaken at the dam site increased the overall project cost but it ensured safety of the dam.

stated under 'weak structural feature', the well-like cavity (fig 6) in North Koel dam foundation though very large in dimension but has no role in leakage as this is a 'blind' cavity without any passage for outflow of water.

Fig.6 : Two blind cavities (larger one of 10m depth and 1.5m dia) in gneissic rock of North Koel dam foundation.

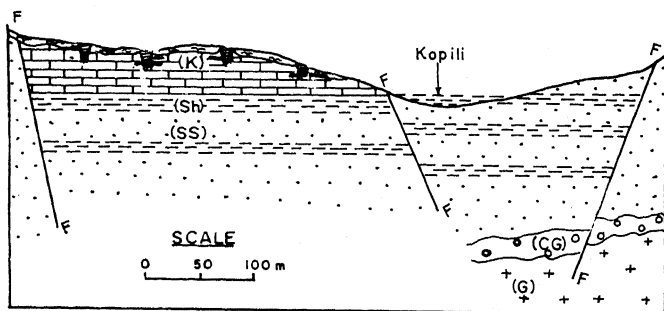
Subsequent investigation (Gangopadhyay, 1971) suggested that the limestone (max. thickness 35m which occurs covering a stretch of 380m in the left bank is karstic (fig 7). Five sinkholes, each of nearly 5m dia were found at the surface with subsurface ramifications. Drill holes proved the presence of a 8m (depthwise) cavity at the sub-surface. These cavities were formed by solution along the joints and bedding planes and these were like 'channels' at the subsurface region with gradient of nearly 1:20 towards downstream which threatened complete loss of reservoir water. The problem was solved by constructing the dam on granitic rock foundation by shifting the site nearly 3 km downstream with modification in the project scheme.

Fig.7 : A section along Kopili confluence dam axis with karstic limestone(K), soft shale(Sh), porous sandstone(SS), permeable conglomerate(CG) and gneiss(G) affected by faults(F).
