## Remediation of River Des Peres Slope Failure – A Case History

Paper No. 2.56

### ABSTRACT

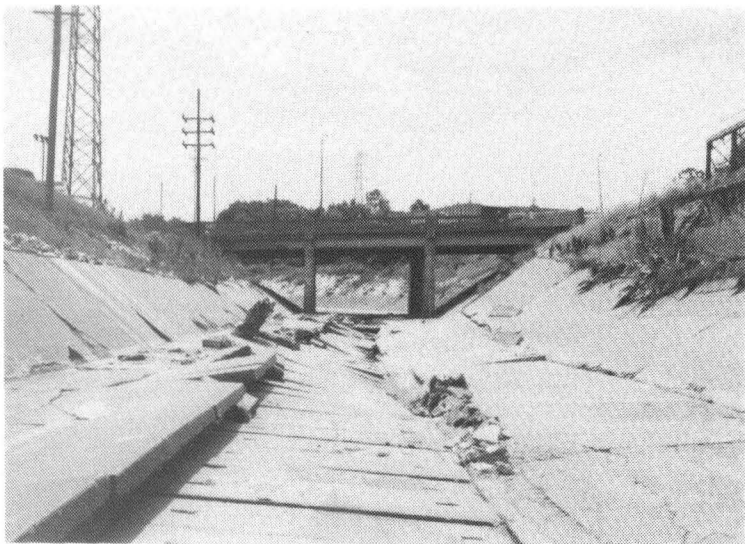
The slope failure was relatively well defined on the western half, with an exposed slide scarp of 6 to 10 feet adjacent to Ellendale Avenue and the 24-inch high pressure gas line underlying the concrete swale along the shoulder. At the toe, in the same general vicinity, the sloped concrete channel walls were pushed laterally into the channel and were heaved upward. The removable concrete panels appeared to have been pushed 2 to 3 feet under the concrete pavement of the south side of the channel. On the east end of the failed area, the slope failure was not as pronounced but, prior to commencement of emergency repairs, a significant tension crack was observed at the south edge of the eastbound lanes of Ellendale Avenue; lateral displacement of the removable concrete panels over the foulwater interceptor in the channel bottom was also observed. The slope failure, as will be shown by the analysis, appeared to be related to the rapid draw down of water within the channel that occur after a major rain.

Figure 1. Photograph showing the slope failure.

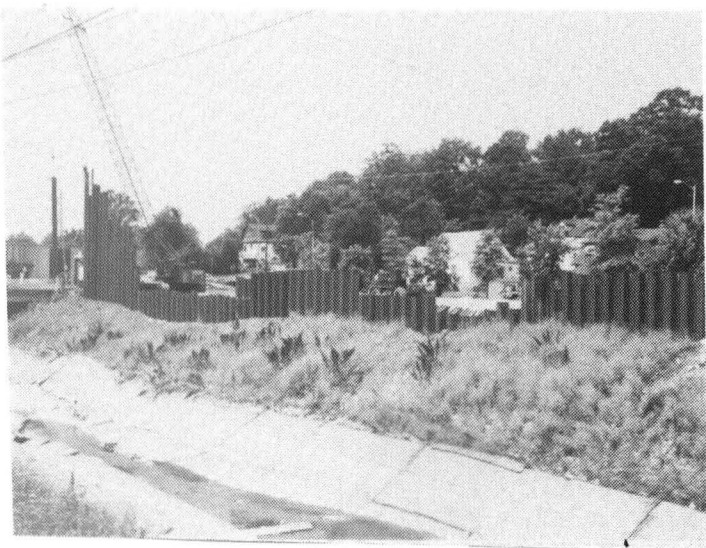
Figure 3. Photograph showing the sheet piles being driven.

Emergency repairs commenced on June 10, 1995 and consisted of driving a wall of PZ27 and PLZ23 steel sheet piles to the top of bedrock approximately 12 feet south of the Ellendale Avenue pavement in the area affected by the slope failure (Figure 3). The steel sheet pile location was chosen by MSD primarily to arrest the advancement of the failed slope, thereby providing some immediate protection to the east bound lane of Ellendale Avenue and the underlying high pressure gas line. Ellendale Avenue was re-opened to traffic on June 27, 1995, following completion of the sheet pile installation. The gas line has remained in service throughout. The long term remediation system, described below, incorporates the steel sheet piles as driven.

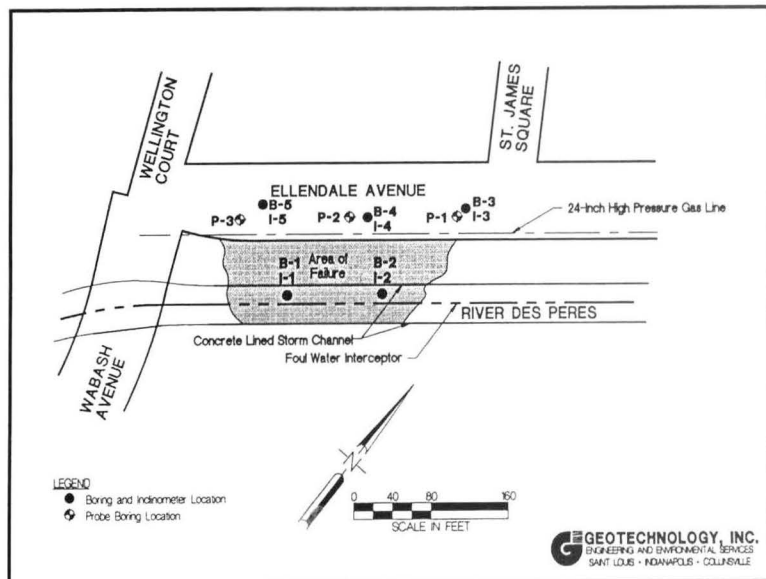
Figure 2. Site plan and boring locations.

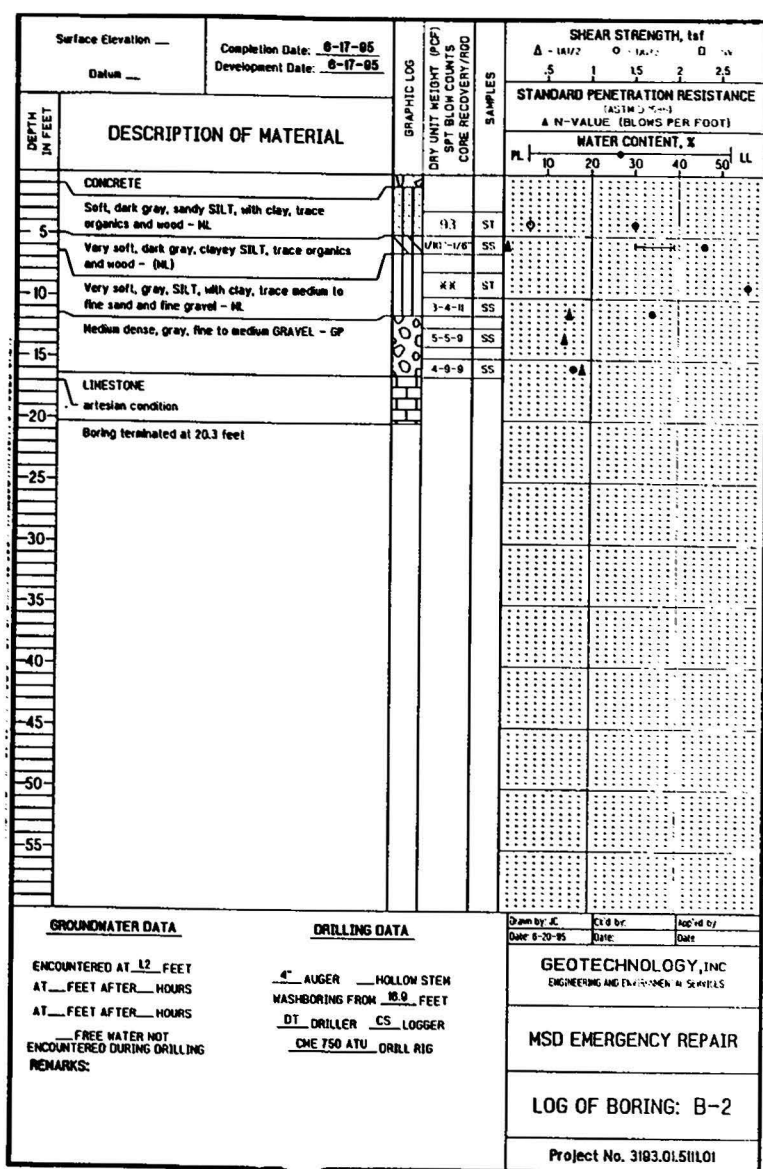
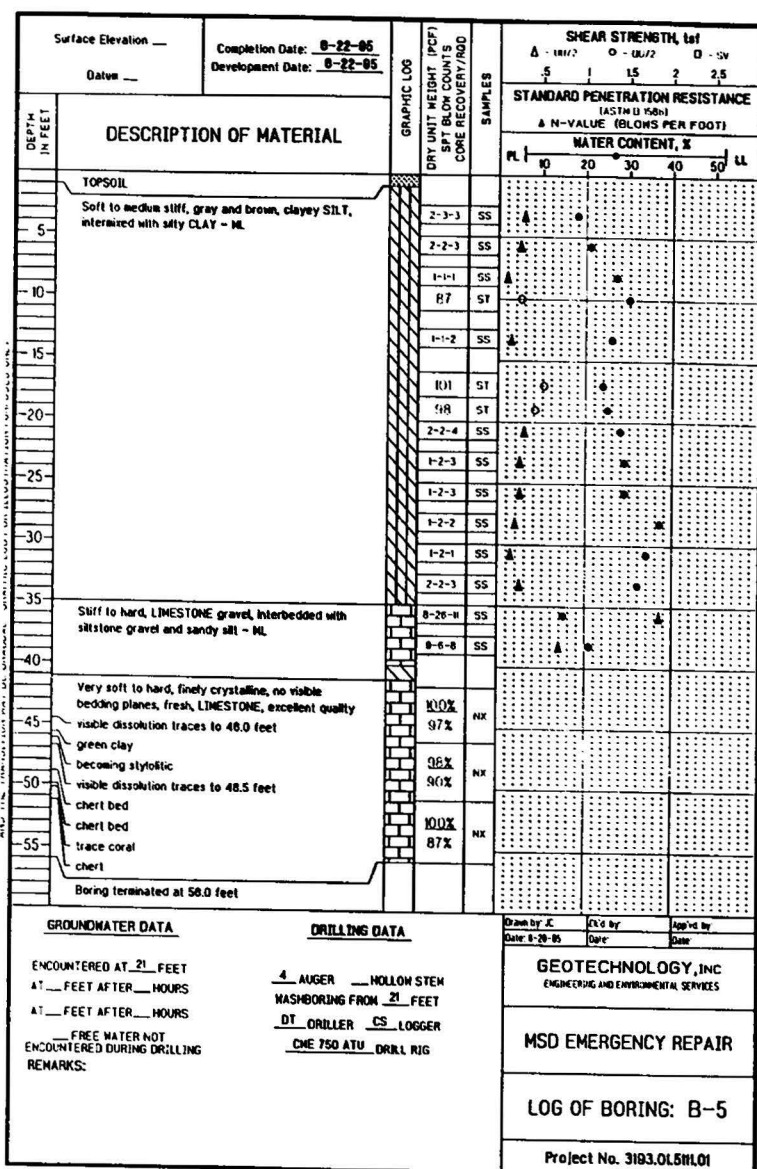
**Lower subsurface profile (below channel bottom)** - Below the reinforced concrete channel bottom, interlayered soft to very soft gray silt, clayey silt, silty clay and sandy silt with a trace of organics and wood, typical of alluvial deposits, was encountered to depths of 7.5 and 11.5 feet in borings B-1 and B-2 respectively. These fine grained soils are underlain by loose to medium dense gray fine sand and silty sand and gray fine to medium gravel until limestone bedrock was encountered at 16 feet beneath the channel bottom.

topsoil in the median between the east and westbound lanes, the soil consists of an upper stratum of soft to stiff, gray and brown, clayey silt intermixed with silty clay to a depth of 27 to 36 feet beneath the ground surface. These alluvial terrace deposits are underlain by dark brown silt, sandy silt, loose to medium dense, silty sand, clay or gravel alluvial deposits until limestone bedrock was encountered at 43 feet in borings B-3 and B-4 and at 35 feet in boring B-5. The limestone bedrock, based on the recovered cores, is moderately hard to very hard, finely crystalline, with chert imbedded, and no visible bedding planes. The percent core recovery and rock quality designation (RQD) were relatively high, with recovery ranging from 88 to 100 percent and RQD ranging from the upper fifty's to the upper nineties.

Figure 4. Typical lower and upper boring logs.

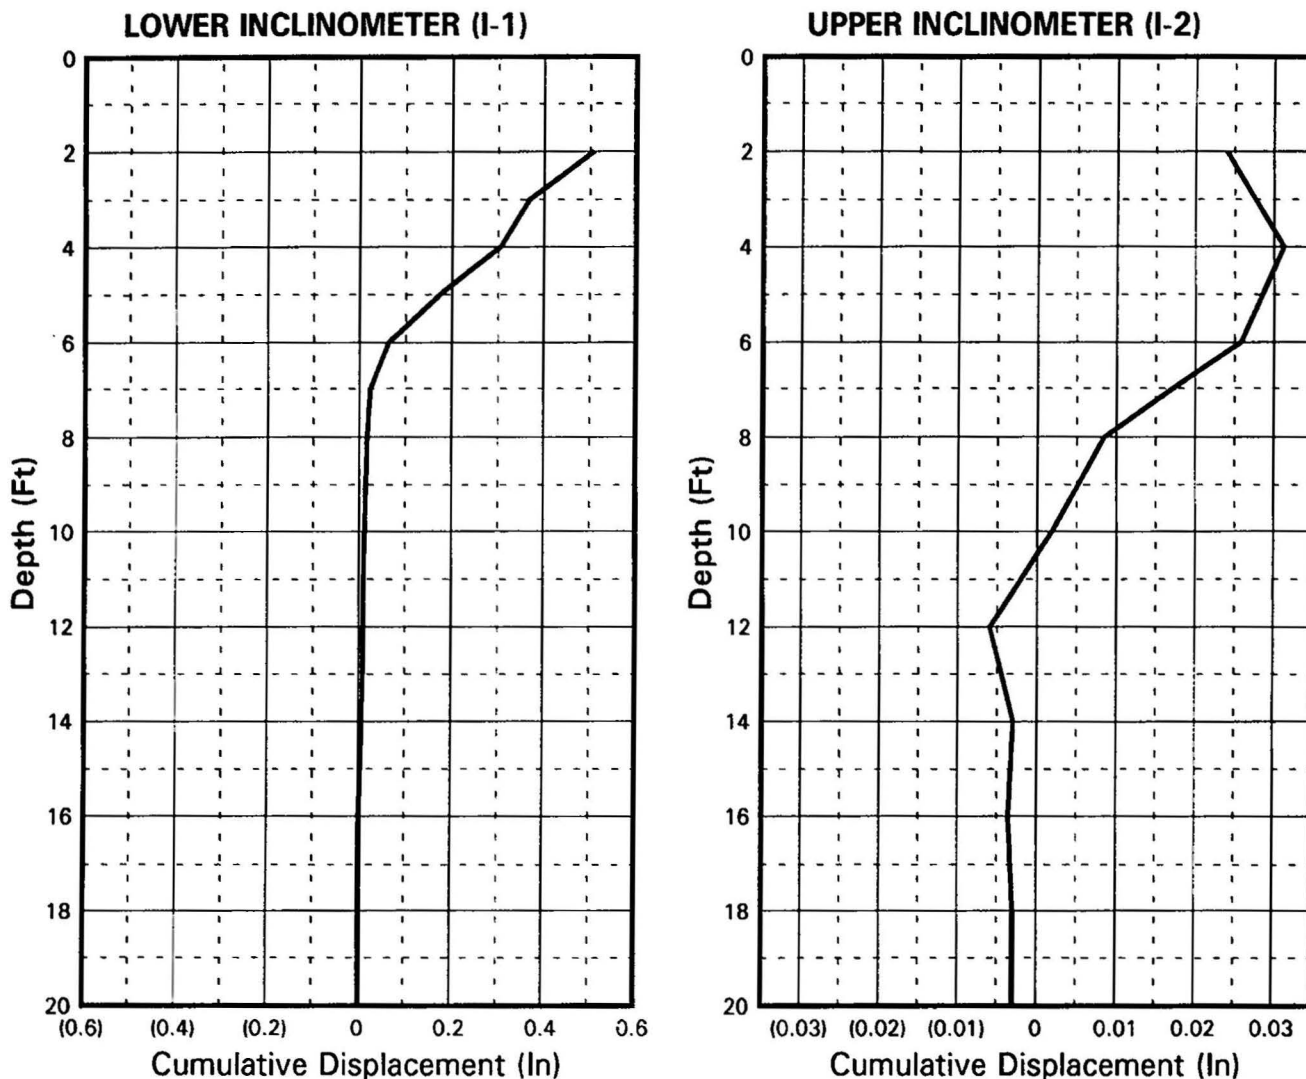
Five inclinometers were installed at the site. Two, I-1 and I-2, were installed at the toe of the slope in the bottom of the channel, and the rest were installed at the top of the slope and were numbered I-3 through -5 as shown in Figure 2. All inclinometer casings were embedded approximately 10 feet into rock and were completely grouted from the outside. Inclinometer data were collected on a regular basis until the failure surface was established with sufficient certainty. Data were collected and analyzed utilizing equipment and computer program manufactured and developed by Slope Indicator company (Slope Indicator Co., 1996). Typical plot of upper and lower inclinometers are shown in Figure 5. The top inclinometers indicated small displacements on the order of 0.1 inches due probably to the disturbance from the sheet pile wall installation. Further, these displacements appeared to be dissipating with time, as indicated by comparing the last readings to the previous. Data from toe inclinometers indicated relatively large displacement continued to occur, particularly at I-1, which is located at the

center of the slide mass. Total displacements were approximately 0.5 inches and 0.17 inches for inclinometers I-1 and I-2, respectively. Data from I-1 and I-2 indicated the slip surface to be located approximately 6 feet below the bottom of the channel. Comparisons of the latest two readings indicated 0.08 inches and 0.09 inches displacement for I-1 and I-2, respectively, indicating that displacements was continuing to occur at both locations prior to remediation.

Figure 5. Typical lower and upper inclinometer data.

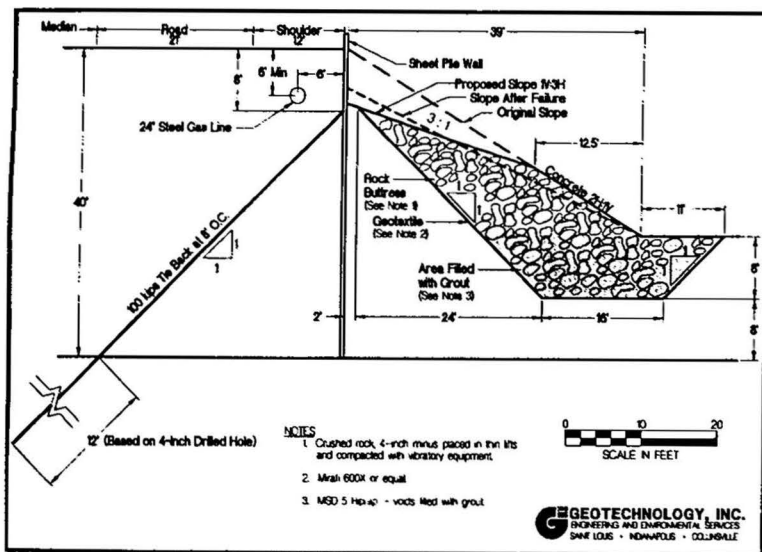
Several slope geometries were investigated in order to determine the optimum solution. However, MSD had specified that the repaired slope should match the geometry of the original slope at the bottom lined portion (1V:2H) to satisfy existing channel hydraulic requirements. This geometry jeopardized the stability of the slope. Similar analysis was conducted to incorporate the concrete lining at 1V:2H and re-grade the remainder of the slope to 1V:5H. The factor of safety for the rapid draw down case was 0.77 which was considerably less than the targeted 1.2 factor of safety for this controlling case.

Figure 6. Slope cross section showing the rock buttress and tiebacks.

A rock buttress alternate was analyzed. This alternative was evaluated based on keeping the lower concrete lined channel at 1V:2H, re-grading the remainder of the slope to 1V:3H, and constructing a rock buttress at the toe area. Different layouts of rock buttress were investigated and the factor of safety for each layout was computed until an acceptable buttress geometry, that provided the minimum acceptable factor of safety, was achieved for the rapid draw down case as shown in Figure 6.

The rock buttress material consisted of 4-inch minus well graded crushed rock placed in relatively thin lifts and compacted with vibratory equipment. Since adequate drainage in the rock buttress cannot be maintained below the channel bottom, MSD 5 rock blanket with predominant rock sizes between 6 and 12 inches (4) was used in this zone, and the voids between the rock pieces were filled with grout to channel bottom surged level. Excavation for the rock buttress was recommended to be accomplished in limited segments perpendicular to the channel alignment to reduce the potential for additional instabilities of the slope. Each segment was required to be backfilled the same day it was opened.

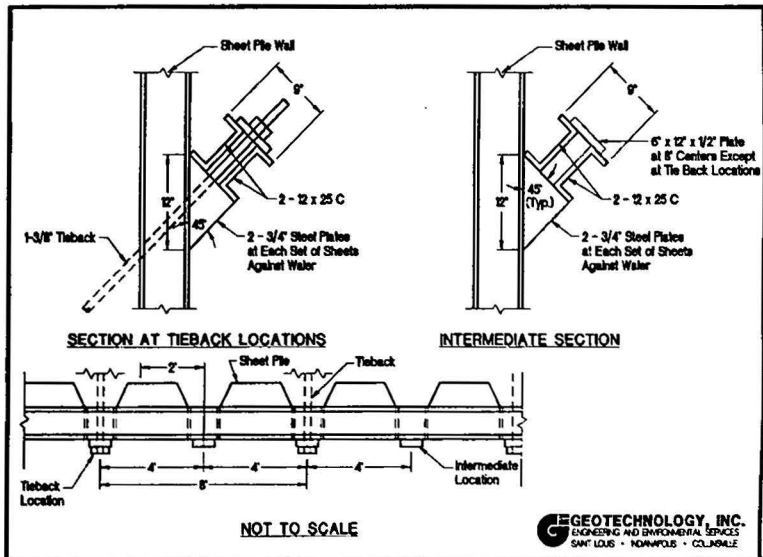
Figure 7. Typical tieback-sheet pile connection detail.

After a stable slope geometry was defined, the sheet pile wall was analyzed incorporating the new rock buttress at the passive side. The analysis was conducted following the procedure outlined in the Navy design Manual DM 7-2 (NAVFAC, 1982) for an anchored sheet pile wall. In the analysis the following assumptions were made: a differential hydrostatic pressure of 14 feet behind the sheet pile wall to exist since drainage is limited in that area; surcharge load at road level of 400 psf; no sheet pile penetration into rock; and a factor of safety of 2 on the passive pressure. Based on the analysis, one row of tiebacks each carrying a 100 kips design load and spaced at eight-foot centers was required. Layout of this system is shown in Figure 6. A DYWIDAG bar tendon 1-3/8 inches diameter, with double corrosion protection, was selected to carry the designed tie back load (Dywidag System International). These bars were designed to be anchored to the underlying rock which necessitated sloping them at 1V:1H. Embedment length in rock, based on 4 inches diameter drilled hole and 70 psi bond stress between rock and grout (Post-Tensioning Institute, 1980), was 12 feet. After testing, tie backs were locked at 60% of their designed loads. The waler was designed as a continuous beam with uniform load supported at tie back locations (US Army Corps of Engineers, 1994)) which resulted in a waler section having two 12x25 channels. Wedge plates were required at the tieback support locations in order to provide the required 1V:1H tiebacks inclination. Detail of the waler and the tieback support system are shown in Figure 7. The stresses resulting from the vertical component of the inclined load were checked to ensure they did not exceed the allowable steel stresses of the sheet pile.
