Reconsideration of Failure Initiating Mechanisms for Teton Dam

Reconsideration of Failure Initiating Mechanisms for Teton Dam*

SYNOPSIS A review of failure mechanisms previously suggested for Teton Dam indicated that they were not fully supported by all the available data. The original mechanisms are reviewed and a failure initiation mechanism is then proposed which does satisfy all the available data, and laboratory tests supporting this mechanism are presented. Additional lessons to be learned from the failure are listed.

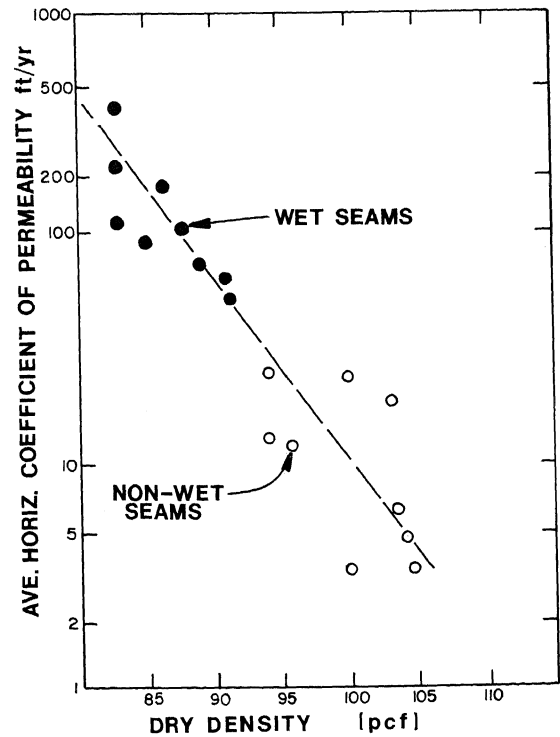
FIG. 3 AVERAGE HORIZONTAL COEFFICIENT OF PERMEABILITY VS. DRY DENSITY, BLOCK SAMPLES FROM LEFT ABUTMENT EXCAVATION

c. Permeability. Horizontal and vertical permeability tests were conducted on samples from hand-cut blocks taken from zone 1 fill. Fig. 3 shows the relation between average horizontal permeability and dry density obtained from these tests. Typically, permeabilities in the wet seams are an order of magnitude higher than outside the wet seams. The IRG attributed these large differences in permeability primarily to differences in dry density and not to other physical, chemical, or mineralogical differences. We interpret it to mean that the wet seam samples not only had lower densities but also were compacted initially well on the dry side of Proctor optimum moisture content.

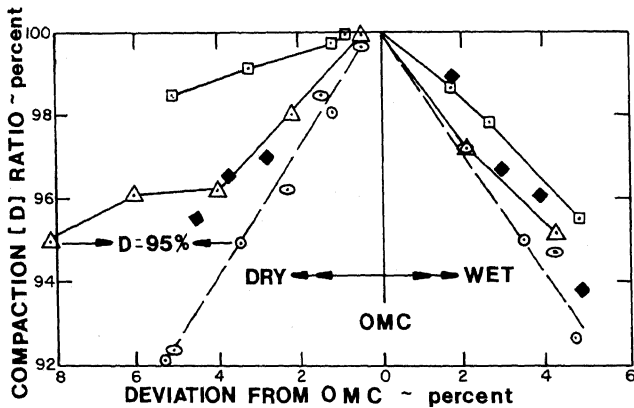
FIG. 2 COMPACTION RATIO VS. DEVIATION FROM OMC FOR TETON AND NEBRASKAN SILTS

samples of the Teton silt can be compacted to D-ratios >95 percent at water contents more than 8 percent dry of optimum, while the Nebraskan silts fall below D = 95 percent when the water content is 3.4 percent dry of optimum.

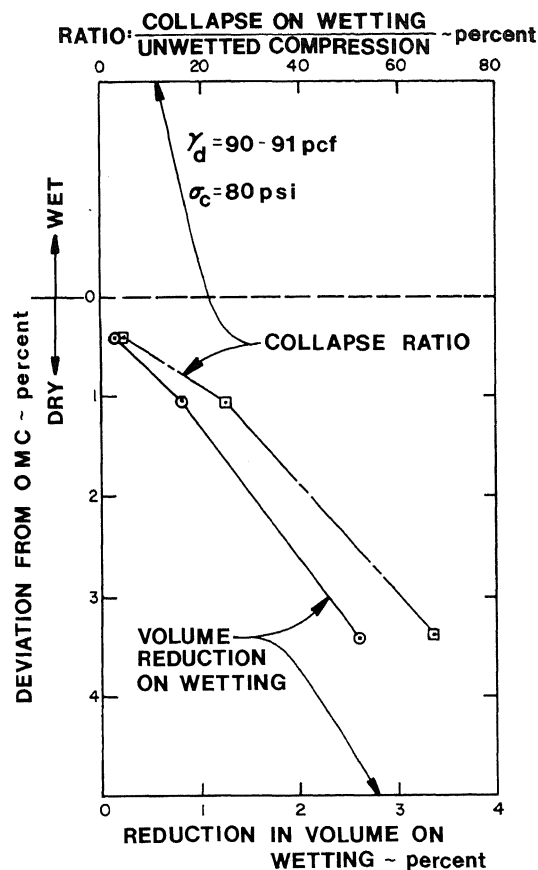
FIG. 4 PERCENT VOLUME REDUCTION AND COLLAPSE RATIO VS DEVIATION FROM OPTIMUM MOISTURE CONTENT, SAMPLE FROM "WET SEAM"

d. Collapse Potential. Three specimens from a wet seam sack sample were compacted to approximately 90 lb/ft³ (93 percent of Proctor maximum) at moisture contents 0.4, 1.1, and 3.5 percent dry of Proctor OMC. After curing they were consolidated rapidly without wetting to 80 lb/in², the approximate preconsolidation pressure of block samples from the wet seams. The 80-lb/in² pressure was maintained for 24 hours before the samples were wetted. Fig. 4 shows the additional compression, or "collapse," on wetting. The 2.6 percent collapse was considered excessive and undesirable, as it was thought it would probably lead to cracking in the relatively brittle zone 1 fill.

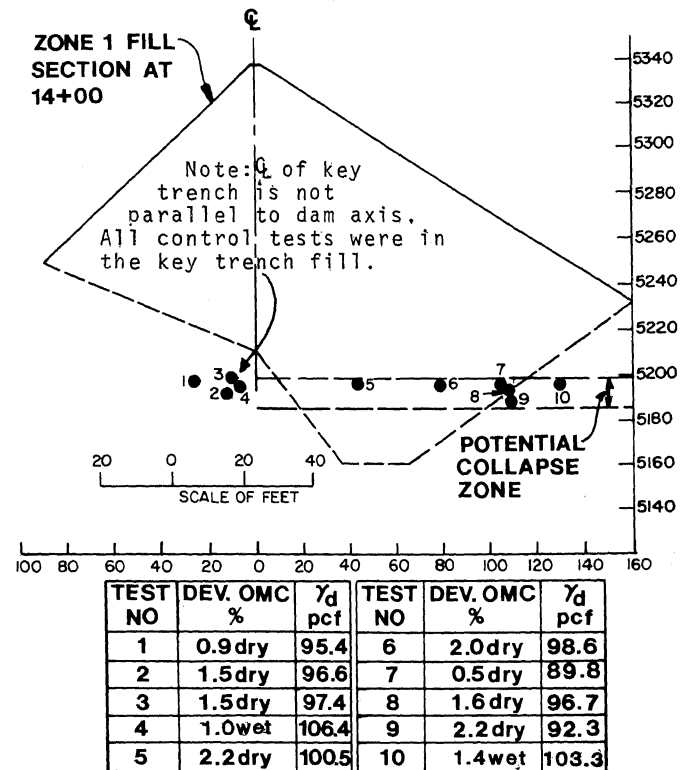
FIG. 5 COMPACTON CONTROL TESTS RESULTS BETWEEN STA.13+90 AND STA.14+40, AND EL.5184 AND EL. 5198

As soon as it was recognized that a high permeability layer could have been built completely across the right key trench fill and not across the left, it immediately became apparent that this could be checked using the records of compaction control tests. The data were computerized and printouts of the moisture/density test results, station by station, were obtained. Data at locations corresponding to the key trench fill, on both abutments, were then plotted for each 100-ft interval. At only one locale did the data suggest a continuous stratum of soil compacted on the dry side of optimum, which - notably - turned out to be 14+00, as illustrated in

Fig. 5. We appreciate that the data are insufficient to reach a definitive conclusion; nevertheless, this remarkable result led us to believe there is a high probability that a continuous layer of high permeability was constructed across the right key trench and not across the left. However, as we have argued before, this is not by itself sufficient to explain the rapid demise of the dam because (1) time is required for seepage to transit the width of the key trench, and (2) due to the relatively modest initial exit gradient, soil would merely slough into an open joint on the downstream wall and piping would only work its way, slowly back to the upstream face. We concluded that the combination of these two effects would require much more time to fail the dam than the limited number of days (perhaps hours) in which the dam was breached. It seemed necessary for the flow rate into a downstream joint to be very high initially so that sloughed soil would immediately be washed out, thereby permitting a larger and larger channel to form rapidly. Only a preformed crack, or hydraulic fracturing, seemed to satisfy this requirement. The dilemma posed by this requirement remained unresolved for months until, one day, Leonards recalled earlier studies on the collapse of compacted clays (Leonards and Altschaeffl, 1971). The brief treatment of "collapse potential" in the IRG report (summarized in Fig. 4) came into focus, and the additional reduction in normal stress at the base of the key trench due to arching that would accompany the collapse was realized.

SUBSIDENCE OR "COLLAPSE" OF A PERMEABLE DRY-SIDE COMPACTED LAYER SPANNING THE WIDTH OF THE KEY TRENCH ON THE RIGHT ABUTMENT, PERMITTED HYDRAULIC FRACTURING (OR SEPARATION) TO OCCUR IN THE KEY TRENCH FILL THEREBY ALLOWING FLOW FROM OPEN JOINTS IN THE UPSTREAM WALL (WITH ACCESS TO THE RESERVOIR) TO OPEN JOINTS IN THE DOWNSTREAM WALL,
