A Case History of Site Instability Due to the Presence of a Shale Layer Above Sloping Bedrock

A CASE HISTORY OF SITE INSTABILITY DUE TO THE PRESENCE OF A SHALE LAYER ABOVE SLOPING BEDROCK

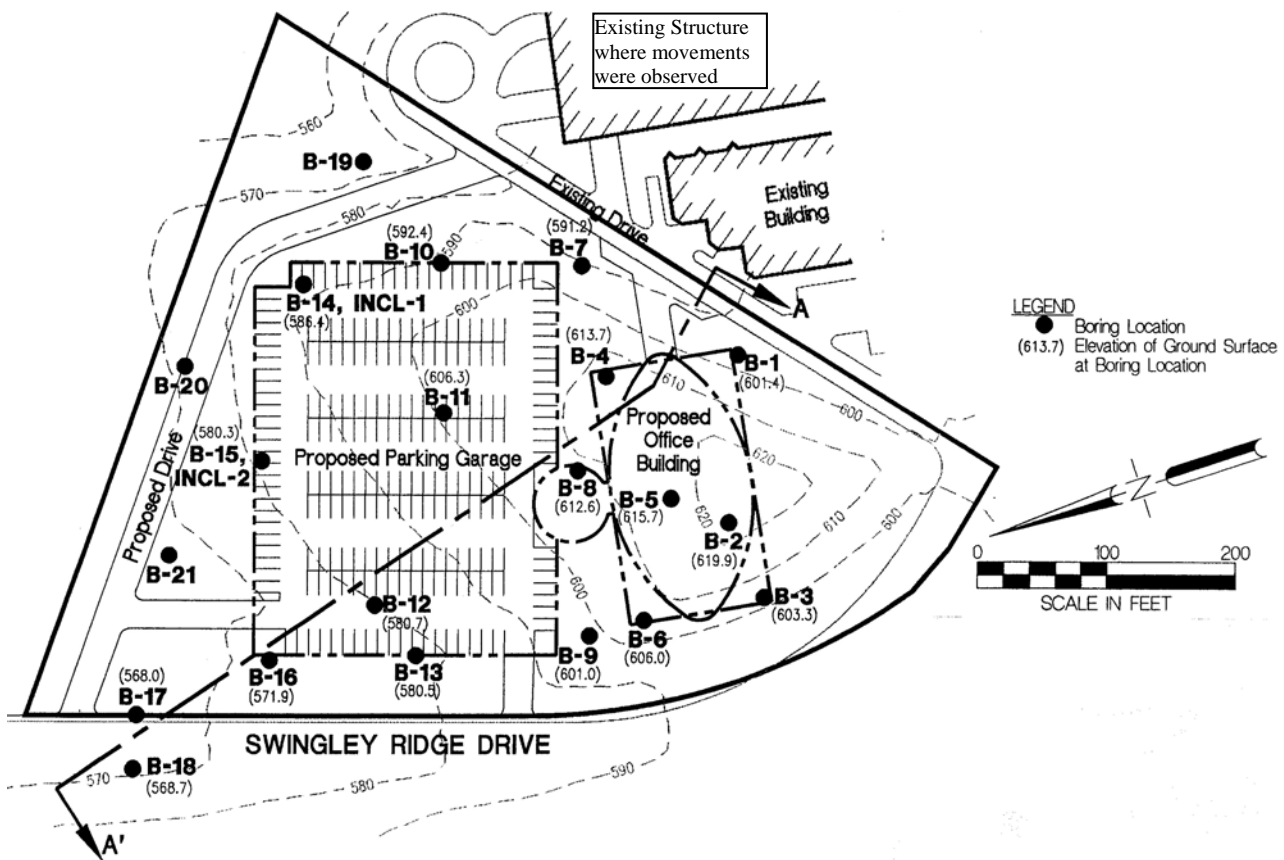
Figure 2 Topography Map including profile line AA' developed by Geotechnology, Inc.

The site topography map is shown in Figure 2. The site is located on a hill with the highest elevation on the south end

being 620 feet above the mean sea level. The site slopes down to the north to an elevation of 560 feet. Several borings were drilled as a part of the subsurface exploration. Boring locations are shown in Figure 2. The soil borings revealed limestone bedrock exposed near the south end of the site and in other borings a clay layer, approximately 20 to 30 feet thick, was encountered as the surface stratum. The clay layer is underlain by an approximate 3-foot thick shale layer, which in turn is underlain by sloping limestone bedrock. Subsurface profile along a cross section A-A' (Refer to Figure 2 for location of A-A') is shown in Figure 3. Figure 3 shows the shale layer sloping down (towards the north) at an angle of approximately 10 degrees. Observations made from this site indicated a possibility that the shale layer is exposed in a dry creek bed at the far end of the site. The adjacent site and the site under discussion appear to share this dry creek bed.

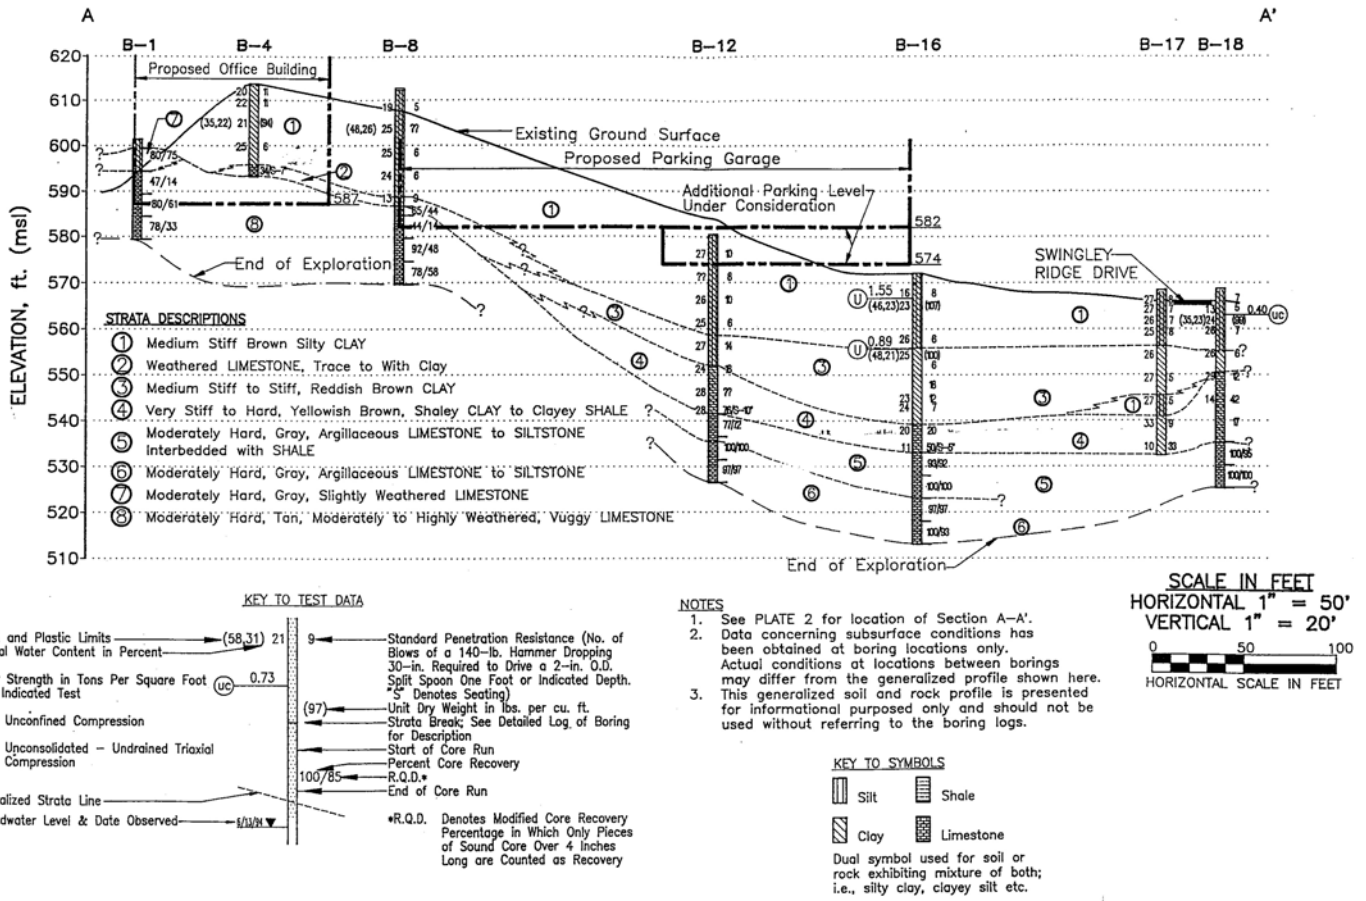
Figure 3 Subsurface Profile Developed by Geotechnology, Inc.

The subsurface profile (Figure 3) shows that the geology at this site was consistent with the geology indicated in the study conducted by Lutzen & Rockaway (1971). Based on the subsurface conditions observed in the borings and the information from the study performed by Lutzen & Rockaway (1971), a conceptual sketch shown in Figure 4 was developed to represent the subsurface conditions at the site. Modifications to the site consisted of construction of a five-story office building and an attached two-story parking garage. The office building was supported on drilled shafts and shallow foundations bearing on bedrock whereas the parking garage was constructed on shallow footings bearing in soil. The finished floor elevations for the office building and the parking garage were such that the site required a cut at the highest point on the site and fill underneath a part of the garage. A conceptual sketch of the modified slope profile is shown in Figure 5, which also shows the modifications planned for the site. To achieve the required finished floor elevations, the site was cut within the footprint of the office building and part of the parking garage, and was filled under the north end of the parking garage.

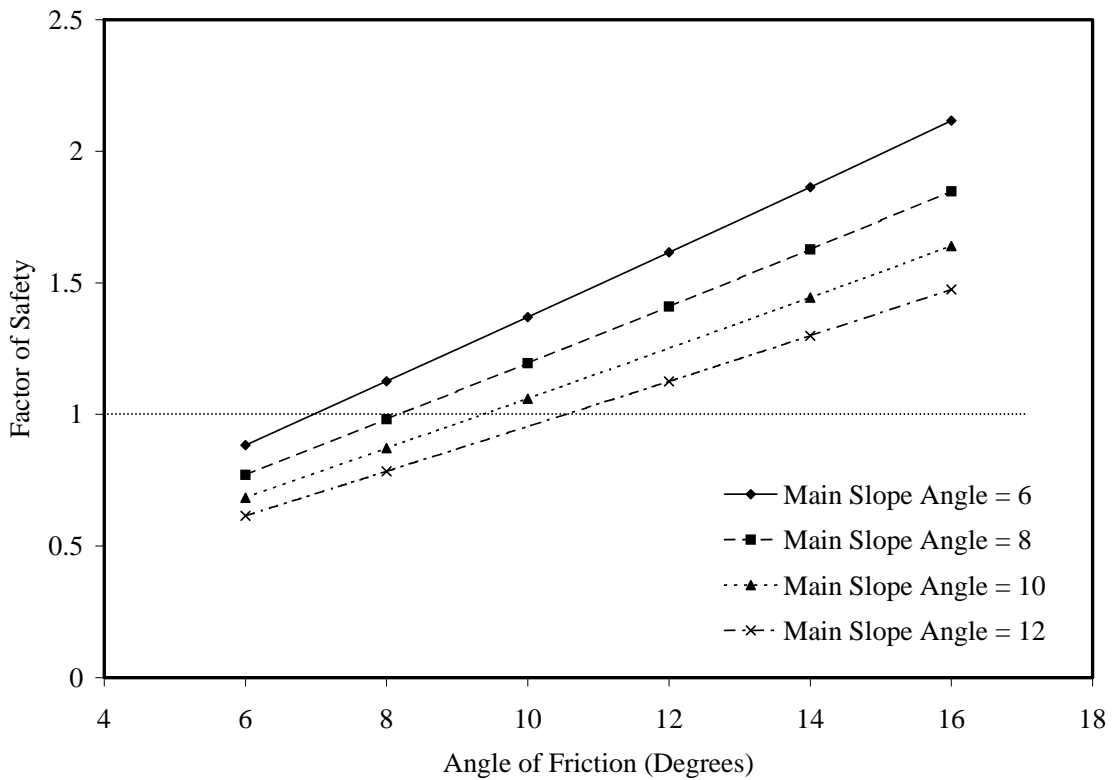
Figure 7 Variation of Factor of Safety with Angle of Internal Friction of Shale

Figure 6 presents the variation of the factor of safety with the change in angle of internal friction of shale for the natural slope configuration. Each curve shown in the figure represents

a different main slope angle. Figure 6 shows that within the range of values of the internal friction angle of shale studied, the factor of safety increases linearly with the increase in the angle of internal friction of shale. The increase in factor of safety observed is obvious because as the strength of the shale increases there is more resisting force available to prevent slip in the shale and hence, the slope is more stable. As discussed in a previous section, the main slope angle was measured to be approximately 10 degrees. From Figure 6, it is clear that the for a main slope angle of 10 degrees, the factor of safety of the slope will reach one when the angle of internal friction of shale reaches approximately 9.5 degrees which is a typical value of residual frictional angle of shale.
