RESTORATION OF EQUALIZATION AND AERATION TANKS OF EFFLUENT TREATMENT PLANT AT THE MYSUGAR FACTORY, MANDYA, KARNATAKA, INDIA

This paper deals with the restoration measures resorted to strengthen the structure and prevent the leakage of the equalization and aeration tanks of effluent treatment plant in a sugar factory. These tanks showed distress at the hydraulic test itself before commissioning due to the failure of the reinforced concrete floor and bund lining on account of loss of support due to excessive deformation of the substratum. Extensive sand piling was resorted to strengthen the substratum before recasting the reinforced concrete floor and bund lining to ensure structural stability and prevent leakage. These tanks are functioning satisfactorily since two years after restoration serving the intended functions of the effluent treatment.

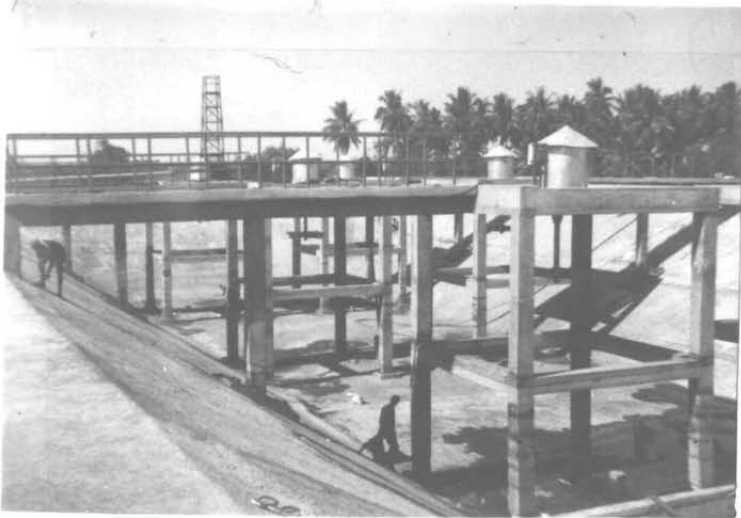
It can be seen in the plan that a stream runs in the west south direction very close to the bund of the aeration tank. It was imperative that these tanks had to be subjected to hydraulic test before being cleared for their intended purposes. The tanks did not pass through this test. Profuse leaking of water of the order of 2000 liters per hour from the equalization tank and 50000liters per hour from aeration tank were noticed. At this stage detailed investigations were undertaken to find the causes for this leakage and as well as, if possible, to restore these tanks by resorting to suitable measures.

Fig. 2 Photograph of general view of aeration tank.

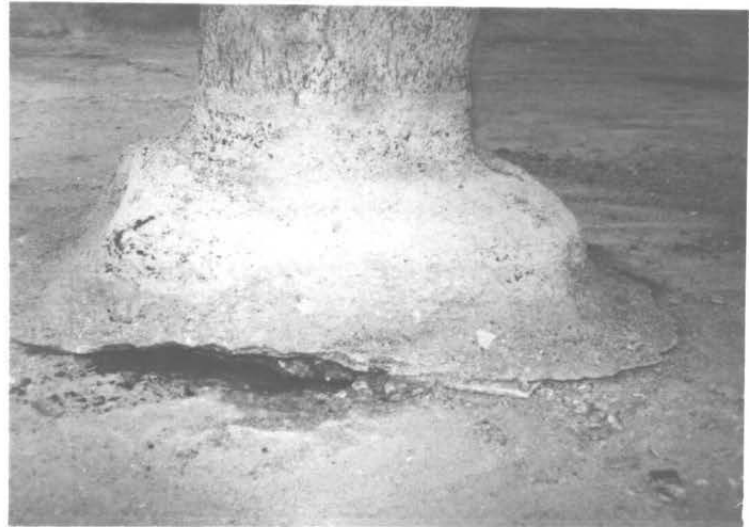
Fig. 3 Photograph of slippage between reinforced concrete floor and column.

basically a cohesionless material, mixed with murum. The density of the soil was very low with low strength parameters. A detailed stability analysis of the bund indicated that these bunds were structurally unsafe for the designed depths of effluent in both these tanks. It was also observed that such cohesionless material towards the north west corner of the aeration tank was considerably eroded since the stream bed was 1.5 meters lower than the floor level of the aeration tank. Due to cyclic fluctuations in the water level in the stream the material below the floor slab progressively got eroded resulting in loss of support for the reinforced concrete floor slab to a greater degree which resulted in severe cracking far more than at other places.

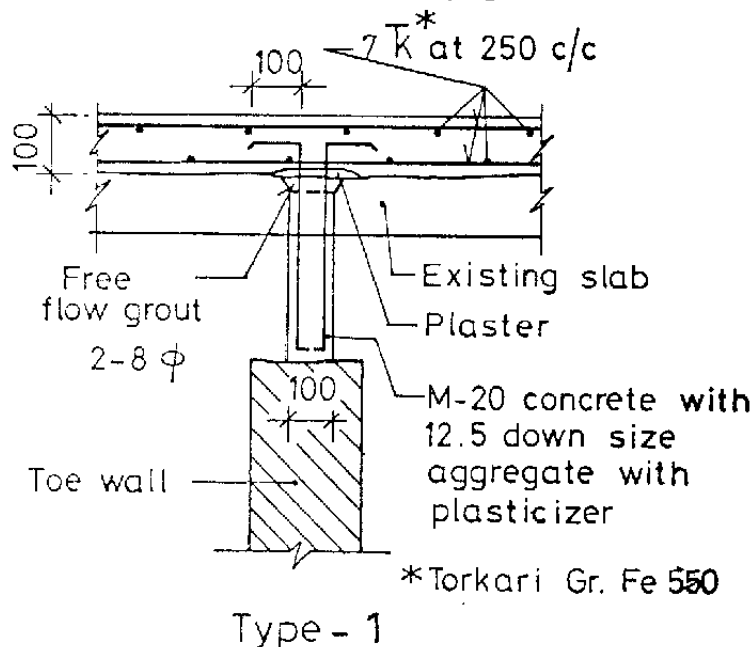
Fig. 4 Concrete piling above the toe wall all along the periphery of the floor of the tanks.

Strengthening of the soil below the floor of aeration tank by sand piling was examined. Examination of the substratum below the floor revealed that strengthening of loose fill was required up to 2 m depth. It was found that a toe wall had been constructed below 1.5m all along the periphery of the floor slab of these tanks with the intension of providing brick lining alternative to reinforced concrete lining. Later it was decided to adopt reinforced concrete lining. As such any piling at the boundary could be restricted to top 1.5 m since the toe wall could serve to provide needed confinement. To obtain necessary confinement cast in-situ concrete piles were resorted to. Figure 4 shows the details of the piling all around.

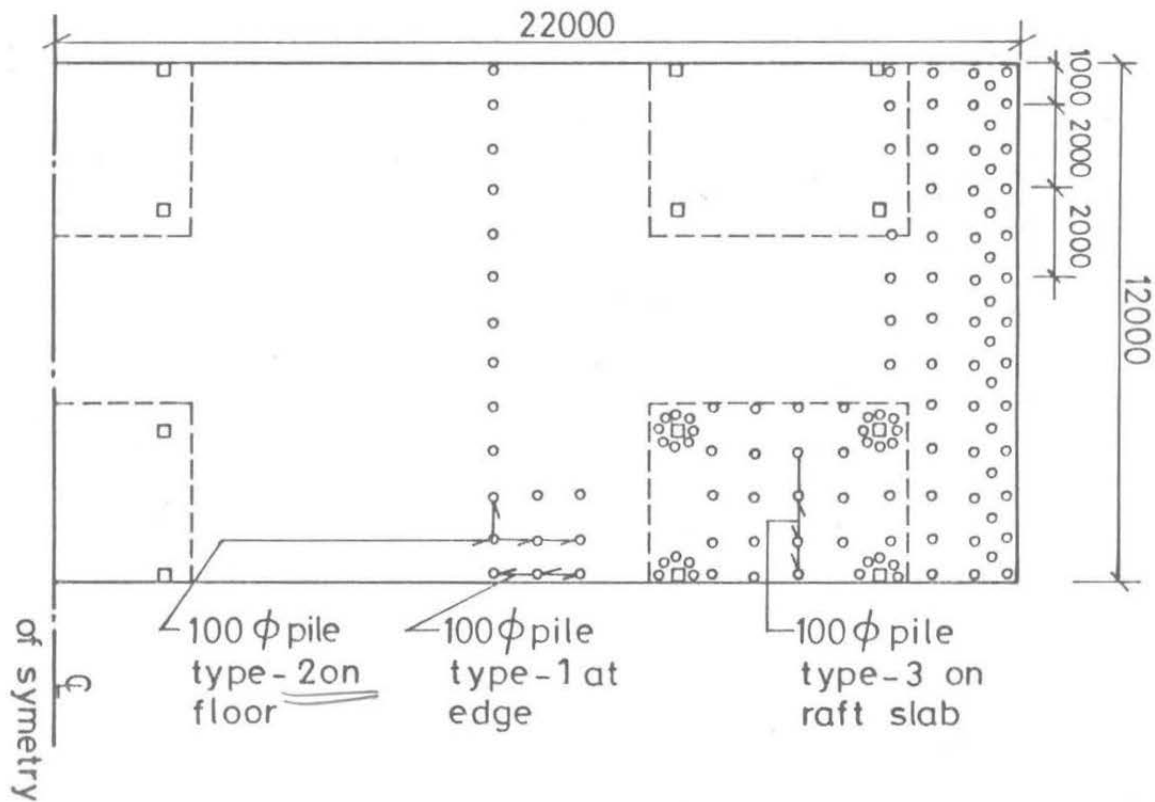
Fig. 5 Details of the location of sand piling resorted to as restoration measure.

To resort to piling in a grid pattern it was necessary to remove the damaged floor slab. It was a difficult proposition since it needed considerable time and effort. Instead the possibility of using the same as support to the new slab and lining was examined. By using profometer the disposition of the reinforcement was determined. After this, the grid pattern for piling were decided. This is as shown in figure 5. In this diagram the pattern of sand piling in the agitator supporting column area has also been shown. These were the locations free from the reinforcement of the damaged column. The existing slab was cored by using the core cutting device to obtain 100 mm. diameter holes for the full depth to facilitate to carry out skirting and sand piling up to a depth of 2m. which happened to be the depth to reach hard stratum. Along the periphery of the floor slab of aeration tank a row of reinforced concrete piles on toe wall as well as a row next to these inwards was provided in order to ensure adequate confinement of the substratum below the floor slab. To reach 2m. depth, the displacement technique adopted to advance the hole, densified the soil in the vicinity of the hole created. The compaction of sand resulted in further densification. In fact the gap between the damaged floor and the substratum as well

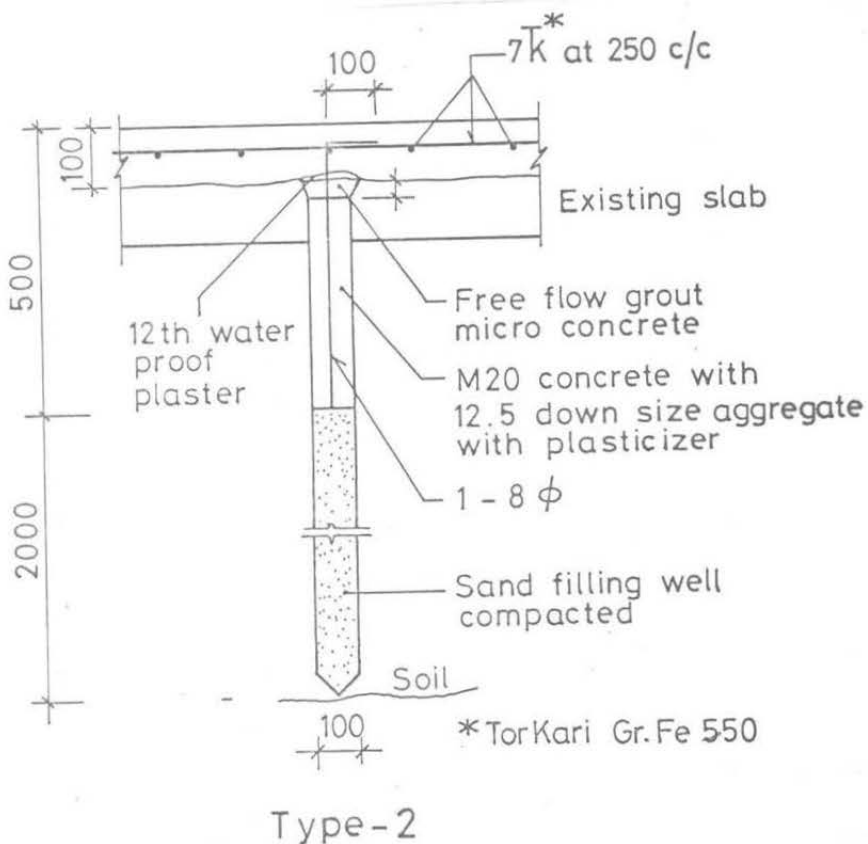
Fig.6 Details of sand piling along with the concrete pile with the projecting reinforcement.

as between the lining and the bund considerably reduced. After sand piling the sand upto a depth of 0.5m was scooped for cast in-situ concrete pile with adequate reinforcement projecting out. In figure 6 the details of the sand piling and the top 0.5m concrete pile with reinforcement projecting out are shown. In figure 7 the photograph of the simple fabricated arrangement for sand piling and other details are shown. On the raft of agitator columns the type of piling was different. This is shown in figure 8. It consisted of reinforced cast in-situ concrete piles after sand piling for confinement which subsequently was removed by scooping.

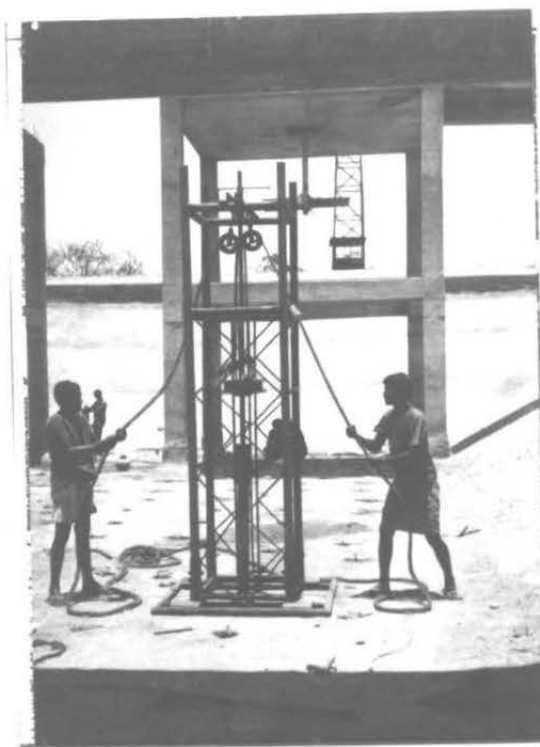
Fig. 7 Photograph of the arrangement for sand piling.

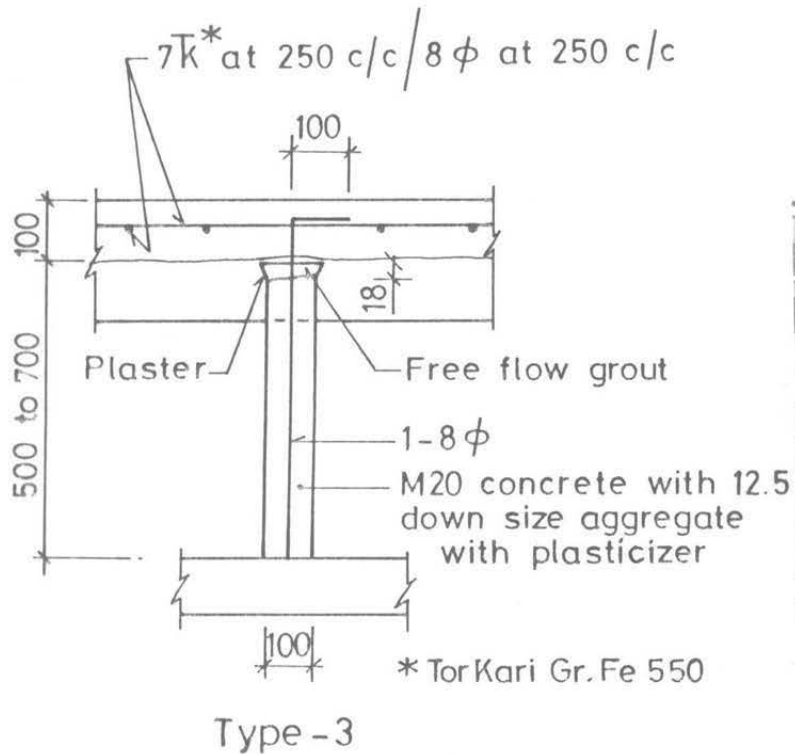
Fig. 8 Details of concrete pile with reinforcement over the raft slab of agitator columns..

In order to make the entire system integral all the projecting reinforcement of the cast in-situ concrete piles were blended with the reinforcement of the additional 90mm thick reinforced floor slab and bund lining cast as a part of restoration to achieve desired leak proof condition. In addition cement slurry grouting with expansive admixture at the interfaces of the columns with floor slab and bund lining was adopted to ensure water tightness. Apart from providing reinforced concrete overlay, a layer of guniting was sprayed for a width of about 400mm at the interface of all construction joints and the intersection of all columns with floor slab and bund lining to make the system absolutely leak proof. In addition the remaining gap between the bund lining and compacted soil was effectively filled by pouring cement mortar of flowable consistency mixed with expansive admixture.

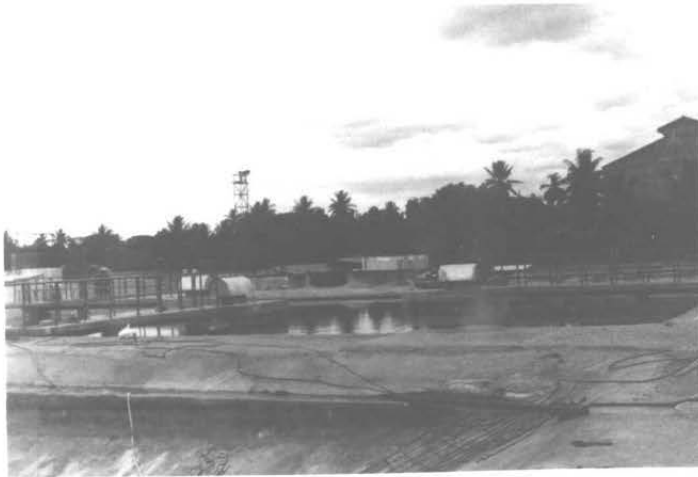
Fig. 9 Photograph of the restored equalization tank after commissioning into operation.

All the above restoration measures were carried out in June 95. The equalization and aeration tanks of the effluent plant were subjected to hydraulic and load tests and finally commissioned. In figures 9 and 10 the photographs of the above tanks of the treatment plant after commissioning into operation are provided. Since then a satisfactory performance of the treatment plant was obtained.

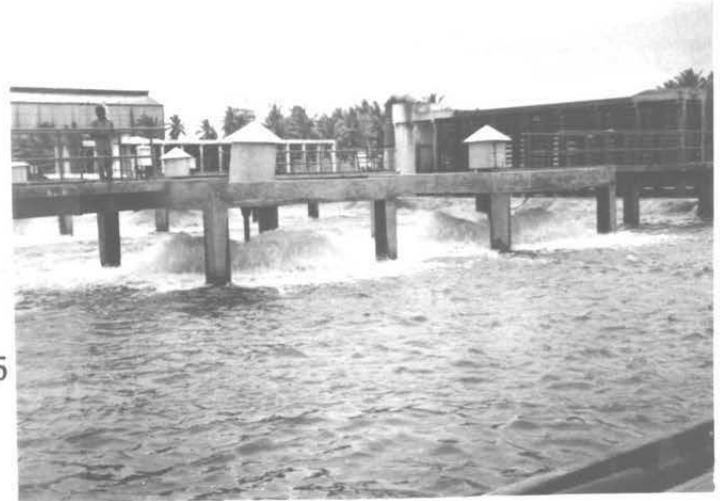
Fig. 10 Photograph of the restored aeration tank after commissioning into operation.
