Post-Earthquake Failure of a Tailings Dam Due to Liquefaction of Pond Deposit

Post-Earthquake Failure of a Tailings Dam Due to Liquefaction of the Pond Deposit

Kenji Ishihara

Department of Civil Engineering, University of Tokyo

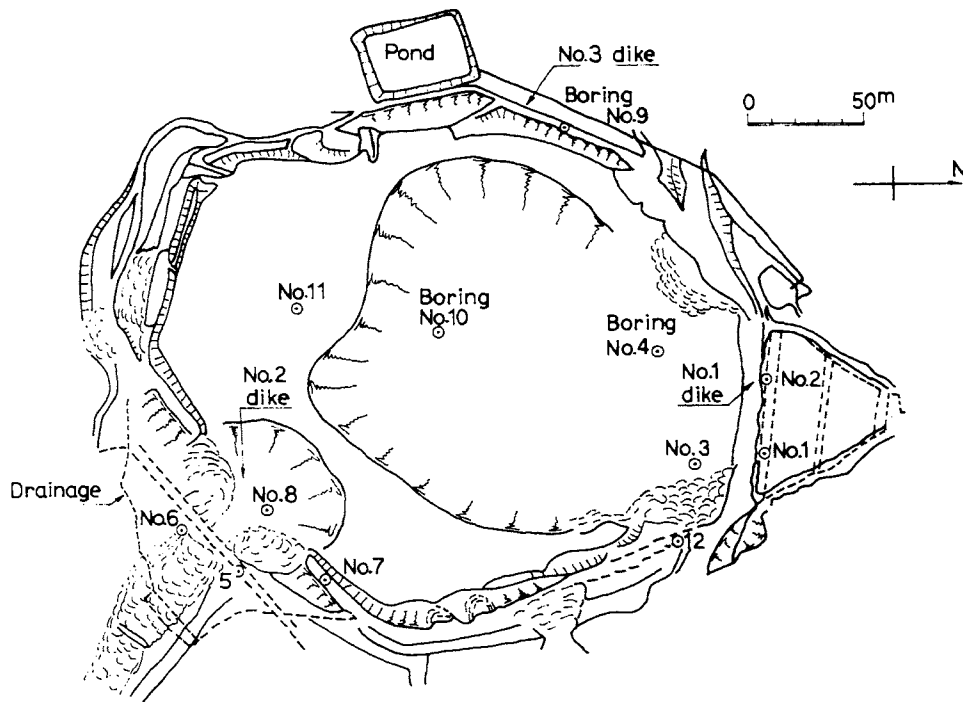
Fig. 5. Plan of the Hozukizawa disposal pond at Mochikoshi

At about 1:00 p.m. on that day, a caretaker standing on the opposite side of the No.2 dike happened to notice a gradual sinking of the central part of the dam. While running to the dam site, he watched the dam failing suddenly through a crest width of about 20 m leading to a release of the impounded tailings sludge. Later on the breach was enlarged to a crest length of 65 m, generating a number of cracks over the sloughing surface. A total volume of 3,000 m³ consisting of 2,000 m³ of tailings slime and 1,000 m³ of dike material flowed down the valley to a distance of about 240 m. The feature of the collapse is shown in Fig. 7. The portion of the five-step dike additions above the starter dam was taken away, as shown in Fig. 7. The plan view of this slide is shown in Fig. 5.

Borings were made at 12 locations in and near the disposal pond, as indicated in Fig. 5. The boring logs in the vicinity of the No.1 dike are shown in Figs. 8 through 10 and those conducted near the No.2 dike are demonstrated in Figs. 11 through 12. The log of Boring No.2 drilled from the exposed failure surface reveals the presence of a thick layer of fill composed of weathered volcanic ashes underlying the deposit of the tailings slime. This fill is the

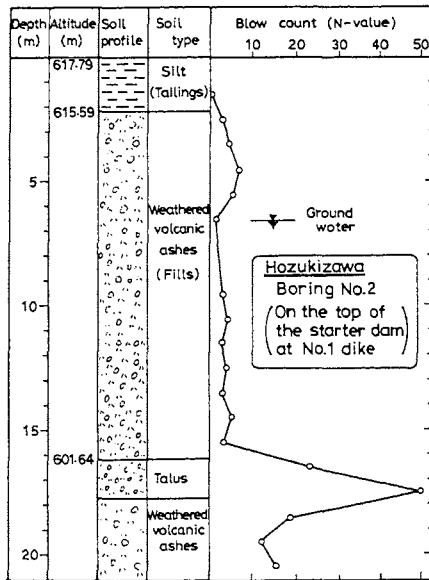
Fig. 8. Soil profile at No.1 dike (From report of the investigation committee)

main body of the starter dam. It may be seen in Fig. 8 that the fill had a blow count value of 3 to 7 in the standard penetration test. The log of Boring 4 conducted in the interior part of the pond indicates that there exists a thick layer of tailings sludge down to a depth of 18 m underlaid by an original deposit in the mountain. The result of the standard penetration test indicates blow count values on the order of 1 to 2 near the surface but somewhat larger values of 4 to 9 in the lower half portion of the sludge deposit. The progression of consolidation with drainage towards the permeable bed soils may have stiffened the slime deposit near the bottom of the disposal pond. Near the surface which coincides with the failure plane, the penetration rod sank by its self-weight to a depth of 2 m without any hammer blow. The presence of the extremely soft layer must have accrued as a result of liquefaction developed to this elevation during the quake. The log of Boring No. 10 drilled in the center of the pond indicates a

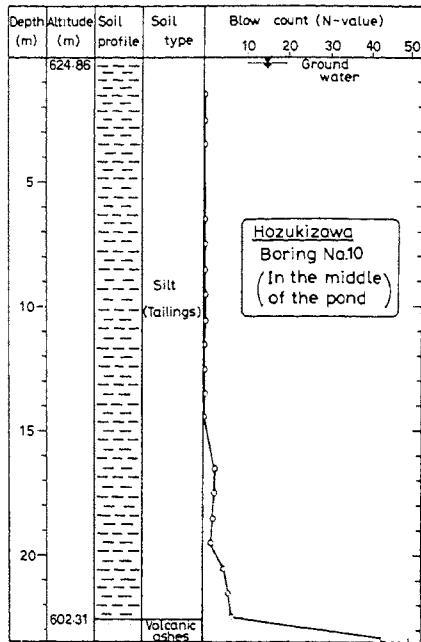
Fig. 10. Soil profile in the middle of Hozukizawa pond (From report of the investigation committee)

complete soil profile from the pre-earthquake surface level not stripped off by the failure. The blow count value is equal to zero down to a depth of 15 m, whereupon it increases to a value between 3 and 6 near the bottom of the slime deposit. Underneath the slime layer there exists the original deposit of the mountain consisting mainly of weathered volcanic ashes. The fact that there is little resistance to penetration down to the depth of 15 m does not appear to have ever been so, but seems to have been caused by the occurrence of liquefaction due to the earthquake.

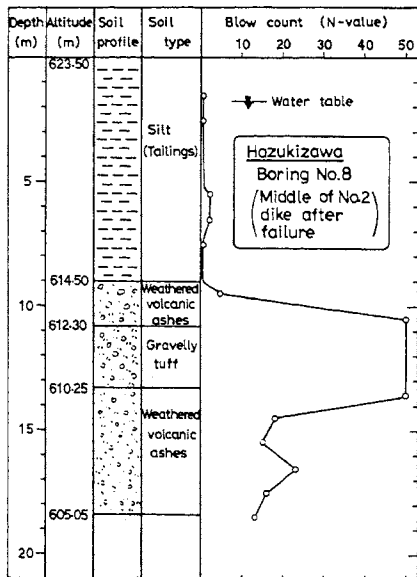
Fig. 11. Soil profile at No.2 dike (From report of the investigation committee)

The log of Boring No. 8 obtained from the failure surface at No.2 dike is demonstrated in Fig. 11, where it may be seen that the tailings slime deposit was probably remolded down to an elevation of 614.50 m as a result of liquefaction

during the earthquake. The layers of deposit underlying the tailings slime are those of original mountain deposits at this site, as can be seen from the location of this boring site shown in Fig. 5. The soil profile data at Boring No. 5 shown in Fig. 12 was obtained from the top of the starter dam and accordingly it misses the

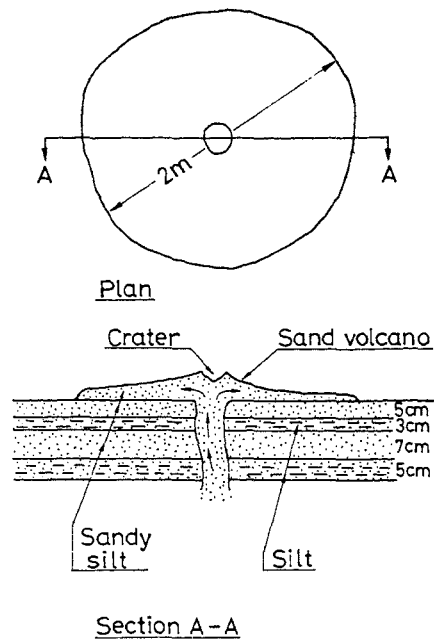
Fig. 14. Cross section of a sand volcano formed on the surface of the disposal pond

Over the surface of the disposal pond on the west side of the No.2 dike, a number of sand volcanos were observed following the earthquake. One of the biggest volcanos about 2 m in diameter of sand spread was carefully excavated to a depth of about 50 cm. The cross-section through the sand volcano thus obtained is shown in Fig. 14, where it can be seen that sand-containing silt (sandy silt) and fine-grained material (silt) are deposited, one on top of the other, in thin layers 3 to 7 cm in thickness. Two batches of samples were recovered separately each from the portion of coarse-grained and fine-grained layers. The grain size distribution curves for each portion are shown in Fig. 15. Also shown in Fig. 15 are two grain size distribution curves for the blended samples obtained by a shovel in block. It is to be noted that there is an upper limit in grain size which is 0.3 mm. This is the maximum grain size specified in the grinding process of the ore. Fig. 15 also shows that the grain size distribution curves for two blended samples lie within the range bounded by those of the silty sand and silt. Void ratio of the tailings was 0.98 and 1.00, and the specific

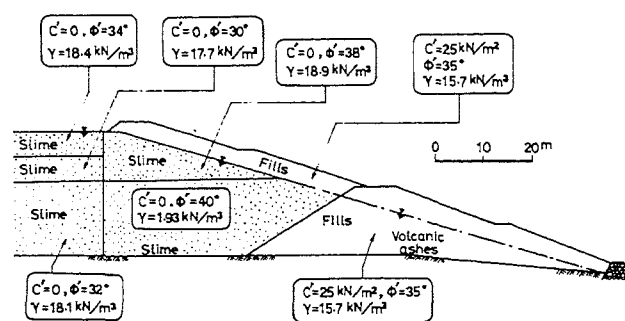
Fig. 19. Cross section of No.1 dike with soil properties used in the stability analysis

gation Committee (1979) for a cross section of the dike having soil properties shown in Fig. 19. The result of the stability analysis showed that for the static condition prior to the earthquake, the factor of safety was 2.32 for No.1 dike. In the seismic loading condition, two cases were considered. In the first case, no excess pore water pressure was allowed for in the analysis and the magnitude of seismic coefficient necessary to bring the computed factor of safety to unity was shown to be as large as 0.3. Then, in the second case some appropriately assessed value of excess pore water pressure due to the seismic shaking was taken into account in the stability computation by Eq. (3). It was found that the seismic coefficient of 0.17 was large enough to bring down the factor of safety to unity from the initial value of 2.32.

As described above, the computed factor of safety for No.1 dike becomes equal to unity, if a seismic coefficient of 0.17 is incorporated into the analysis with a proper assessment of excess pore water pressures caused by the earthquake shaking. This magnitude of seismic coefficient was considered reasonable well within the range of 0.15 and 0.25 predicted from the seismic response analysis. It was then sought what the factor of safety would be for the stability of No.2 dike under the identical conditions in which the failure of No.1 dike did occur. Using the seismic coefficient of 0.17 and incorporating the effects of similarly assessed excess pore water pressures, the factor of safety was calculated to be about 1.5 for No.2 dike. The Investigation Committee then concluded that the No.2 dike had been potentially more stable than the embankment of No.1 dam approximately by a factor of 1.5.

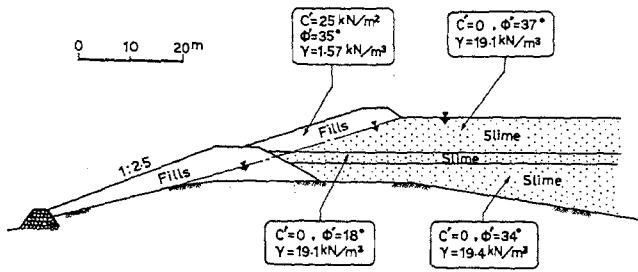
Fig. 20. Cross section of No.2 dike with soil properties used in the stability analysis

The stability analysis for the static loading prior to the earthquake was made by the Investigation Committee (1979) for a cross section of the dike having soil properties shown in Fig. 20. The result of analysis indicated a factor of safety of 2.75. In the case of seismic loading conditions, the seismic coefficient value as much as 0.4 was shown to be needed to bring the computed factor of safety to unity, if no excess pore water pressure is taken into account. When the excess pore water pressure is allowed for in the stability computation, the value of the seismic coefficient to bring the safety factor

down to unity was 0.23.

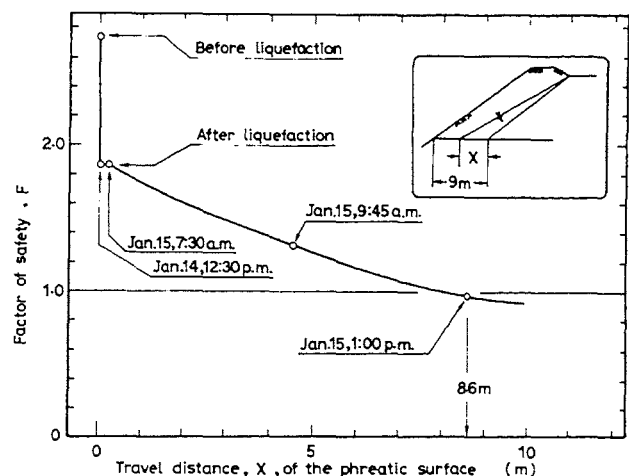
Fig. 26. Change of factor safety caused by the movement of phreatic surface

plotting the computed factor of safety against the travel distance of the phreatic surface. The corresponding period of elapsed time computed through Eq. (5) is also indicated in Fig. 26. In the static condition prior to the earthquake, the factor of safety was computed as being 2.75 as mentioned in the foregoing, but it dropped drastically to 1.85 upon development of liquefaction in the tailings deposit behind the No.2 dike due to the shaking of the main shock which occurred at 12:30 p.m. on January 14, 1978. It is to be noted that at this stage the pore water pressure increase due to the liquefaction is assumed to have propagated into the portion

allowing for redistribution of excess pore water pressures generated by the earthquake. The factor of safety computed for the stage immediately after the main shock was 1.85 but following a series of aftershocks, the factor of safety was conceived to have decreased gradually due to a sharp increase in permeability of the dike fills caused by the development of cracks and fissures in the embankment. About 5.5 hours after the occurrence of the aftershocks, the computed factor of safety dropped to a value close to unity, indicating that the bank was brought to a very precarious state. The computed result of analysis was thus shown to be coincident with what actually happened in the embankment.
