(1984) - First International Conference on Case
Histories in Geotechnical Engineering

Quest and Probe Related to Erosion in the Wrap-Around of an Embankment

R.J.R. Cardia

Civil Engineer, Civil Engineering Central Laboratory, CESP, Ilha Solteira, SP, Brazil

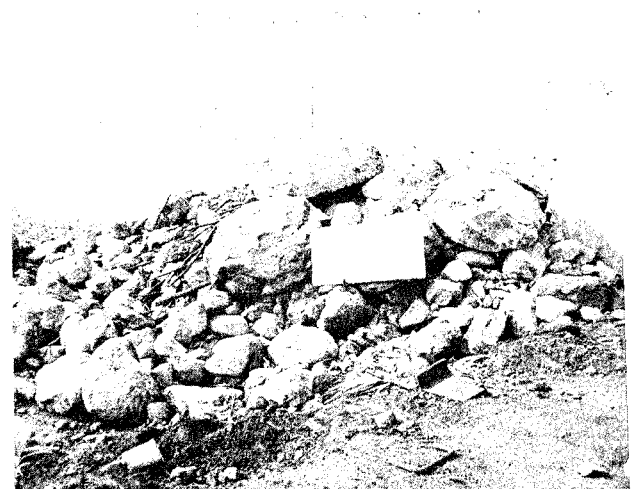
During one of the aforementioned routine underwater inspections (1977), large amount of salt blocks, iron rebars and scaffolding pipes and bracing components were found, scattered over the stilling basin, near the end sill. Initially, those materials were suspected to have been detached and drawn backward from the protected rock-bottom downstream, by recirculating water.

Fig. 4 - Material hauled off the stilling basin by divers.

All debris were then hand removed (NOV77) from the stilling basin by divers, to avoid progression of erosion on the concrete slab surface abrasion.

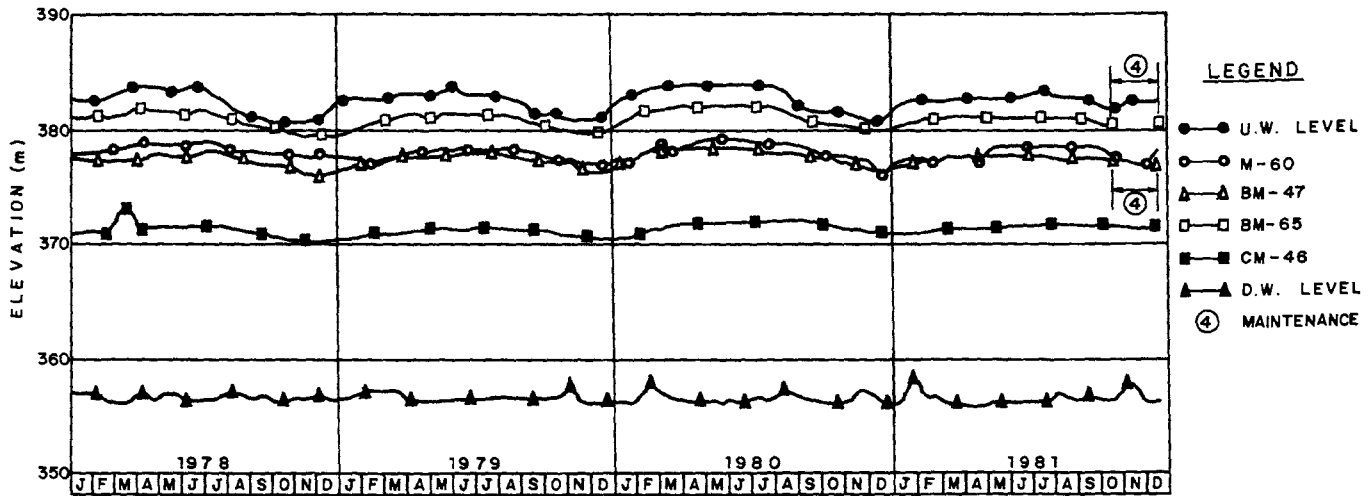
The main instrumented cross-section is located in the station 165 whereas the wrap-around is spread out between stations 158 and 162. So there was no instrumentation available exactly in the probable affected area. Instruments in station 165 didn't present any alteration at all, when new data were compared with previously registered values. Visual inspection in the upstream rip-rap protection showed that some blocks had slid but perhaps this could have been caused by severe action of high waves over

Fig. 8 - Some of the piezometric read-outs in station 165.

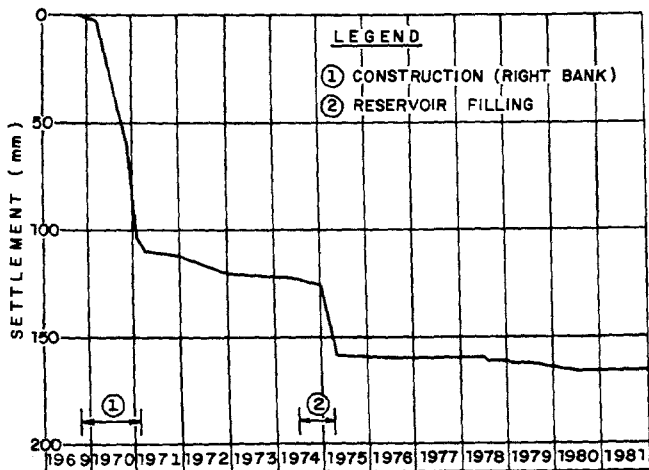
Fig. 9 - Settlement records. KM-4 meter.

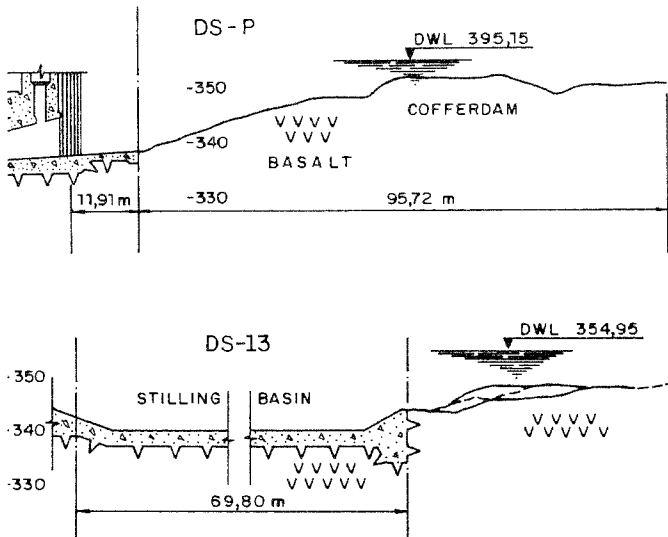
By that occasion a first survey was made with the echo-sounder sailing along the power-house's return channel and downstream river-bed.

Fig. 10 - Echo-sounder survey in the return channel and in the stilling basin

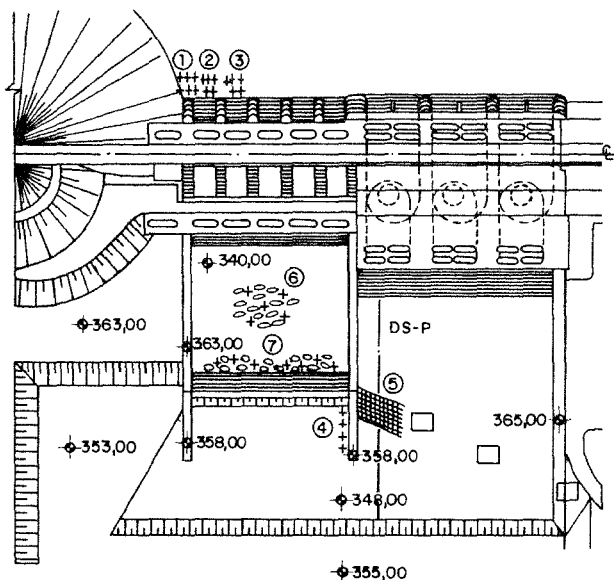
All upstream marked blocks were still standing in the same place without signs of movement, even those identified "in situ" with paint, in the DEC80 tests. It became clearly evident that all debris now found by divers in the central area of the stilling basin, including some blocks identified by gray and yellow strips, had its source in a cofferdam, abandoned at the power-house's return channel (and well upstream of the dividing wall's downstream end).

Third step: all five gates were kept open for 30 minutes (position III; h = 1,5 m) and with that hydraulic symmetrical operation, the water didn't show recirculation. As soon as the gates had been shut, divers were sent to inspect the upstream region and found no alteration at the control blocks. And all the material that was in the stilling basin downstream had been moved, now lying near the end sill. All small sized blocks had been carried away.

Fig. 12 - Result of Hydraulic Tests. Plan

The cofferdam, composed of basalt blocks, a clayey seal and even having some construction debris, was then the actual source of all rubbish found in those underwater inspections of the stilling basin. The materials had been drawn back and sideways by recirculating flow, whenever a non-symmetrical operation of the gates occurred. Topographic situation of the elevated

As a result of this test all manevrers of the

gates should be following a hydraulic symmetrical operation, at least until the programmed removal of the downstream cofferdam remnants had been completed.
