International Conference on Case Histories in Geotechnical Engineering (2008) - Sixth International Conference on Case Histories in Geotechnical Engineering

Analysis of Problems in Cut Slope Survey and Design Based on Case Studies

ANALYSIS OF PROBLEMS IN CUT SLOPE SURVEY AND DESIGN BASED ON CASE STUDIES

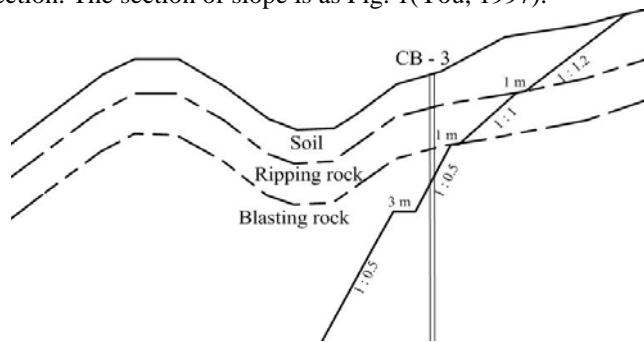
Fig. 1. Slope cross section

Therefore, in application of standard inclination, it has been designed that earth and sand are 1:1.2~1.5, ripping rock is 1:1 and blasting rock is 1:0.5. Installation of berm has been performed installing berm of 3m width at 20 m point from the bottom of slope and berm of 1m width for every 5m of the rest section. The section of slope is as Fig. 1(You, 1997).

In construction by the design, the toppling failure and wedge failure is generated on 4 places due to the development of a fracture zone paralleled with slope on lower part of the slope and by the fracture zone or combination of fragmental zone of fault and joint.

For the cause of slope failure, it is investigated that the slope failure has been generated from development of fracture zone, unexpected at design, on lower part of the slope.

First, at planning soil investigation, it could not consider the topographical characteristic (fault topography) indicating that strike-slip fault growing parallel with route has been developed. Second, while the investigation has been executed down to 1.0m of design height of slope to cut, the depth of boring investigation could not meet the requirements of investigating position and toppling failure.

Finally, since topographical characteristic could not be considered, the position of boring investigation and horizontal direction of elastic wave exploration are inappropriate.

Therefore, the way of resolving these problems is to set the position of boring investigation and the horizontal direction of geophysical exploration at planning soil investigation fully reflecting the result of preliminary investigation and to increase the depth of drilling investigation properly to satisfy the geological condition of toppling failure (Fig. 2). The inclined boring is also a recommendable method.

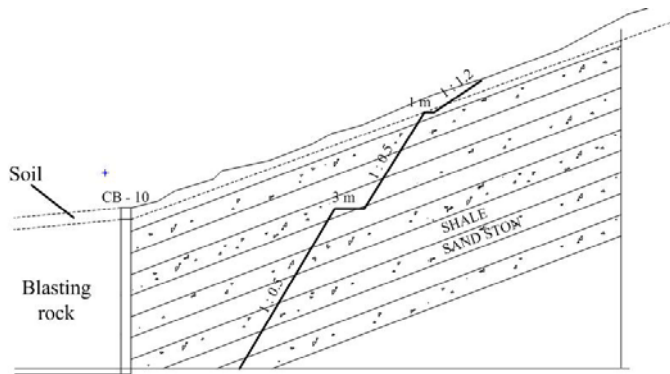
Fig. 3. Slope cross section

Therefore, in application of standard inclination, it has been designed that earth and sand is 1:1.2, ripping rock is 1:1 and blasting rock is 1:0.5. Installation of berm has been performed installing berm of 3m width at 20 m point from the bottom of slope and berm of 1m width for every 5m of the rest section. The representative section of slope is as Fig. 3.

As a bedding plane with narrow uncemented clay layer between sand stone layer and shale layer in the lower part of the slope has been developed during the construction, a large scale plane failure has been generated along with vertical joint performing a role of tension cracking.

For the cause of this slope failure, it is shown that the slope failure has been generated from development of uncemented clay layer, unpredicted at design, in narrow existed bedding plane, and from increase of sliding force and decline of shear strength of ground by rainfall.

First, at planning soil investigation, it could not consider the characteristic of bedding (stratification) that is a feature of sedimentary rock developing paralleled with route.

Second, the depth of boring investigation has been performed to 1.0m down of design height of slope to cut, regardless of satisfying the position of investigation and geological condition of plane failure.

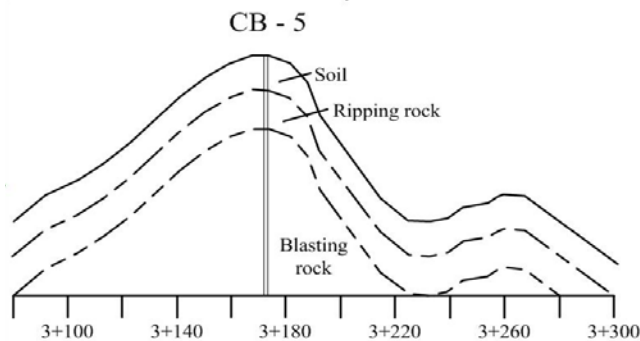
Fig. 5. Layers conditions (design)

Constituent rocks are black mica and granite; the earth and sand (weathered- residual soil) are distributed in a layer of 5.5m from the ground, 4.0m of the ripping rock distributed in its below and 9.5m of blasting rock in the lower part (Fig. 5). N value of earth and sand is 18 times/30 cm ~ 50 times/13 cm that indicates a relative density from middle to high dense, and unified classification is resulted to classify as SM. It has been estimated that the unconfined compressive strength of rock is 765~1210 kg/cm², TCR is 73~95%, RQD is about 35~90%, and it comes under III-IV class in the result of Rock mass classification system by RMR.

From the result of face mapping, the safety of slope could not be evaluated by stereographic projection method, as the discontinuity could not be investigated due to absence of outcrop development and fine growth of vegetation.

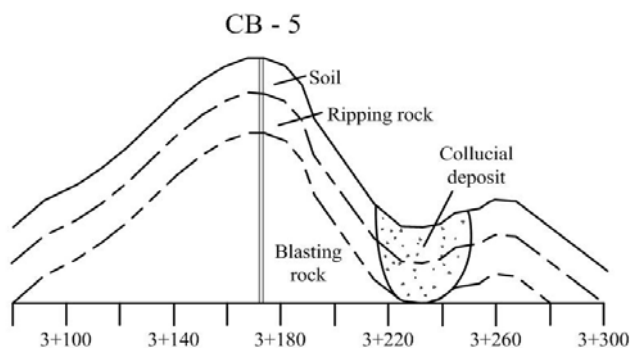
Fig. 6. Layers conditions (construction)

As the following Fig. 6, the collucial deposit is distributed with 8.5m thickness in valley part, a circular failure has been generated during construction (slope inclination 1:1.5).

For the cause of slope failure, it is reviewed that the slope failure has been generated from development of collucial deposit, unpredicted at design, on valley part, and pore water pressure and increase of sliding force by rainfall.

First, the face mapping has not been performed properly as, at planning soil investigation, it could not consider the geological characteristic (gentle slope) showing that collucial deposit was growing.

Second, the item and position of soil investigation have not been appropriate. In other words, the test pit investigation has been performed only at maximum cutting section and a hand auger boring has not been performed at valley part of cutting block.

but the constituent factor of the layer (residual soil and collucial soil), i.e. a significant influence factor, has not been considered. Therefore, the way of resolving these problems is that directional set, terms and position of soil investigation should be determined by fully reflecting the result of preliminary investigation at planning soil investigation. In other words, the investigation of face mapping should be executed as; examining the distribution of collucial deposit; in accordance with the result of the examination, performing test pit investigation, hand auger boring, or etc. even in valley part; and seizing the distribution characteristic of collucial deposit.

The design standard of cut-slope should set an adequate standard inclination (over 1:2.0) by adding constituent items of the layer that is a primary factor affecting the safety of slope.
