International Conference on Case Histories in Geotechnical Engineering (1993) - Third International Conference on Case Histories in Geotechnical Engineering

Case History of a Bridge Foundation

Associate Professor of Civil Engineering, Hunan University, Changsha, Hunan, China

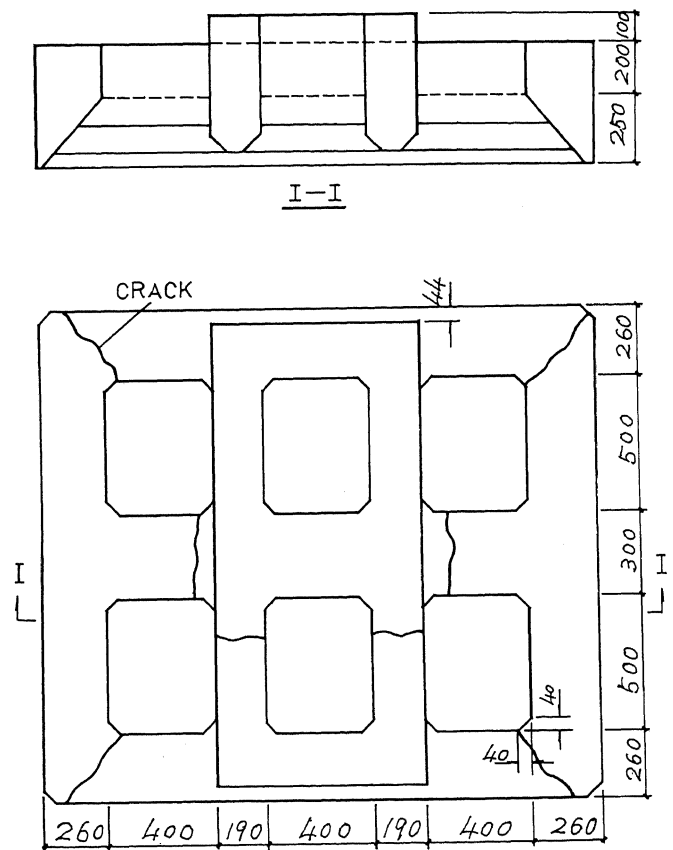
Fig. 1 4[#] Open Caisson and Cracks Position

By the afternoon Nov. 29, the constructors had found some small cracks on the interior walls and sketched the figure of some cracks on the interior walls with chalk. It was 7 o'clock this afternoon that the caisson broke up with a snap in four blocks and the outside walls were inclined to inside. There were eight big cracks which shapes were big-end-down and the widths of these cracks bottom were 66cm, 80cm, 70cm, 60cm, 50cm, 38cm, 58cm and

60cm respectively (See Fig. 1 and Fig. 2). At each corner of the outside walls there was one crack. At three interior walls there were four cracks. Up to that time the caisson had sunk about 20cm.

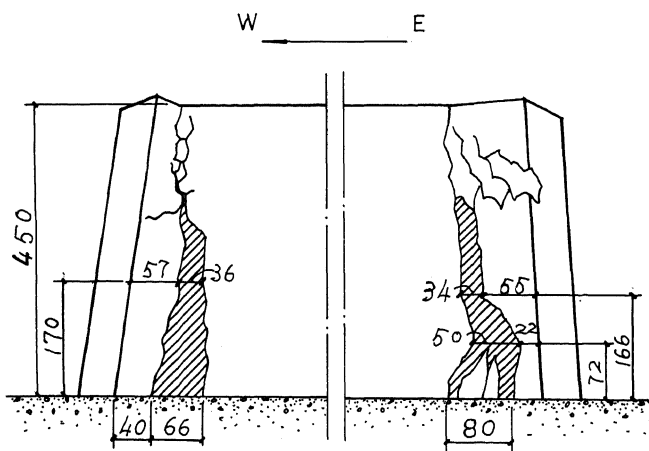
Fig. 2. Part Cracks

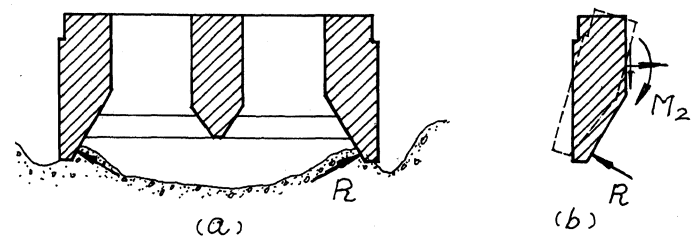
Fig. 3. Condition Bearing Forces on Caisson

area of contact of walls cutting edges and the earth was little. The lower part of the cutting edges beared the big earth resistance R which formed the torques M_1 on the outside walls so that the outside walls were turned outside, as shown in Fig. 3.

2. If the caisson had sunk down in the earth, the outside passive earth pressure would partly or all have set-off the earth resistance R in th wells. But as above, a trench was excavated a-long the outside walls, so the passive earth pressure even the friction vanished.

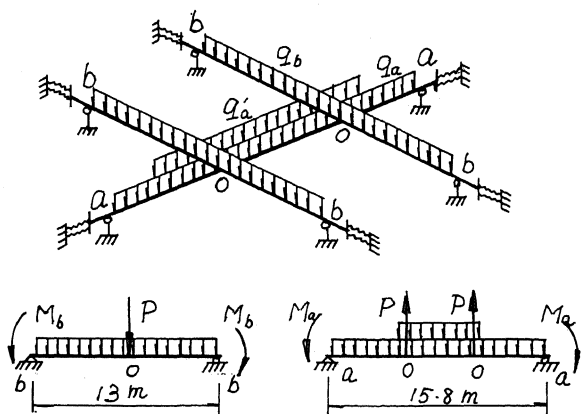
Fig. 4. Bearing Forces of Interior Walls

As consistent with the above explanation the calculation of the caisson was carried on again after the investigation. The interior walls, as shown in Fig. 4, were regarded as a two-cross

beam. Let us regarded the joints of the interior walls and the outside walls as semirigid and decomposed the two-cross beam to turn into beam a-a and beam b-b shown in Fig. 4. If the moment M_a and M_b of semirigid end of the beams and force P at the cross point of the beams are knowiug, thus the problem can be solved. In Fig. 4, δ_{oa} and δ_{ob} are the deflections of the beam a-a and the beam b-b at point O respectively; θ_a and β_a are the turning angles of the beam a-a and the outside walls at point a respectively; θ_b and β_b are the turning angles of the beam b-b and the outside walls at point b. According to harmonious conditions of deformation, thus we have:

From the above calculating we know that the concrete of the interior walls and the corners of the outside walls beared very big tensile stress. But these part scarcely have reinforcement, so that broke up.

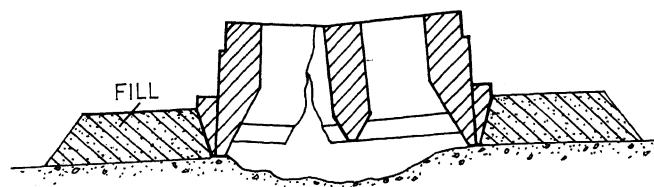
Fig. 5. Opposite Cutting Edge

2. A opposite cutting edge with highness 2.

0m, as shown in Fig. 5, was constructed at the lower part of each outside walls, but it hadn't been constructed at the corners of the outside walls until then. The outside ground was filled earth 1.5m thick in order that the outside earth pressure could exert on the opposite cutting edge.

3. Having cleared out the cracks of concrete fragments, the constructors carefully and evenly excavated the earth in the wells, so the caisson slowly sunk 1.1m. The caisson sinking, the earth pressure of the outside fill to the opposite cutting edge pushed the outside walls towards the interior of the wells, thus the cracks closed and the outside walls were readjusted vertical. The remnant cracks were filled with expanding cement concrete and mortar.

4. The opposite cutting edges at the corners of the outside walls were constructed. These methods were: first, the horizontal reinforcement ($23\phi 25$) in the opposite cutting of the outside walls was jointed at the corner of the outside walls, thus they were formed the continuous rings. The timber form having been put up, the concrete of the corner opposite cutting edge was placed. That is to say, the opposite cutting edge and among reinforcement had formed the continuous hoops.
