International Conference on Case Histories in Geotechnical Engineering (1993) - Third International Conference on Case Histories in Geotechnical Engineering

Response of House Foundations During the Loma Prieta Earthquake

Gennaro G. Marino
Engineering Consultants, Champaign, Illinois

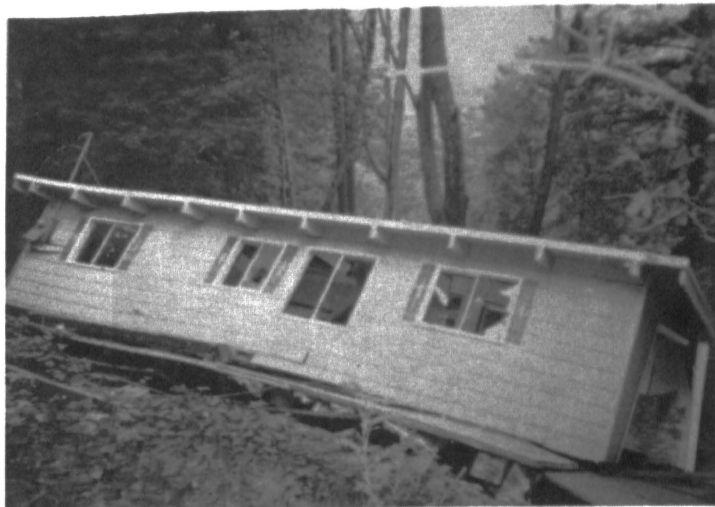
The vertically-oriented tensile cracking observed in foundations was apparently caused by out-of-phase inertia forces in different foundation sections. This foundation damage was not severe consisting generally of racks of hairline widths. Where shaking was severe enough and the floor was not bolted to the foundation, the floor displaced laterally relative to the foundation. In the Loma Prieta earthquake some houses were knocked completely off the foundation (see Figure 3). Even with bolting, however, lateral shifting of the floor relative to the foundation still occurred when the floor was elevated off the concrete foundation by wood-stud-bearing wall (see Figure 4). This type of shifting results from the out-of-plane moment couple created by inertia forces in the floor structure and the foundation at the top and bottom of the stud wall, respectively. In order to mitigate this type of damage, knee braces could be installed to prevent out-of-plane rotation of the cripple wall.

FIGURE 3 HOUSE THAT WAS NOT BOLTED DOWN WAS KNOCKED OFF IT'S FOUNDATION DURING THE LOMA PRIETA EARTHQUAKE

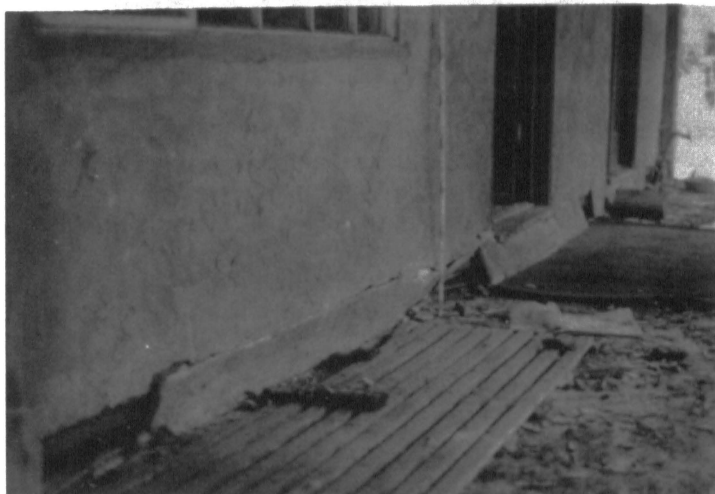
FIGURE 4 LATERAL SHIFTING OF THE FLOOR STRUCTURE OVER THE FOUNDATION CREATED BY A LACK OF BRACING OF THE CRIPPLE WALL

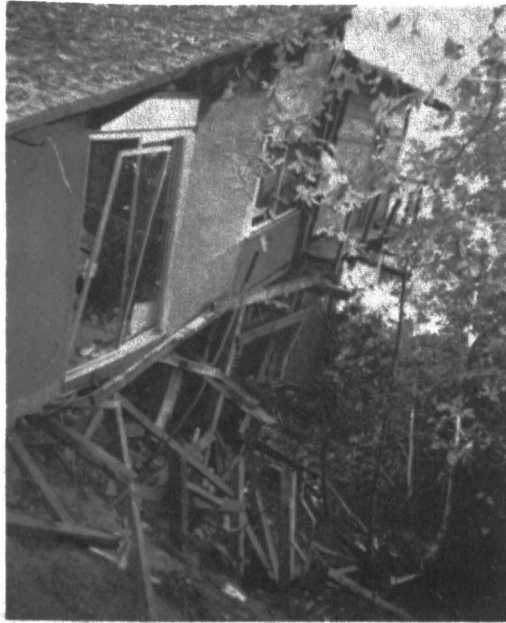
founded on small, shallow; concrete piers (or pedestals) they become significantly racked and displaced as the house shook. Figure 5 is a photograph of this type of racking damage. It is interesting to compare the behavior of the post-and-pier foundations to pole foundations under similar circumstances (i.e., supporting house on hillside). Pole foundations sustained less damage. Pole foundations being fixed into the ground behaved like moment-resisting structures when shook. Where damage to pole foundations occurred, floor diaphragm distortions and fracturing of the pole-floor connections resulted due to the different response of various length poles and the upslope wall foundation.

FIGURE 5 RACKING OF POST-AND-PIER FOUNDATION ON MOUNTAIN SIDE FROM SHAKING

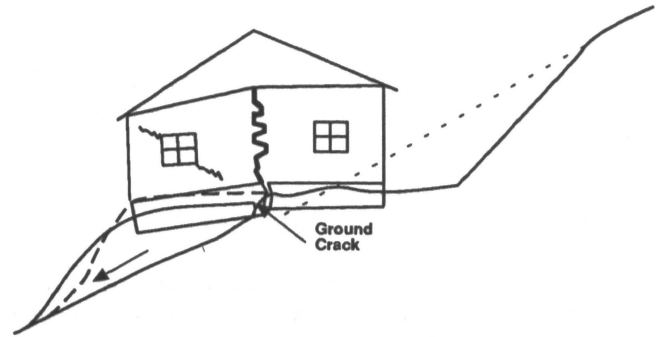
well as unstable fill on the hillside, ground displacements with hogging curvatures and extension resulted beneath the house. Foundations most affected by this movement were perimeter foundation systems which have little resistance to this movement and are very flexible. Drilled-in concrete piers socketed into underlying stable ground with sufficient fixity and rigidity performed the best. Pipe piles also used in wedge fill situations were found to be too flexible to resist bending from lateral earth pressures due to sliding.

FIGURE 6 CROSS-SECTION OF SLIDING OF WEDGE FILL FROM EQ.

More subtle and repairable damage conditions were related to sites where shifting of downslope fill or exacerbation of slope creep occurred. EQ instability of wedge-fill was typically attributed to uncontrolled placement. Although the sliding of the fill were commonly in the range of inches, cases of more extensive sliding also occurred (see Figure 6). In addition to fill these displacements, downslope movements subjacent to foundations on hillside fill sites were attributed to EQ-induced shifting of slope creep materials.

In addition to foundation stabilization measures necessary to correct the above landsliding damage (which many times included underpinning), the induced downslope tilt required that the house be releveled.

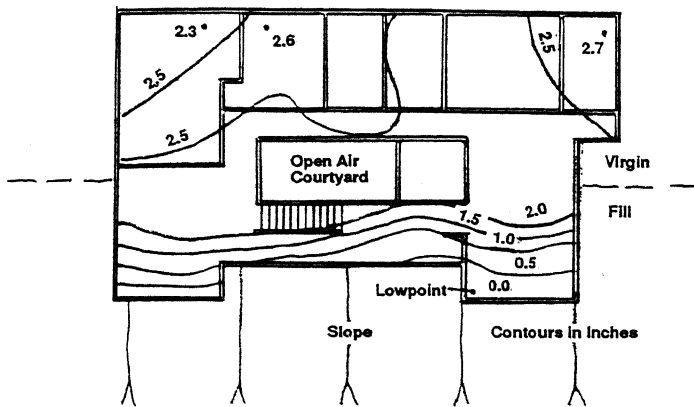
FIGURE 7 MANOMETER SURVEY OF FIRST FLOOR OF HOUSE WHICH IS OUT OF LEVEL DUE TO SLIDING AND SETTLING OF WEDGE FILL

Underpinning was a common recommendation to stabilize and relevel the foundation over such ground conditions. Figure 7 shows a manometer survey performed on the first floor of house which settlement from some sliding and densification of the wedge fill.

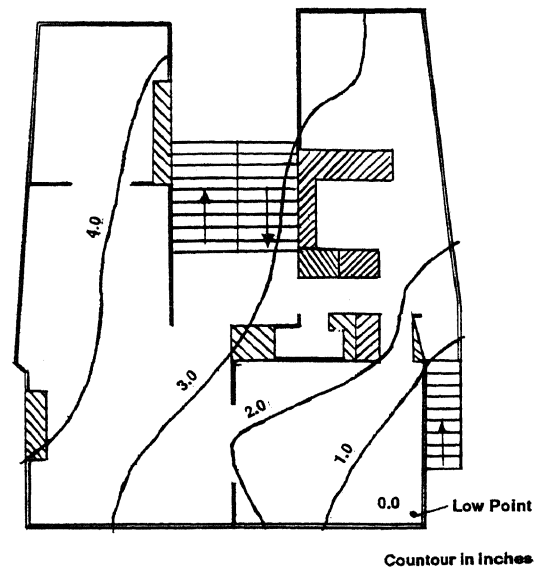
FIGURE 8 MANOMETER SURVEY OF FIRST FLOOR OF HOUSE IN MARINA DISTRICT OF SAN FRANCISCO WHERE SUBJACENT LIQUEFACTION OCCURED

Houses on perimeter foundation systems were most susceptible to damage from liquefaction. These foundation responded to subjacent liquefaction by willingly bending and breaking. Resultant differential settlements were evident by the induced racking in the house frame and irregular tilting of floor areas. In Figure 8 a manometer survey is presented of the floor of the house in the Marina District where the subjacent soil have undergone liquefaction. Common foundation repair recommendations where liquefaction resulted involved compaction grouting of the loose sands or installation of a mat foundation.
