Structural Damage of a 5-Storey Building: Differential Settlement Due to Construction of an Adjacent Building or Because of Construction Defects?

STRUCTURAL DAMAGE OF A 5-STOUREY BUILDING: DIFFERENTIAL SETTLEMENT DUE TO CONSTRUCTION OF AN ADJACENT BUILDING OR BECAUSE OF CONSTRUCTION DEFECTS ?

ABSTRACT

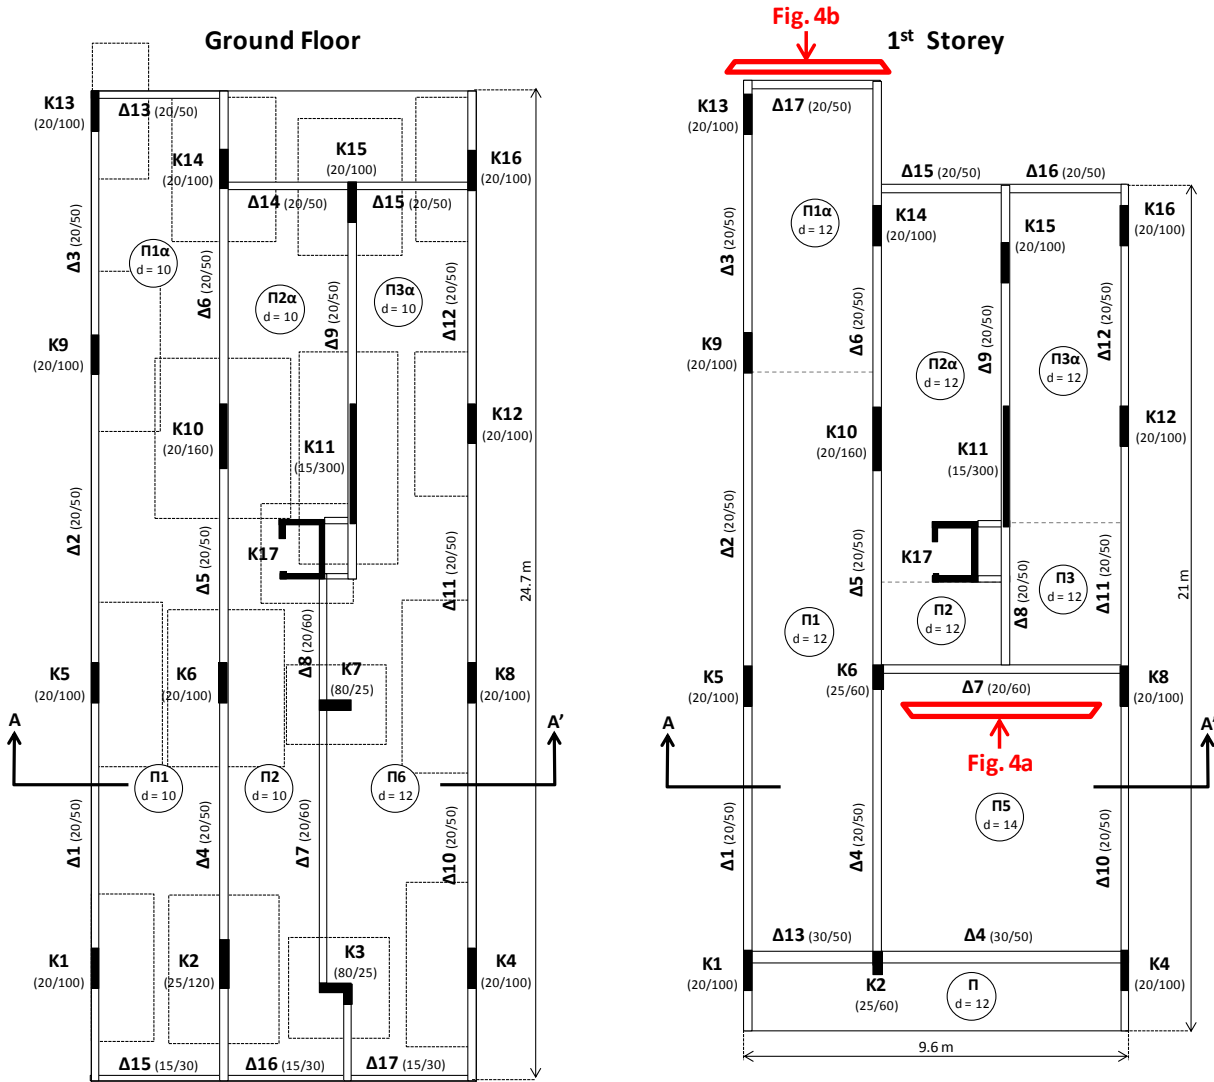
Fig. 2. Plan view of the ground and 1st floor of Building A, showing the locations of the photos of Fig. 4.

In the transverse direction, the RC frame has four column rows, spaced at roughly 3 m. As a result, the footings (especially the ones closer to Building B) are almost in contact: the distance between two adjacent rows is no more than 30 cm (Fig. 2). In such cases, a grid or a slab foundation is typically preferred. As also pointed out by the study of the

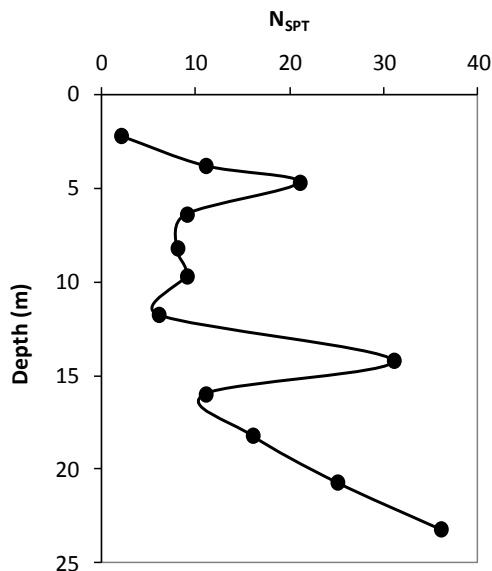
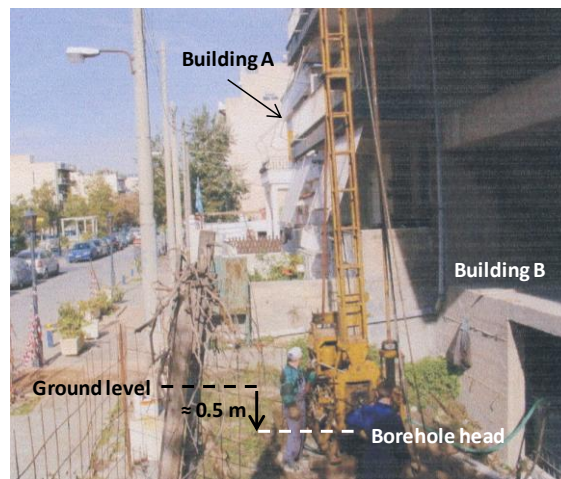
According to the Supervising Engineer of Building B, although no geotechnical investigation was conducted (as it is not mandatory for such buildings), three 10 m–deep boreholes from neighboring larger constructions were available and were taken into consideration. Based on those boreholes, the first 5 m should consist of soft clayey silt, followed by medium density silty sand, with the water table being at a depth of approximately 1.5 m from the ground surface. This was confirmed by the later conducted geotechnical investigation at the front of Building B [Triton, 2004], according to which the first 15 m consist of soft clayey silt to sandy silt with gravel, fine sand with silt, and high plasticity silty to sandy clay. At 15 m depth, soft clay is encountered, becoming stiffer at 20 m depth. After 22 m depth the clay contains pebbles and gravel, turning to hard sandstone at 26 m depth. Standard penetration tests (*SPT*) were also executed, according to which N_{SPT} ranges from 2 (first 2.5 m) to 36 (at 25 m depth). Note that down to 15 m depth, the average N_{SPT} is of the order of 10 (**Fig. 3**), implying that the soil is indeed quite soft. The ground

Fig. 3. Distribution of N_{SPT} with depth and photo of the borehole in front of Building B [Triton, 2004].

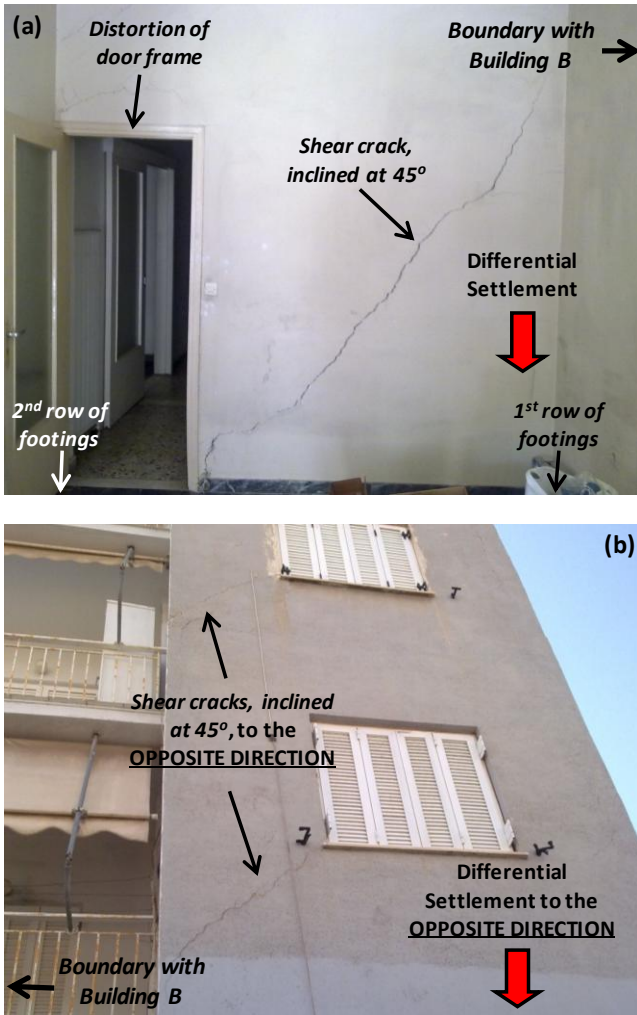
In addition to the cracks of the internal infill walls, which are documented in all technical reports, during the present forensic investigation similar shear cracks were detected on exterior transverse infill walls, as shown in **Fig. 4b** (see **Fig. 2** for the exact location). Inclined at approximately 45° , these cracks are also indicative of differential settlement, but to the *opposite direction*. Therefore, they cannot possibly be related to settlement caused by the additional loading due to construction of the RC frame of Building B. It was therefore deemed necessary to measure the deformation of Building A.

Fig. 4. Observed damage: (a) photo of internal transverse wall, showing shear cracks and door frame distortions; and (b) photo of external transverse wall showing shear cracks to the opposite direction.

Based on the observed cracks, in conjunction with the aforementioned precision leveling measurements, it may be concluded that Building A suffers from: (a) differential settlement of the order of 2.5 cm due to its own weight, as evidenced by the cracks of Fig. 4b and the measured height differences of the floors; and (b) differential settlement of the order of 2.5 cm due to the additional settlement of Building B, as evidenced by the cracks in Fig. 4a and the measured height differences of the floors. It is therefore reasonable to assume that the total measured differential settlement of approximately 5 cm is due to the superposition of the two above differential settlements.

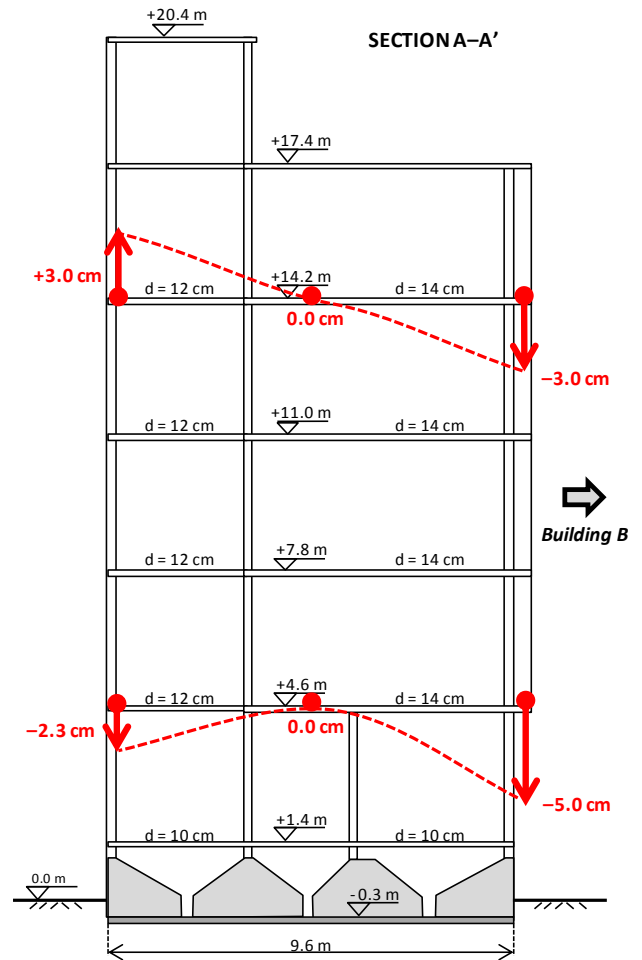
On July 2011, precision leveling measurements were conducted inside Building A, on the slabs of the 1st, 2nd, and 4th floor. Based on these measurements, the maximum height difference on the first floor is about 5 cm. As sketched in Fig. 5, having the stairway as a reference, the maximum relative settlement of 5 cm is observed at the boundary with Building B at the front wall of the building. A smaller relative settlement of 2.4 cm is observed at the opposite side of the building. Note that this differential settlement is to the opposite direction, and cannot possibly be attributed to the settlement of Building B. Evidently, the observed cracks of Figs. 4a and 4b are totally compatible with the precision leveling measurements. It should, however, be noted that the height differences measured through internal precision leveling are not necessarily exactly equal to the differential settlements, as they may be partly due to construction “flaws” of the floors.

Fig. 5. Section A-A' of Building A, showing the key results of internal precision leveling measurements (July 2011).

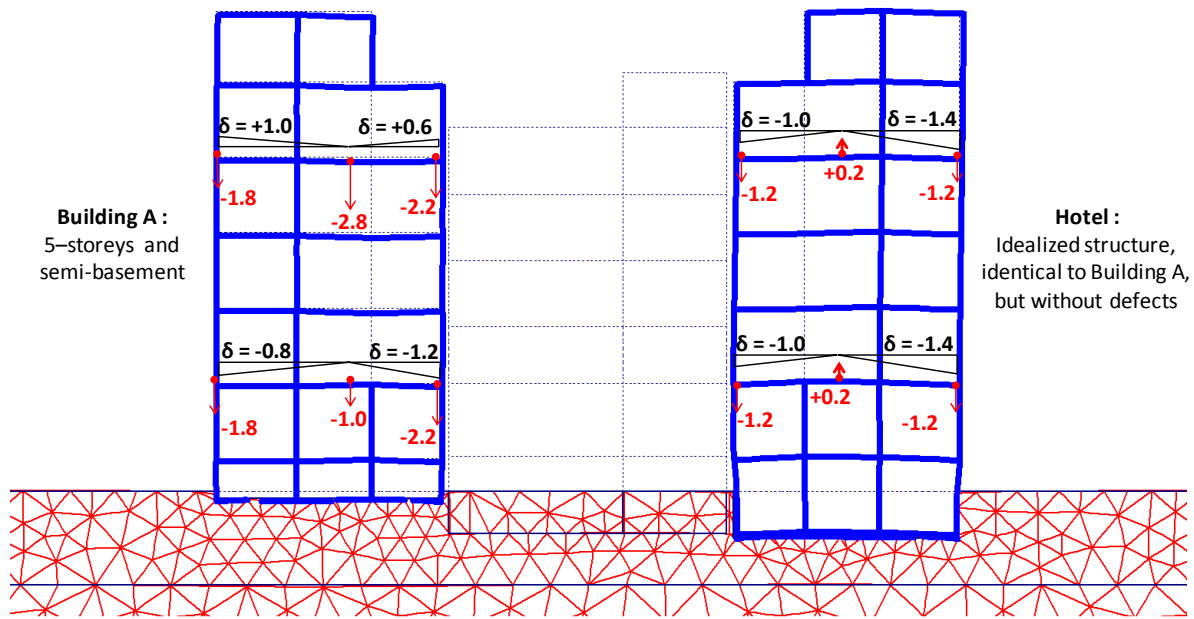
The results are presented in **Fig. 7** in terms of absolute (marked in red) and differential (marked in black) settlements at characteristic locations of the two buildings (corresponding to the locations of the measurements). Evidently, only with the dead loads of its RC frame, Building A experiences maximum absolute settlement of -2.2 cm (right footing). At the same time, the maximum absolute settlement of the idealized building at the location of the hotel is almost 50% lower: -1.2 cm. Since the two buildings are identical, this difference can only be attributed to the construction defects of Building A, due to which its foundation and superstructure are indeed extremely flexible in the transverse direction.

However, at this stage the differences between the two structures are not that important in terms of differential settlements. Taking as a reference the middle of the building (as for the precision leveling measurements), the left span of the 1st floor experiences differential settlement $d = -0.8$ cm and the right one -1.2 cm. In the fourth floor, the left span has a relative elevation $d = +1.0$ cm while the right one $+0.6$ cm. This strange distribution is due to the elimination of the middle-right column from the first floor and above. Since the infill walls (and the door frames, etc.) have not yet been constructed at this stage, these differential settlements (or elevations) could not have caused any damage.

Fig. 7. Numerical analysis results for Step 1 – Construction of the RC frame of Building A and the corresponding idealized building in place of the adjacent Hotel: absolute (in red) and differential (in black) settlements at characteristic locations of the two buildings.

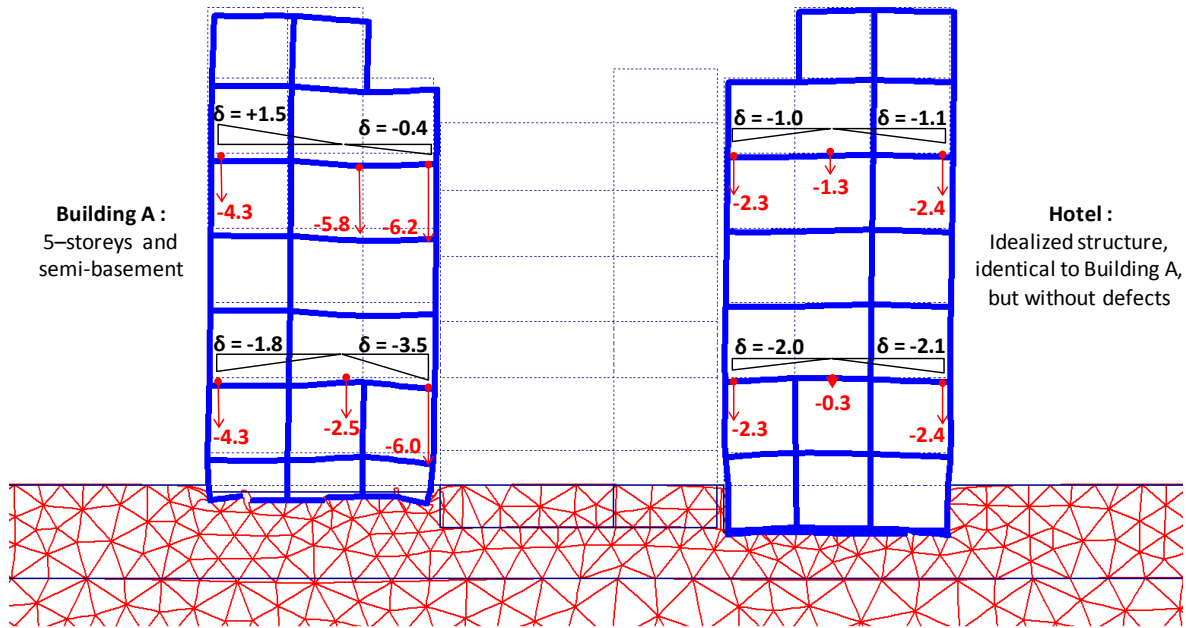
The results are presented in **Fig. 8** in terms of absolute (in red) and differential (in black) settlements at characteristic locations of the two buildings. Even considering a lower bound estimate for the additional permanent loads (infill walls, floors, etc.), and assuming that only 50% of the design live loads is imposed, Building A is subjected to a maximum absolute settlement of -6.0 cm (left footing) – purely due to its own weight. Correspondingly, the maximum absolute settlement of the idealized building in place of the neighboring Hotel does not exceed -2.4 cm. Evidently, since the two buildings are identical, this major difference is solely

In contrast to the previous analysis step, the differences between the two structures in terms of differential settlements are quite noticeable. Always taking as a reference the middle of the building, the left span of the 1st floor is subjected to differential settlement $d = -1.8$ cm, and the right one to $d = -3.5$ cm. In the 4th floor, the left span experiences differential elevation $d = +1.5$ cm, while the right one $d = -0.4$ cm. As mentioned above, this peculiar distribution is due to the elimination of the middle-right column from the 1st floor and above. Such differential settlements could have caused noticeable damage to infill walls and door panels. However, since the differential settlements took place gradually during construction, the infill walls were actually subjected to the differential settlements that took place after their construction: i.e., the difference between this step and the previous one. Under this prism, the differential settlements that were actually “felt” by the infill walls of Building A did not exceed -2.3 cm (on its right side, close to the boundary with Building B). Hence, it is quite reasonable that no damage had been observed for almost 30 years.

Fig. 8. Numerical analysis results for Step 2 – Completion of Building A and the corresponding idealized building in place of the adjacent Hotel: absolute (in red) and differential (in black) settlements at characteristic locations of the two buildings.

- Before the erection of the RC frame of Building B (Fig. 8), the maximum settlement of Building A (due to its own weight) reached -6.0 cm, leading to maximum differential settlement of -3.5 cm. Since the latter took place gradually during construction, the infill walls were subjected to the differential settlements that took place after their construction, namely -2.3 cm. Therefore, it is reasonable that no damage had been observed for 30 years.

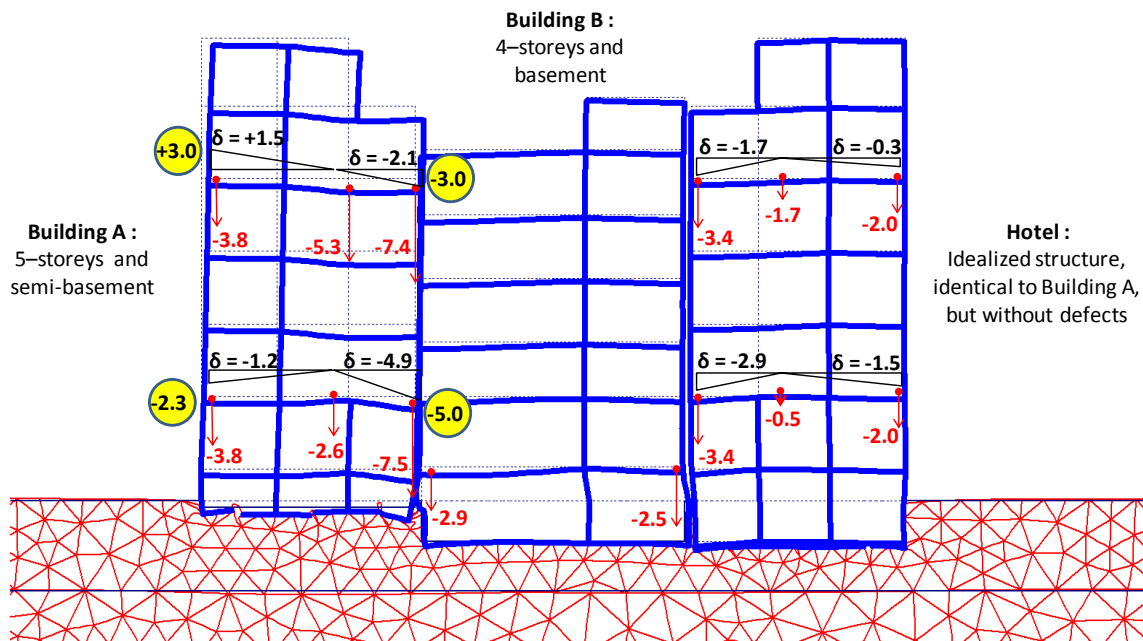
This final analysis step is of particular importance as it corresponds to the current situation. Moreover, as discussed below, through comparison with the precision leveling measurements, this step also serves as validation of the numerical analysis conducted herein. The results are presented in Fig. 9 in terms of absolute (in red) and differential (in black) settlements at characteristic locations of the two buildings. Considering a conservative upper bound for the dead loads of the RC frame of Building B, the maximum settlement due to its erection reaches -2.9 cm – totally reasonable for such soft soil. This inevitable (at least with a raft foundation) settlement led to an increase of the settlement of the two neighboring buildings. More specifically, the maximum absolute settlement of Building A is increased to -7.5 cm (as expected, at the boundary with Building B). Note that the increase of the absolute settlement of Building A due to erection of the RC frame of Building B is only -1.5 cm, as Building A had already settled by -6.0 cm due to its own weight (see Fig. 8). At the same time, the maximum absolute

Taking as a reference the middle of the building, the computed differential settlements (or elevations) are directly comparable to the precision leveling measurements. In Fig. 9, the measured values are shown in yellow circles to facilitate direct comparison with the numerical analysis results. On the left span of the 1st floor of Building A, a differential settlement $d = -1.2$ cm is computed (compared to -2.3 cm of the measurements); the right span of the same floor experiences much larger differential settlement $d = -4.9$ cm (as opposed to -5 cm of the measurements). Note that this is exactly at the location where the most severe shear cracking is observed (see the photo of Fig. 4a). Moreover, notice that the differential settlement of the left span is to the opposite direction, being totally consistent with the observed damage of the outer infill walls (see the photo of Fig. 4b). In the 4th floor, the left span experiences differential elevation $d = +1.5$ cm (compared to +3.0 cm of the measurements), and the right one differential settlement $d = -2.1$ cm (as opposed to -3.0 cm of the measurements). The numerical prediction can be seen to compare adequately well with the measurements qualitatively and quantitatively, confirming the validity of the analysis method and the adopted soil parameters.

Fig. 9. Numerical analysis results for Step 3 – Construction of the RC frame of Building B: absolute (in red) and differential (in black) settlements at characteristic locations of the two buildings. The values in yellow circles correspond to the measurements.

- The additional loads due to construction of the RC frame of Building B (Fig. 9) led to maximum absolute settlement of -2.9 cm – reasonable for such soft soil. This led to an increase of the maximum absolute settlement of Building A from -6.0 cm to -7.5 cm, and to an increase of the maximum differential settlement from -3.5 cm to -4.9 cm. The differential settlement actually suffered by the infill walls of Building A rose from -2.3 cm to -3.7 cm, leading to the observed shear cracking of infill walls.
