## Case Study on the Foundation and Site Geotechnical Evaluation for the Rehabilitation of an Emergency Hospital Building

Ion Vlad

*Technical University of Civil Engineering, Bucharest, Romania*

This case study is about the foundation and the site geotechnical potential evaluation for the rehabilitation of an emergency hospital building, placed in Bucharest. This building was strongly damaged by the main earthquakes that occurred in Romania, within the last 30 years (March 4<sup>th</sup>, 1977, August 30<sup>th</sup>, 1986 and May 30<sup>th</sup>, 1990). The building had, from the beginning, an unfavorable structural concept, in what concerns its shape in plane. The paper presents the methods used for the rehabilitation of the existing building foundation, together with the integration of a new foundation for a new building, that appeared necessary to be built, as a single solution for the strengthening of the old one. Important additional loads were considered for the proposed solution and thus an extensive study on the foundation and geotechnical aspects of the project were carried out, including a site geotechnical study, evaluation of bearing capacity and settlement, evaluat

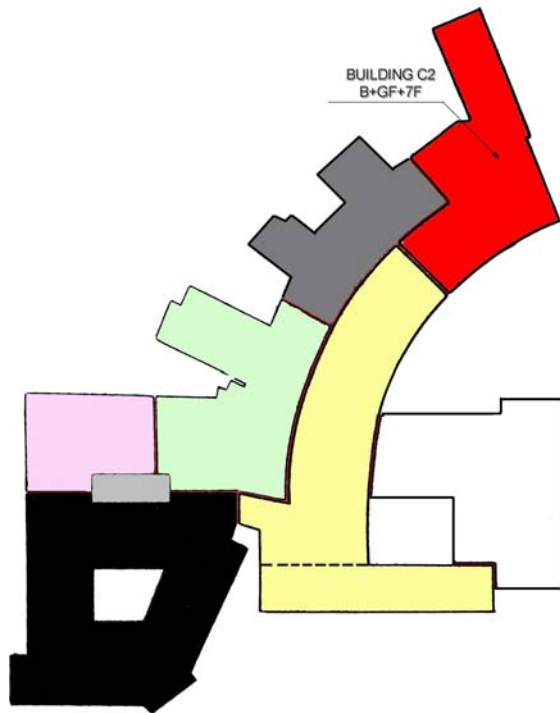
Fig. 2 General drawing of the buildings belonging to the Bucharest "Emergency Hospital"

- after the 1977 strong motion, very severe damage was reported, and the works consisted in strict local repairing of damaged elements (without having a general concept of strengthening);
- the body “C2” has an unfavorable plan layout (Fig. 2), elastic and inertial dissymmetry;
- a general state of visible damage was present (cracks and fissures);
- the building was designed in 1967, by applying the first Romanian seismic standard approved in 1963 at that time.
