Remedial Measures to a Building Settlement Problem

SYNOPSIS A ten storeyed building, built on a subsoil of an onshore marine soil, was observed to be tilting away from the vertical. Extensive field and laboratory investigations were carried out to establish the reasons for the differential settlement causing the tilting. Though, nearly uniform pressure has been achieved at the foundation level, presence of a soft marine clay layer with varied thickness and location has caused the differential settlement. To arrest further increase in differential settlement, micropiling in the zone of higher settlement and additional loading and lowering of water table in the zone of lower settlement have been carried out as remedial measures. Controlled removal of the silty soil from below the foundation in the low settlement zone has reduced the differential settlement. The performance of the remedial measures has been monitored for more than two years.

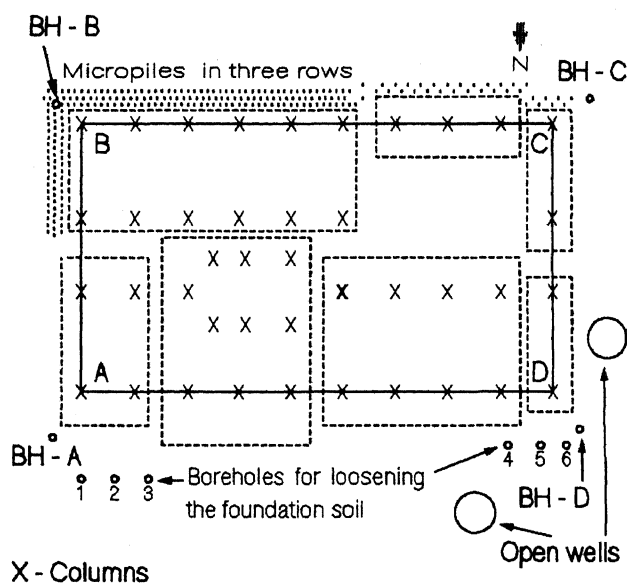
As a first step, the structural design details of the building and the original soil investigation report were reviewed. The building has a 3 m basement construction below the general ground level. The foundation level has been at 2.4 m below the basement level i.e., 5.4 m below the general ground level. The ground water level has been at the foundation level during the month of July and fluctuates ± 1 m over the year. The types of foundation adapted has been combined raft for about 60% of the area, combined footings and independent footings for the rest of the area. Fig. 1 shows a schematic plan and details of the foundations.

Fig. 1 Layout plan of the building at foundation level.

Fresh soil investigations were carried out to a depth of about 20 m below the foundation level at four corner locations (A, B, C and D in Fig. 1) around the building. The soil profile indicated layers of silty clay, silty sand, soft clay, clayey sand and silty sand with varying thickness of each layer in the four locations. Fig. 2 shows the

1. Driving micropiles in zone B and C: Three rows of micropiles inclined at an angle of 60° with the horizontal (Fig. 5), at a spacing of 250 mm c/c in both the directions were driven below the foundation level in the South-East quadrant of the building (Fig. 1). These piles were of 100 mm dia. and 10 m long galvanised steel pipes with bottom end closed with a shoe. While driving the piles outer row was driven first and the piles in the second and third row were staggered. Around the corner C the piles were driven along CB in two rows at a spacing of 250 mm c/c.

2. Additional loading in zone D: The North-West quadrant of the basement floor was loaded with sand bags for a height of 2.4 m and to an area of about 200 sq. m. This was to induce additional settlement in corner D.

3. Lowering of ground water table in zone D: As mentioned earlier the general ground water level was at foundation level during the months of July - August. Two open wells of dia 2.5 m were sunk to a depth of 15 m from the ground level. The locations are shown in Fig. 1. Using continuous pumping the ground water level was lowered and maintained at 10.4 m below the ground level. This gave an additional uniform loading of about $3-5 \text{ T/m}^2$ in the corner D and its surrounding area.

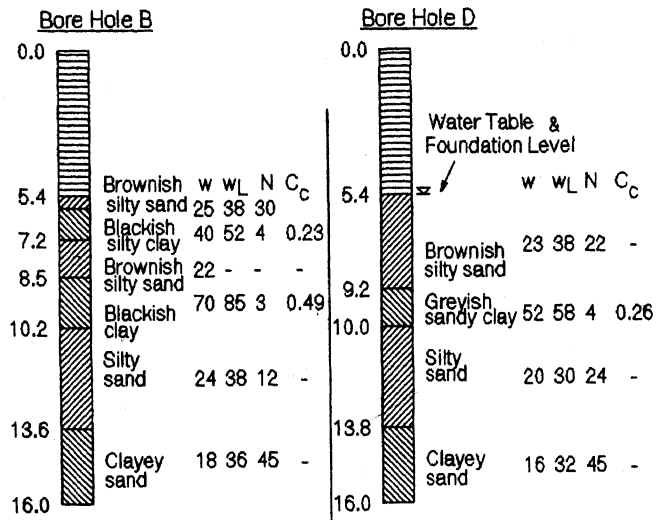
Fig. 2 Soil profile from bore holes at B and D corners

bore log details with N values, water content, liquid limit and C_c for the locations B and D forming the extreme conditions. The other two bore logs were also similar except for the variations in the thickness of different layers. Laboratory oedometer tests were conducted on the undisturbed samples from these locations. Fig. 3(a) shows the typical time-compression curve while Fig. 3(b) shows the typical e - log σ_v' curves.

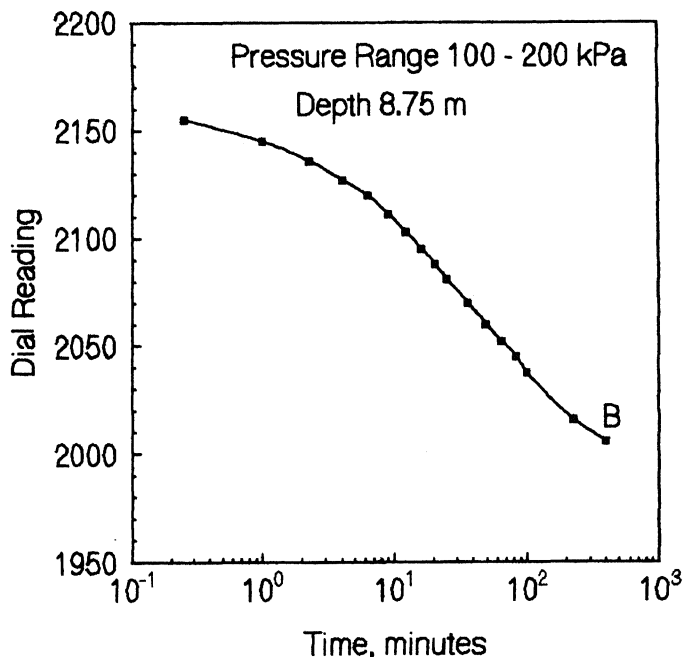
Fig. 3a Typical time versus dial reading plot of soft clay from location B

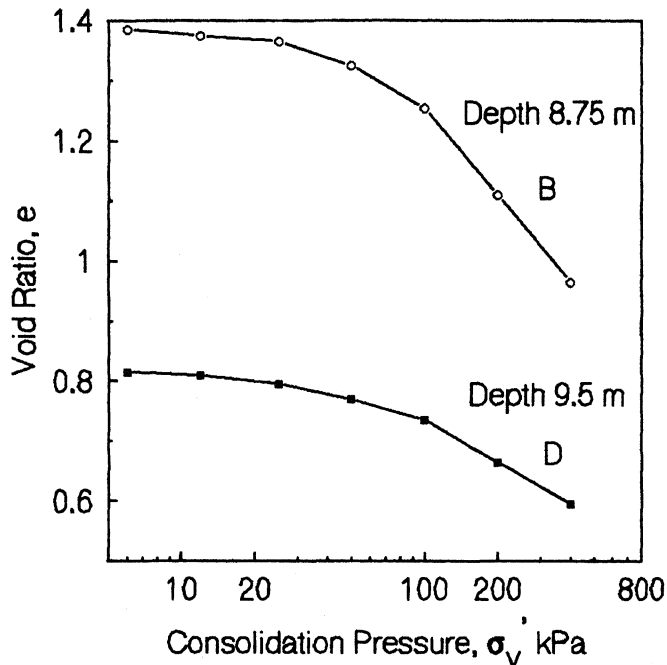
Fig. 3b Typical e - log σ_v' plots of the soft clay from locations B and D

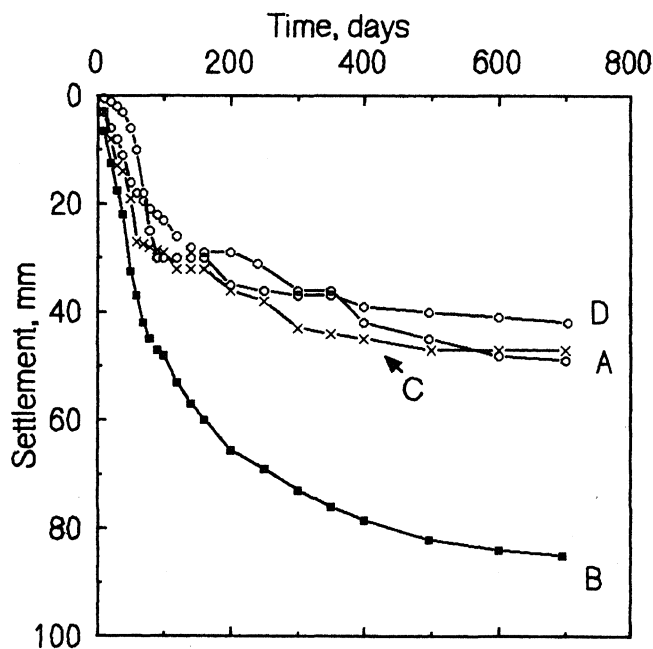
Fig. 4 Time versus settlement plot of the four corners of the building

Settlement measurements were started simultaneously in July 1990 at the four corners of the building. The settlements were monitored using mercury filled flexible nylon tubes in relation to an established permanent bench mark outside the building area. This method enabled recording of the settlement to an accuracy of ± 0.5 mm. The initial part of the curve in Fig. 4 shows the thus observed settlements at all the four locations. During the first 38 days of observation, the corner B had a settlement of 22 mm against a settlement of 3 mm in corner D. The corners A and C had settlements of 11 mm and 14 mm during the same period. This resulted in a greater rotation in the North-South direction (about 11 mm in 20 m) than that in West-East direction (8 mm in 35 m). This was comparable with the rotation of the plumb-line which was about 20 mm in 30 m, during the same period.

The above remedial measures were implemented with in the first 100 days. The subsequent settlement measurement (Fig. 4) indicated a substantial decrease in rate of settlement of the corner B and an increase in rate of settlement of the corner D. There was a slight increase in the rate of settlement of corners A and C, may be due to overall lowering of the water table, which reduced with time. Fig. 4 shows clearly the variations of differential settlement with time. However, the following additional remedial measure was adapted which induced increased settlements of corners D and A to maintain a near constancy of differential settlement between A and B.

Fig. 4 indicates the monitored settlement for about 700 days which includes the effect of rectification measures. Had the rectification measures were not taken up immediately, the corner B would have settled much more and the corner D would have practically no settlement at all. During the implementation of remedial measures including the removal of the soil a close monitoring of all the structural components of the building was carried out. No structural distress was noticed. It may be mentioned here that because of very stiff structural elements like stiff foundations, beams and columns, short spans, etc., the whole building behaved like a rigid body. The measurement of tilt at opposite points and at different locations using plumb-lines confirmed the rigid body rotation. The building was commissioned for its slated purpose during May 1991.

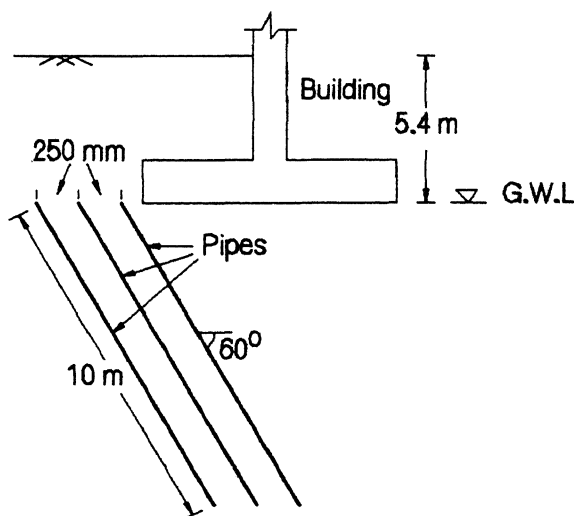
Fig. 5 Schematic orientation of micropiles.

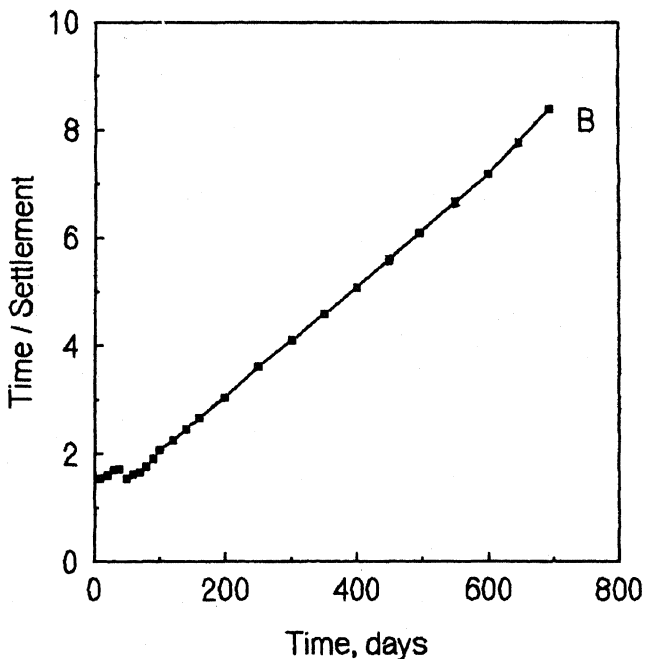
Fig. 6 Time versus Time/Settlement plot for the location B

hyperbola. Fig. 6 shows the time vs settlement of corner B, replotted in the form of time versus time/settlement. In this plot, the reciprocal of the slope at the latter part of the curve gives the ultimate settlement. From the Fig. 6 it can be observed that the initial part of the curve has a flatter slope (before treatment i.e., first 38 days) indicating a much higher settlement. After treatment the slope (after 100 days) has gradually increased to become a constant. From this, an ultimate settlement of about 110 mm is predicted. This compares against a possible settlement of about 300 mm based on initial slope which was much flatter before treatment.
