Geotechnical Forensic Investigation of Observed Cracks on a Building in Tallahassee, Florida

GEOTECHNICAL FORENSIC INVESTIGATION OF OBSERVED CRACKS ON A BUILDING IN TALLAHASSEE, FLORIDA

In July 2010, two vapor extraction wells were installed about 15 feet from a building at an angle of 50 degrees to the horizontal using rotosonic drilling technique (RDT). In June 2011, a crack approximately 0.5 inch wide on the wall of the building was reported. Several other small cracks were observed on the building following inspection by the authors. The owner of the building expressed concerns that the rotosonic drilling was the cause of the cracks and wanted assurance that subsequent drillings would not exacerbate the problem.

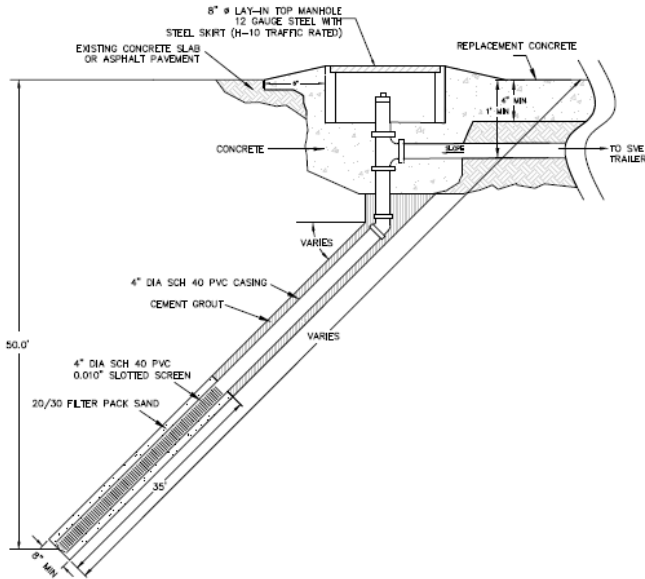
The sand filter pack was placed from the bottom to approximately 1 ft. above the slotted portion of the pipe and the remainder of the annular space was filled with cement grout. Figure 2 shows a section of the angled vapor extraction well. The angled wells went underneath the southwest wall and are estimated to be 18 ft. below the wall of the building.

Fig. 2. Angle drilled vapor extraction well section.

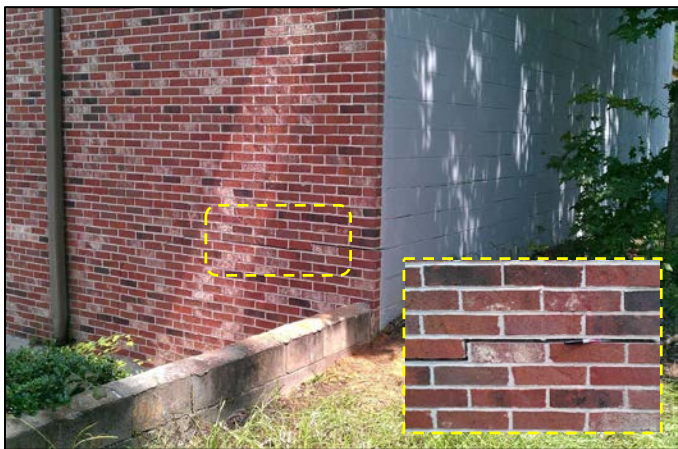
Fig. 3. Observed Cracks on the front brick façade of the building.

A small vertical crack was observed near the drainage downchute on the front façade of the structure. The vertical crack width was in the range of 0.079 to 0.28 in. The crack continued vertically on the wall and then translated to a horizontal crack. The horizontal crack width ranged between 0.18 and 0.55 in. (Fig. 3). The crack depth ranged from 1.18 to 5.12 in. The maximum crack width of 0.55 in. was observed to be at the corner where the southwest wall and the front façade meet (Fig. 4). The crack continued on the southwest wall, which is a masonry wall, of the structure.

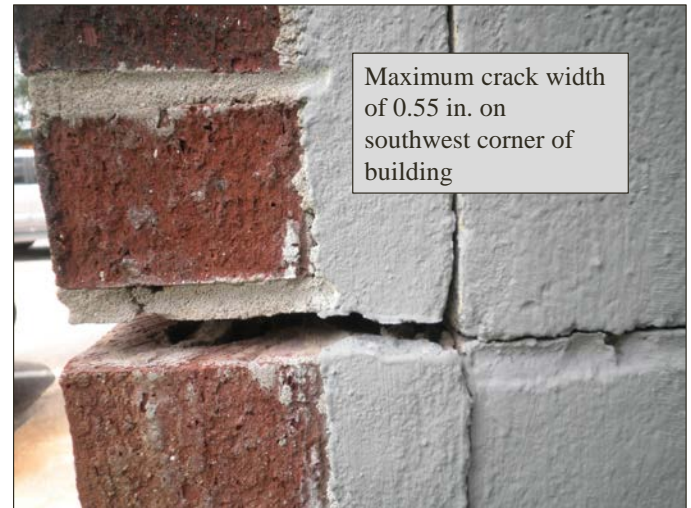
Fig. 4. A crack 0.55 in. wide observed on the southwest corner of the building.

most probable that the higher precipitation resulted in ponding and further infiltration of stormwater in the area near the southwest wall. The infiltrated water reached down to and saturated the expansive clay approximately 10 ft. BLS. This was followed by comparatively lower precipitation and dry period leading to moisture egress from the clayey soils. The expansive clay experienced moisture fluctuations. Moisture reduction led to volumetric shrinkage of the clay. Since the thickness of the clay layer varies from 11 ft. at SB-1 to 6 ft. at SB-3, the volumetric shrinkage was differential. The differential volumetric shrinkage led to differential settlement of the clay layer. Thus, greater settlement occurred for the thicker clay layer which showed up as a crack at the corner of the structure.

Eliminate potential problems with trees and its roots. One other recommendation was to remove and/or relocate both the Sweetgum trees to a distance of 75% of the tree height from the wall. In case the trees cannot be relocated, the roots of the trees growing toward/underneath shall be identified and cut off to prevent future growth.

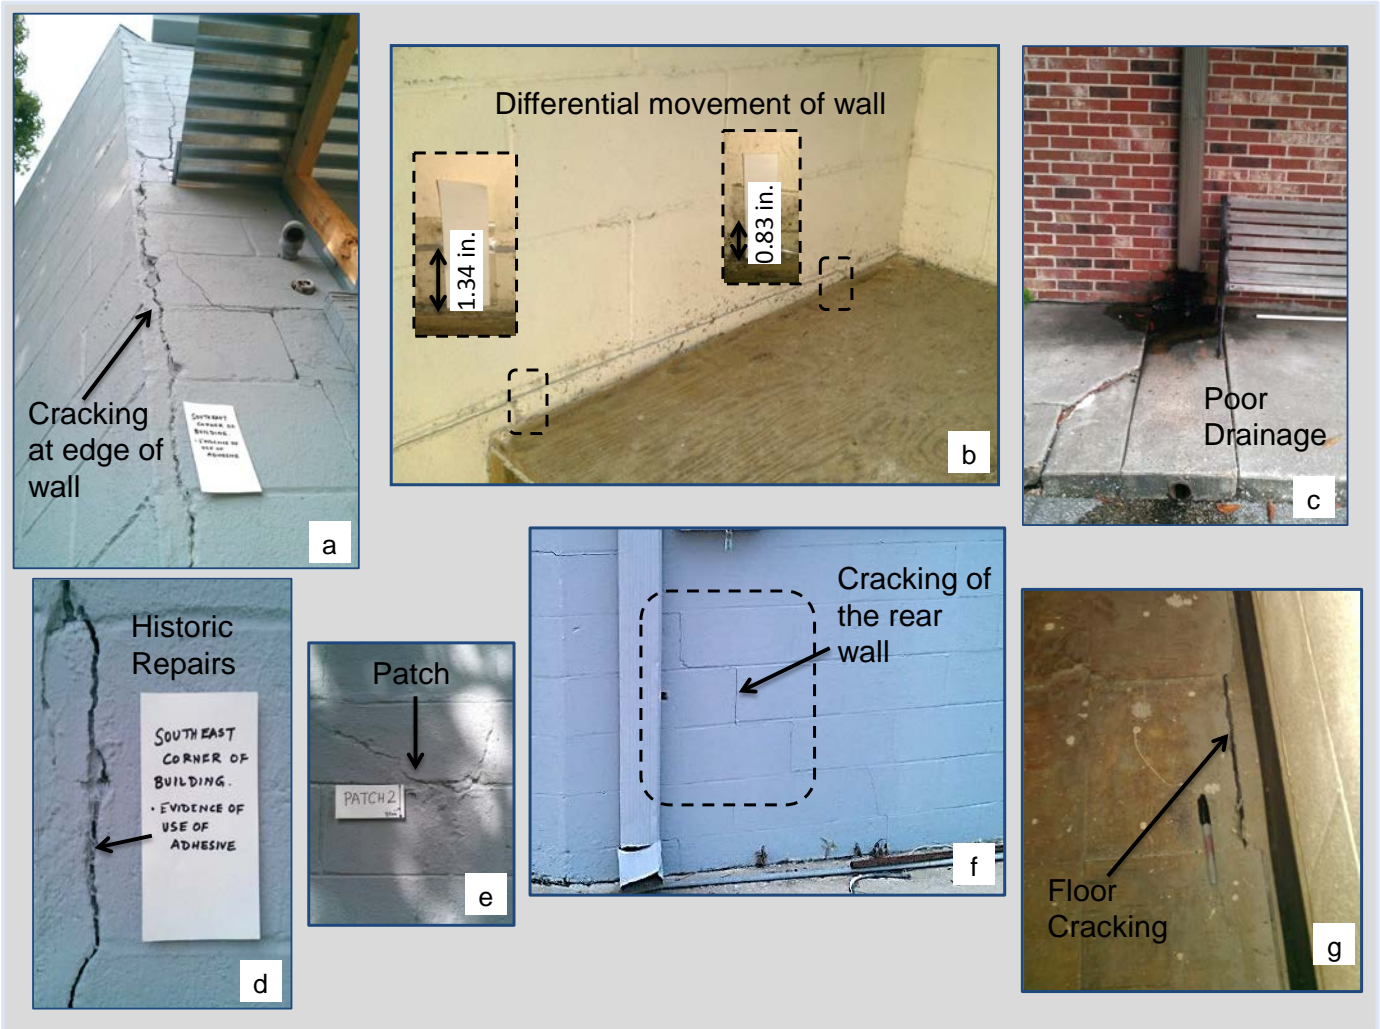
Fig. 7. Various building distresses identified during field reconnaissance survey.

Observations were performed for potential areas experiencing lack of stormwater drainage and thereby leading to stormwater ponding. Various distresses including vertical and horizontal cracks inside and outside the structure, patches, holes, and interior slab settlement were observed. Cracks were observed on the southwest, southeast and on the front wall of the structure. The observed building distresses are depicted in Fig. 7.

Evidence of historical repairs was observed at the site. On the exterior of the southwest wall, three patches were observed (Fig. 7e). On the exterior corner of the southeast wall, a thick crack extending from the roof to the floor slab was observed (Fig. 7a). The crack appeared to be filled-in with an adhesive (Fig. 7d). Cracking was observed on the southeast wall as shown in Fig. 7f.

From the interior of the structure, cracking was observed in the front wall near the roof. Patches were observed on the southwest wall from the interior. Further, patches, paints and cracks were observed at the southeast corner from inside the structure. The inside floor of the structure depicted cracks (Fig. 7g) filled with cement/grout. Outward movement of the wall was observed from the interior of the structure. A gap was observed between the wooden stairs resting on the floor slab and the southwest wall. Differential vertical movement of the southwest wall was observed near the top of the stairs (Fig. 7b).

Close inspection of the cracks and floor repair depicted presence of paint in the cracks and on the grout. The fact that there was evidence of some patches to repair or close some cracks on the building wall in the past indicated that some movement or displacement of the building wall or foundation had already taken place.

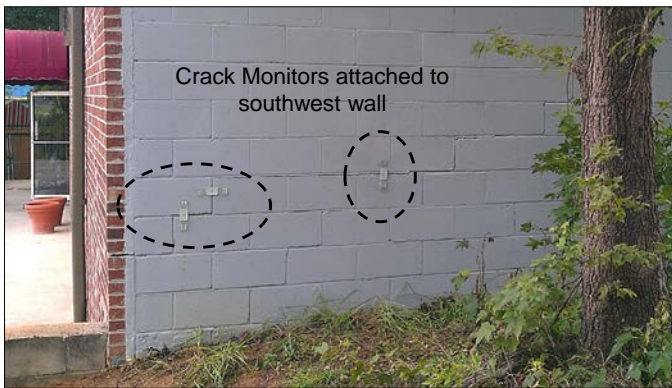
Fig. 8. Crack monitors attached to the southwest wall.

Continued Crack Monitoring. From the crack monitoring, it was concluded that the structure was experiencing continued vertical movements. Continued crack monitoring was recommended to evaluate increase and/or decrease in the crack width. The increase/decrease in the crack widths can be

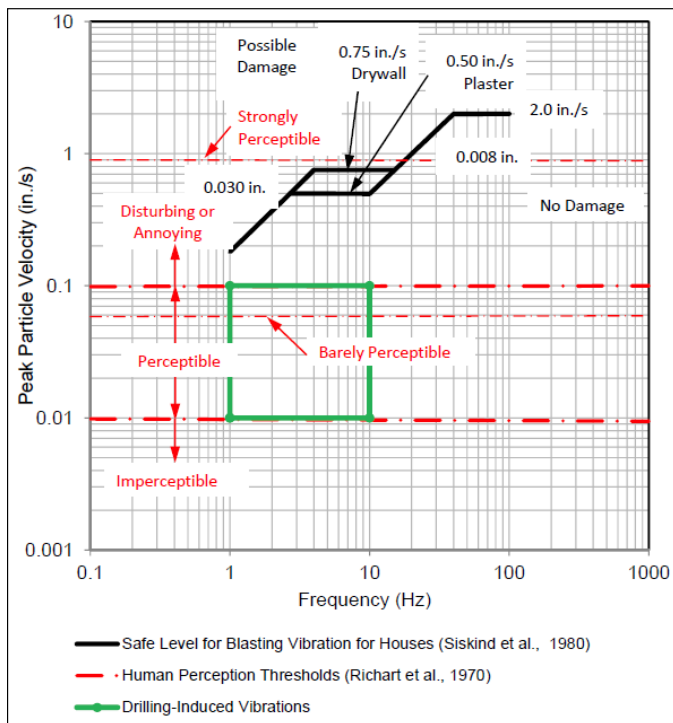
Fig. 11. Vibration data analysis chart.

As can be seen from Fig. 11, evaluated velocity/frequency pairs fall within the range of perceptible vibrations, yet vibrations that do not induce damage to plaster and/or drywall.

Therefore, it can be concluded that the vibrations from the SPT tests using the HSA drilling techniques, were significantly low to have any impact on the structure. Drilling induced vibrations attenuate with distance and as such the vibrations from a rotonic drilling at 15 ft. from the wall are expected to be less than those from SPT tests using HSA drilling 4 ft. from the wall based on the phenomenon of radiation damping. As such, it was postulated that the rotonic drilling in July 2010 did not cause the cracks on the building.

Real-time Vibration Monitoring during Rotosonic Drilling. Additional real-time vibration monitoring and analysis was recommended to be performed during future rotosonic drilling at the site to confirm the aforementioned conclusion.

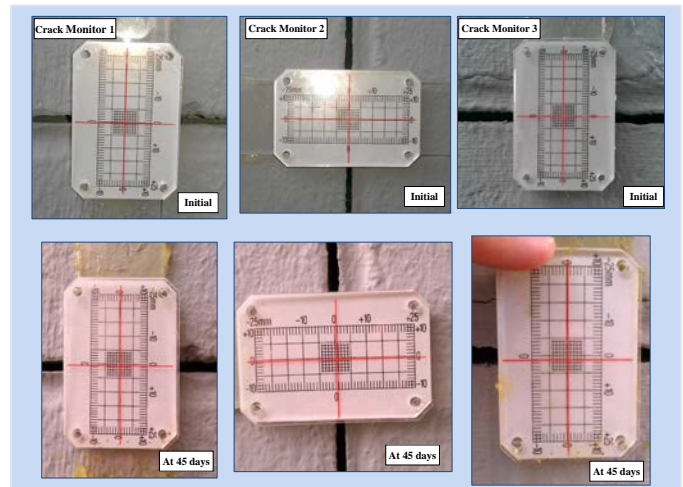
On September 27, 2011 a condition survey was performed to observe and record additional displacements of the cracks since installation of the monitors in August 2011. The crack monitors depicted additional displacements since installation on August 12, 2011. Figure 12 depicts the measured displacements in 45 days. Crack monitor 1 showed 0.0197-in. vertical and horizontal displacements. Crack monitor 2 showed a vertical displacement of 0.0197-in. and horizontal displacement of 0.0295-in. Crack monitor 3 depicted a vertical displacement of 0.0591-in. and no horizontal displacement.

Fig. 12. Crack monitors depicting displacements.

The displacements indicate that there have been continued movements of the structure since their installation on August 12, 2011. It should be noted that these additional displacements were observed in the absence of drilling activities.

correlated to the wetting and drying seasons to determine if volumetric changes in the expansive clay are the cause for the cracks.
