International Conference on Case Histories in Geotechnical Engineering (2008) - Sixth International Conference on Case Histories in Geotechnical Engineering

Behaviour Monitorization of a 13m High Gabions Wall

BEHAVIOUR MONITORIZATION OF A 13M HIGH GABIONS WALL

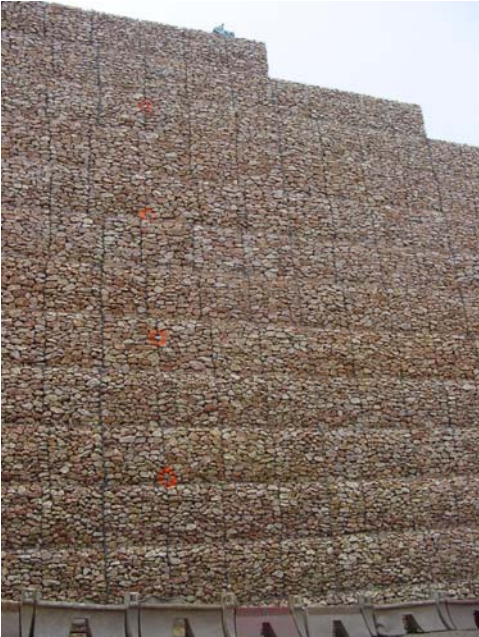
The highest wall is 13m high and on its top the soil has a slope of $H=3$; $V=2$ (See Fig. 1 and Photos 1 and 2).

Photo 1. General view with backfill

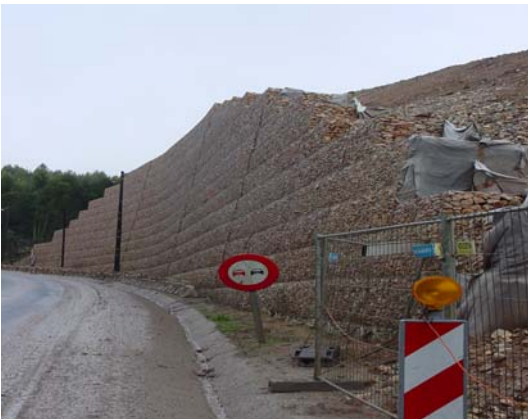
Photo 2. Partial front view

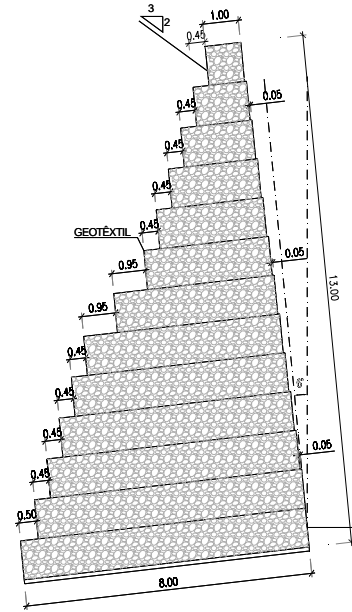
Fig. 1. Higher cross section

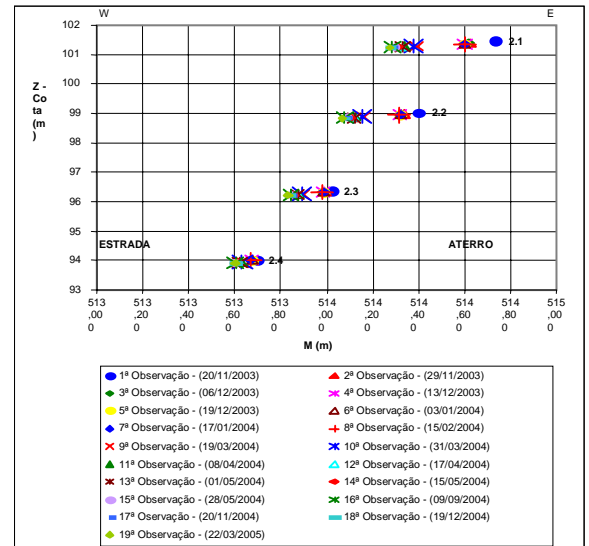
The maximum horizontal displacement was on the top and attained 46,0 cm decreasing to its base where 9,0 cm was measured (see Fig. 2).

The referred displacements were related to the most intensive fases of the earthfill execution on the wall back.

Some of the cages wires broke in the zones where the maximum displacements were measured.

Fig. 2. Horizontal displacements of higher section

So it is important to be careful when executing the backfill avoiding the use of equipments of great compaction energy in the zones adjacent to the gabions walls, to avoid significant displacements.
