Stabilization of a Large Paleo-Landslide Reactivated Because of the Works to Install a New Ski Lift in Formigal Skiing Resort

STABILIZATION OF A LARGE PALEO-LANDSLIDE REACTIVATED BECAUSE OF THE WORKS TO INSTALL A NEW SKI LIFT IN FORMIGAL SKIING RESORT

The paper presents the study and stabilization of a paleo-landslide reactivated because of the excavation works carried out at its foot to construct a new lift in Formigal skiing resort. Inclinometers were installed and surface movements were controlled by GPS techniques in order to analyse the sliding surface and to define the stabilization measures to undertake. The data obtained from the instrumentation was used to perform a back-analysis that allowed to determine the kinematics of the movement as well as to define the appropriate stabilization measures. Presently, the evolution of the movement is controlled by GPS.

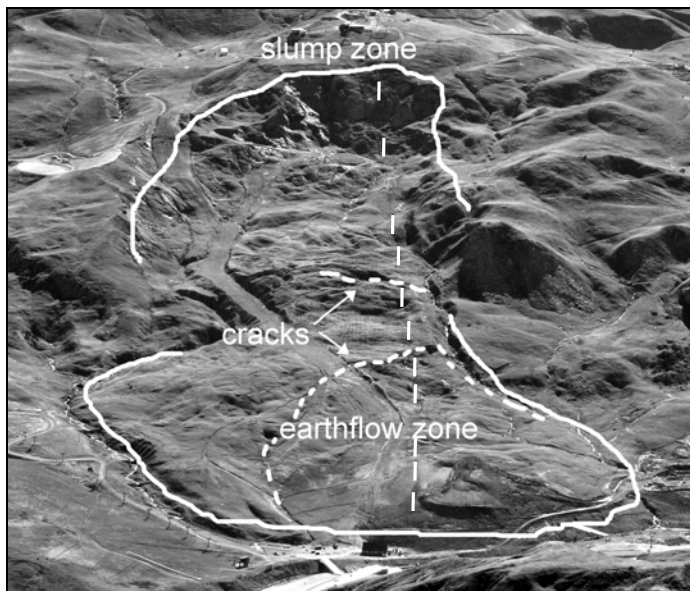
Figure 1. Panoramic view of the paleo-slide

The surface of the slope is completely convex in the area occupied by the slid mass, and creeping phenomena are frequent there. At the toe of the slide, the Gállego river is in a process of excavating the slid mass tongue. This is the cause of the existence of small slides near the river course.

Figure 1 shows a panoramic view of the paleo-slide, as well as the location of the main cracks and the pillars of the ski lift.

As shown in figure 1, the slide was reactivated at an area of accumulation of paleo-slide materials. This new slide has a length of 550 m, an average width of 250 m and a depth around 35-40 m. The slide was detected in October 2004 and the cause of the reactivation was associated to the excavation works carried out at the foot of the hillside to construct a new ski lift.

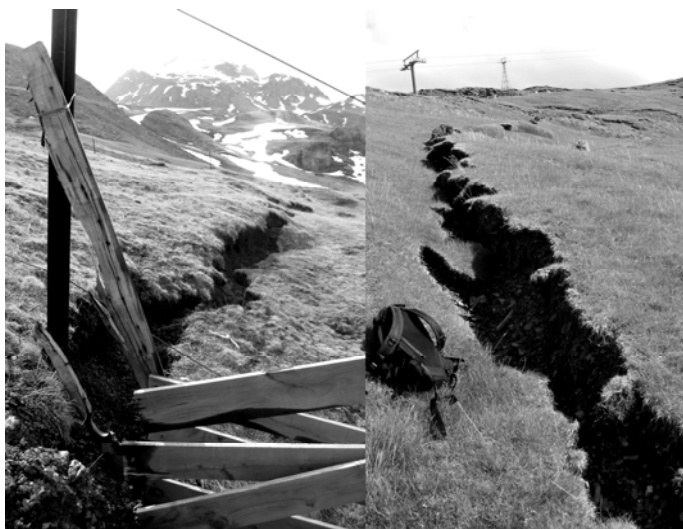
Figure 2. Cracks at the crest of the slide.

The most important cracks appeared at mid-height of the hillside, between pillars 7 and 8 of the ski lift. These cracks, with widths up to 2 m (see figure 2), form a big circle that cuts all the width of the paleo-slide. Other secondary cracks were observed at a higher elevation, around pillars 9 and 10, as a consequence of the lack of support originated by the slide below.

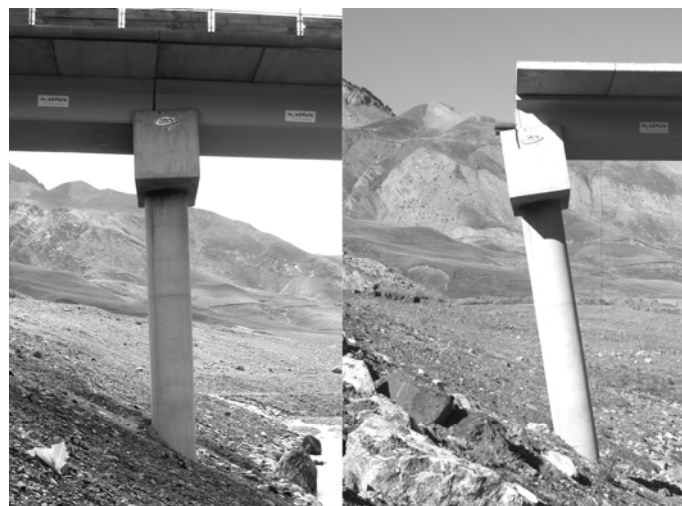
At the toe, the slide reaches the river. No surface cracks were visible at that area. However the movement of a pillar of a bridge over the river, the one located at the paleo-slide bank (see figure 3), shows clearly the occurrence of movements in depth at that zone.

Figure 3. Evolution of the movement of a pillar located close to the toe of the slide

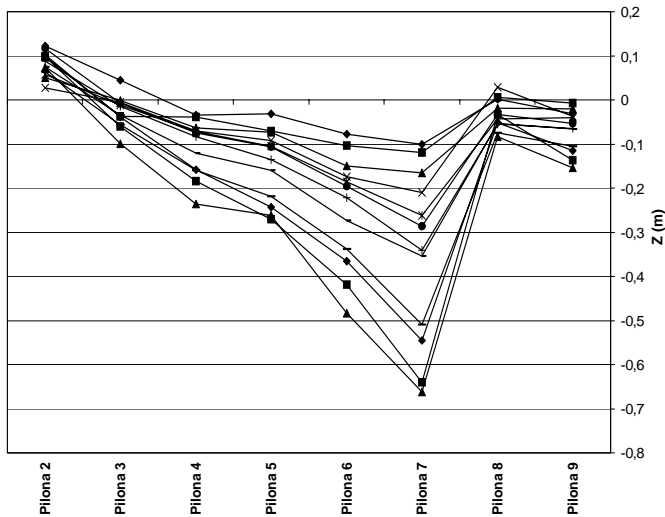
The cross-section corresponding to the alignment of the ski lift pillars, located at the center of the slide and along a line of maximum slope, was chosen for analysing the slope movement. The points located at this cross-section at the pillars near the crest of the slide exhibited downward vertical displacements, whereas those situated at the toe of the slope showed a slight upward vertical displacement (figure 4). A similar pattern of surface movements was observed over the entire slide area. Movements were measured from October 2004 to January 2007 and they are still being controlled.

Figure 4. Vertical displacements measured of ground surface at the ski lift pillars

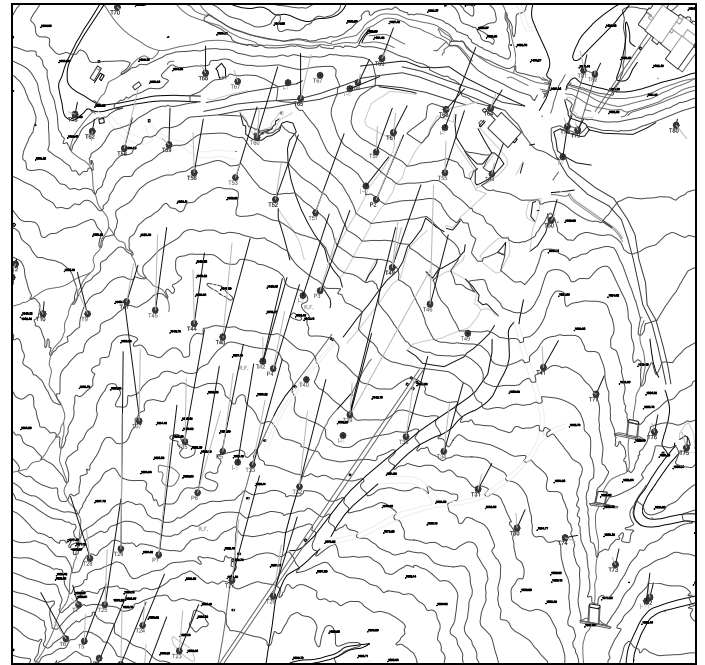
As to horizontal movements, figure 5 shows the horizontal projection of the displacement vectors determined for the different control points. The vectors are oriented towards the lower zone of the slope. Displacement rates of up to 7 m/year were registered.

Figure 5. Displacement vectors measured at the surface marks by topographical control.

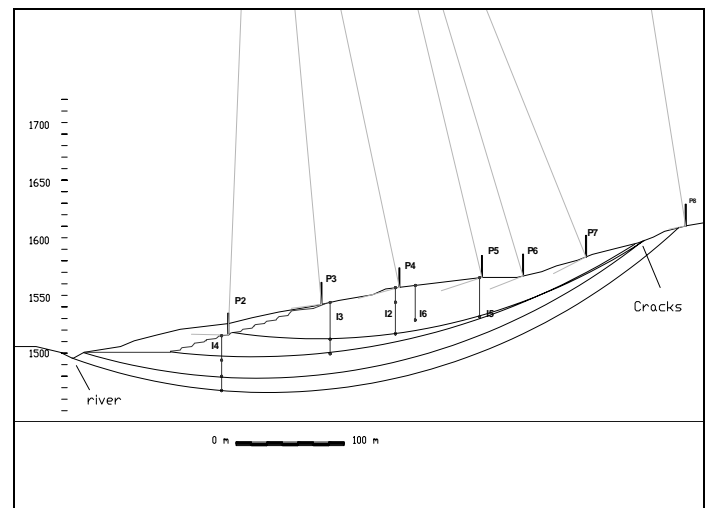
By drawing the perpendiculars to the displacement vectors corresponding to the ski lift pillars, an array of straight lines was obtained converging very accurately on the same point, showing that the movement of the sliding mass could be assumed to be circular.

So, by drawing circles passing through the failure points determined by the inclinometers, four different possible failure surfaces were obtained.

Figure 6. Possible failure circles determined from displacement vectors and inclinometer readings

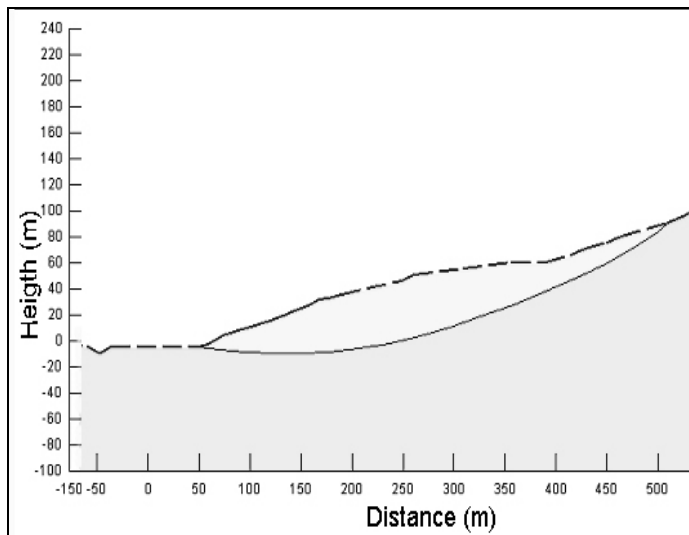
Figure 7 shows one of the failure surfaces analysed in the study.

In order to calculate the strength parameters of the natural ground, a fixed value was considered for one of the parameters (cohesion or angle of friction), and then the other was obtained by imposing a factor of safety of the order of unity. According to this, four couples of strength parameters were considered for each failure surface geometry in the study. Values of 5, 10, 15 and 30 kN/m² were adopted for cohesion, the corresponding values for the friction angle being those shown in table 1.

Figure 7. Example of one of the failure surfaces analysed.

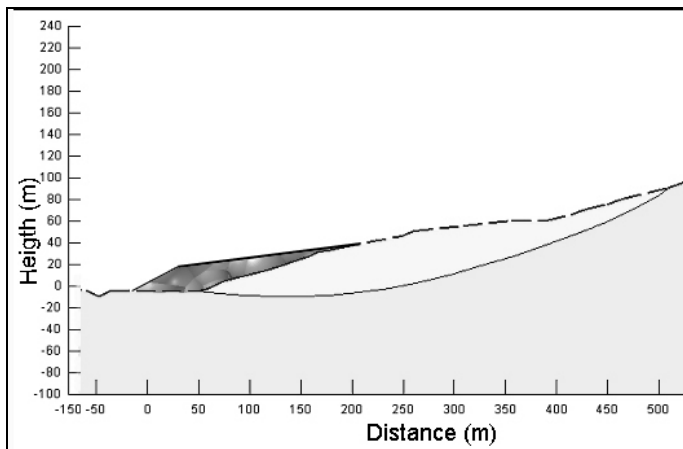
The geometry adopted for the second case, (situation after execution of drainage and construction of fill) is shown in figure 8. In this case, the water level was considered to be located at the position of the natural ground under the fill.

Figure 8. Cross-section of the landslide showing one of the failure surfaces and the fill at the toe area

As to the second case, with the fill and the effect of the drainage, factors of safety increased significantly to values between 1.28 and 1.54, considered sufficient for the slope stability, taking into account the assumptions adopted in the analyses, in particular, the values adopted for the strength parameters, deduced from back-analyses.

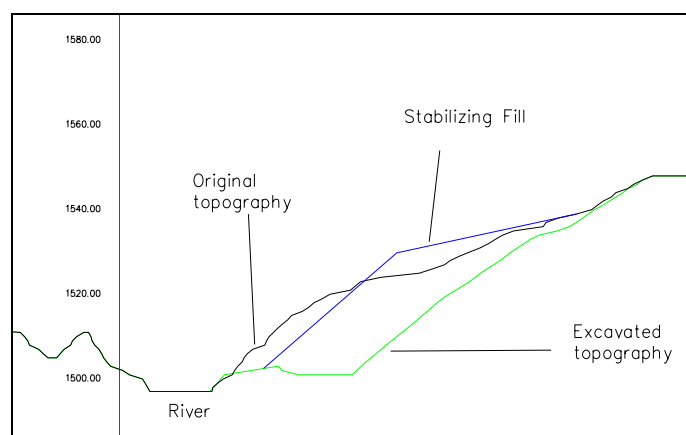
Figure 9. Detail of final cross-section after construction of the fill compared with the pre-existing geometry

The fill was constructed with the same material extracted from the excavation, but improving its properties by a proper placing procedure and compaction.

Besides, additional weight was provided by increasing by 30% the height of the pre-existing material.

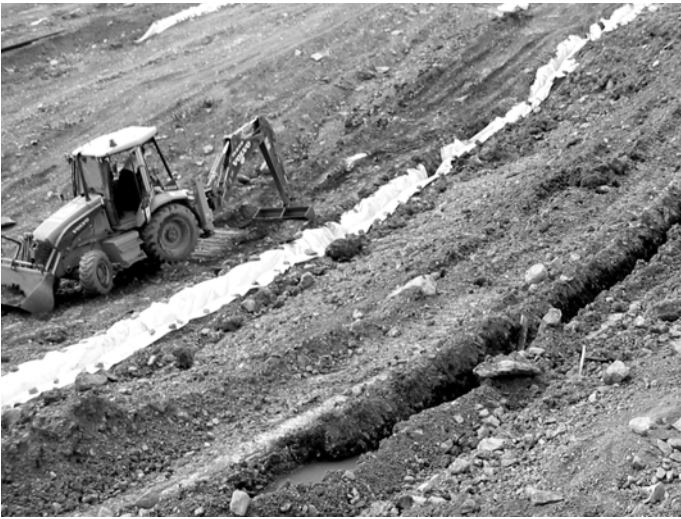
Figure 10. Construction of the drainage trenches

To allow drainage of the surface prior to the placement of the fill, a system of draining trenches, also oriented in the direction of the maximum slope, was constructed. These trenches were 0.5 m wide and 0.5 m high, and were provided with a filter geotextile, granular material and slotted tube at the bottom of the trench. Distance between trenches was 10 m.

Some other trenches were made following an oblique direction in order to facilitate interconnection between them and a better way out for the drainage water.

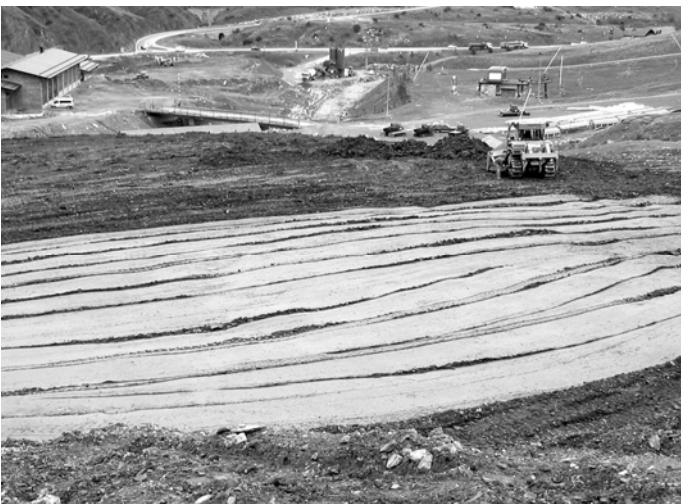
Figure 11. Placement and compaction of fill material

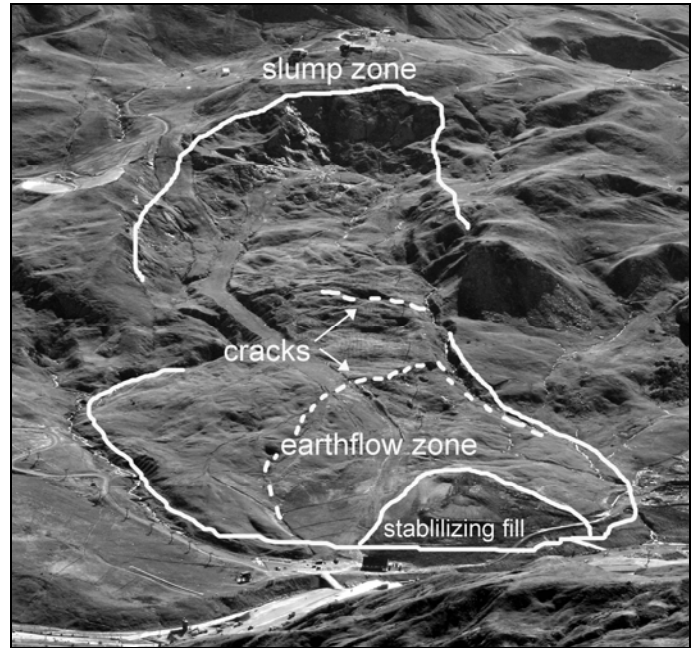
Finally, figure 12 shows a panoramic view of the slide after completion of the stabilization works. In the figure, the broken lines represent the main cracks at the head of the slide, whereas the location of the drainage works and stabilizing fill is drawn in continuous line.

Figure 12. Panoramic view of the location of the stabilizing fill

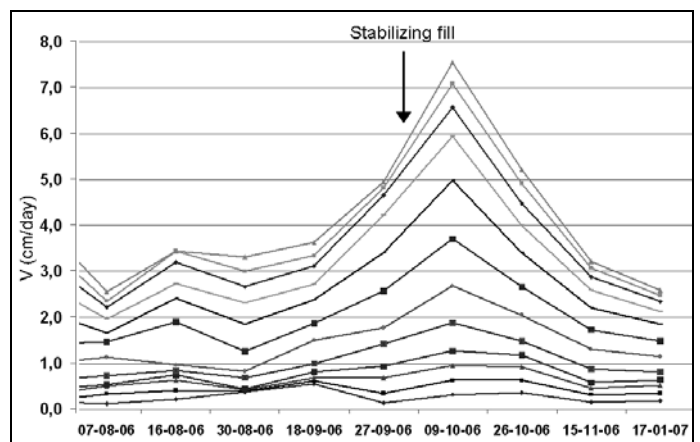
Figure 13 shows how the displacement rates of the control points have decreased after the construction of the drainage system and stabilizing fill.

Figure 13. Displacement rates at control points located at the ski lift pillars

Although the whole slid mass movement continues, as a consequence of its considerable big inertia, it is foreseeable that these displacements will diminish in time.
