General Report for the Theme Three – Case Histories in Dams, Embankments and Slopes

General Report for Theme Three Case Histories in Dams, Embankments and Slopes

D.E. Kleiner

Head, Geotechnical Department, Harza Engineering Company, Chicago, Illinois,
U.S.A.

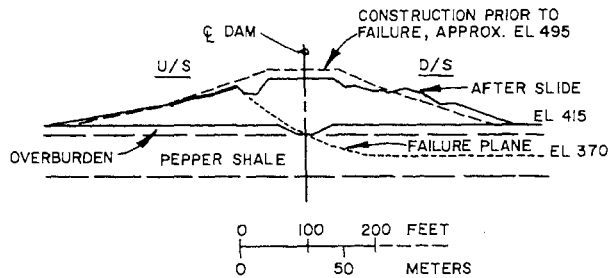
Fig. 1 WACO DAM, TEXAS--EMBANKMENT AFTER FAILURE

several days resulting in cumulative movement at the crest of the fill of more than 20 ft. The configuration of the embankment after failure is illustrated on Figure 1. The base of the sliding mass coincides approximately with the middle of the Pepper clay shale stratum.

to sample foundation materials and for installation of piezometers and slope indicators. The studies revealed that significant faulting was involved in the embankment foundation and that the faulting had a significant influence on the location and magnitude of the slide. As a result of the faulting the relatively soft Pepper clay shale occurred in the foundation immediately beneath the dam in a reach of approximately 700 ft. The piezometers installed subsequent to the failure showed a high distribution of pore pressure. At the Pepper/Del Rio contact excess pore pressures at the axis of the dam were about 100 percent of the pressure applied by the embankment. The investigations also indicated that the shear strength of the Pepper shale was very low. Direct shear tests performed on pre-cut specimens showed friction angles varying from 7° to 9° with no cohesion.

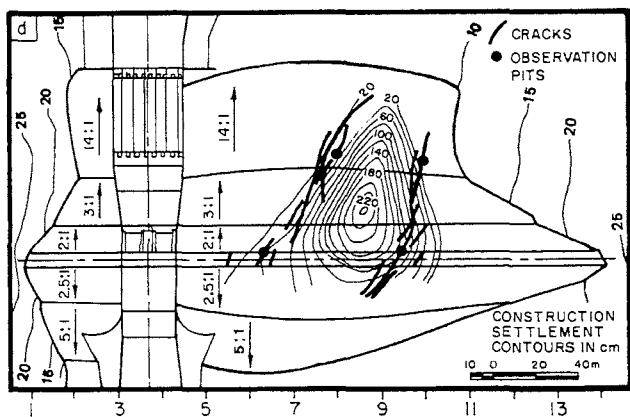
Fig. 3 SANTA HELENA DAM, BRAZIL
CONSTRUCTION SETTLEMENT IN FOUNDATION
AND OBSERVED CRACKS

Messrs. GARGA, ROCHA, and RAMOS present the performance of a 28 meter high compacted earthfill dam founded in part over soft to very soft silty clays in their paper titled, "The Santa Helena Dam on Compressible Foundation". For economic reasons a portion of the dam fill was founded directly over an 8 meter thick deposit of soft compressible clay. Large diameter sand drains were installed in the soft clay to accelerate the consolidation and to develop adequate shear strength during construction of the dam. Large settlements were expected and subsequently measured. Typical blow counts in the soft clayey deposit ranged from 1 to less than 1 blow per foot. Instrumentation was used to control the rate of construction and to assess the stability of the dam during its construction. Pneumatic piezometers, open standpipe piezometers and several instrumentation types to monitor settlement were installed. A maximum of about 2.5 meters of foundation settlement occurred during construction as compared to an estimated settlement of somewhat in excess of 4 meters, see Fig. 3.

Cracking of the fill first occurred when the dam height reached approximately 10 meters. Subsequently, at the completion of the dam, additional cracks were observed. The cracks were a maximum of 3.5 meters deep and were generally of hairline width. Occasionally cracks to a maximum opening of 2 centimeters were observed. Cracks were cleaned by injecting water under low head and subsequently filled with a 5 to 7 percent bentonite mix.

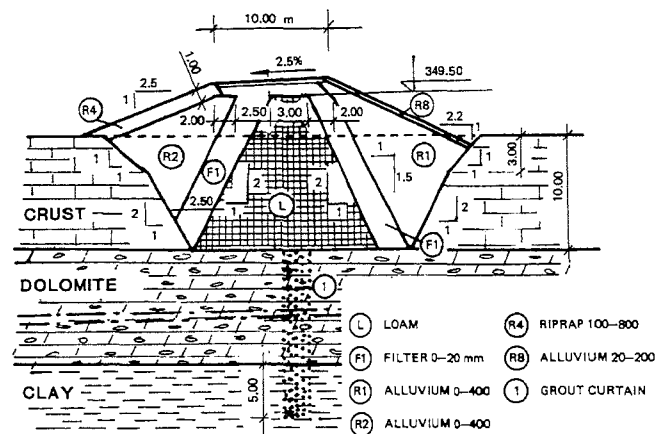
Fig. 4 WADI-ZARAT DAM, LIBYA-CROSS SECTION OF
RIGHT BANK AT STATION 1915, AFTER REMOVAL OF CREST

Authors BENLTAYF, ATALLA, and RABAH in their paper, "The Foundation of the Right Bank in Wadi-Zarat Dam" describe the engineering characteristics of a calcareous crust that formed the foundation of the right abutment of the Wadi-Zarat Dam, in Libya. This crust is extremely heterogeneous with potential for collapse on wetting. Locally, it is highly permeable with evidence of dissolution features.

Excavation of the crust was adopted.

Grout tests indicated that improvement was not significant and that the crust was generally not groutable with ordinary cement grouts. The slurry wall concept was abandoned partly because slurry trench technology is not available in Libya and partly because of the potential for differential settlement to occur under the dam. Figure 4 illustrates the adopted solution showing that more than half of the dam is backfilled in the deep wide core trench. This solution has been commonly used at other dams and represent a positive means to treat a difficult foundation.

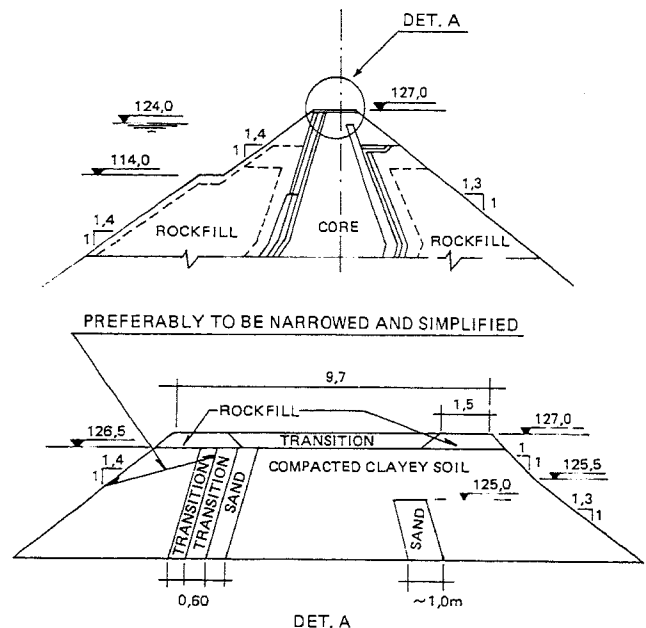
Fig. 5 SUGGESTED DESIGN REVISION NEAR CREST

In response to longitudinal cracks that have been observed at the crest of dams, Dr. de Mello suggests minimizing the number of zones in the top 20 meters of a high dam and moving toward an embankment section in the crest which is more homogeneous. Figure 5 illustrates this concept.

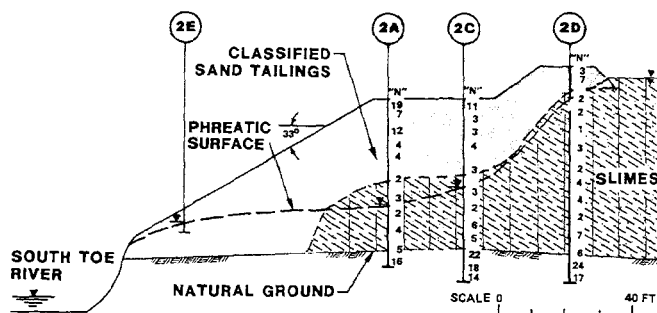
Fig. 6 MICACEOUS WASTE TAILINGS DAM, NORTH CAROLINA SECTION THROUGH DAM NEAR FAILURE ZONE

Stability analysis prior to the failure indicated a factor of safety slightly above 1.0. It was concluded that the dam was only marginally stable and should not be raised further. During the following seven or eight months the dam was raised several times to an elevation eight feet higher than at the time the analyses were made. Following rains and erosion on the outer face of the tailings dam, a 200-foot long section of the dam failed resulting in about 50,000 cubic yards of tailings sliding and slumping into the adjacent river.

Figure 6 indicates the position of the phreatic surface within the tailings dam and the values of standard penetration tests. SPT values within the slimes range from one to five blows per foot indicating very soft low strength and low density materials.

Repairs consisted of cleanup of the slide debris and reconstructing the failed section of the dam. Slopes were flattened to two horizontal to one vertical which required some placement of fill in the river bed.

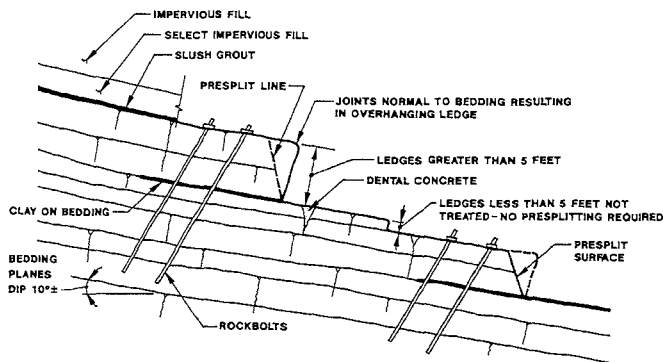
Fig. 12 BATH COUNTY PUMPED STORAGE PROJECT, VIRGINIA--UPPER DAM LEFT ABUTMENT CORE FOUNDATION

On the left abutment, foundation shaping was required to remove unacceptable overhangs. Minor overhangs were tolerated, if less than 6 inches, if the overhang was not more than 10 feet long and if the bed thickness was less than 6 feet. More competent, thicker sandstone ledges, with more pronounced overhangs were shaped by presplitting. However, the presence of locally occurring clay seams along bedding planes, or weak shales at the base of some higher ledges, necessitated stabilization prior to presplitting by rock-bolting to stabilize rock.

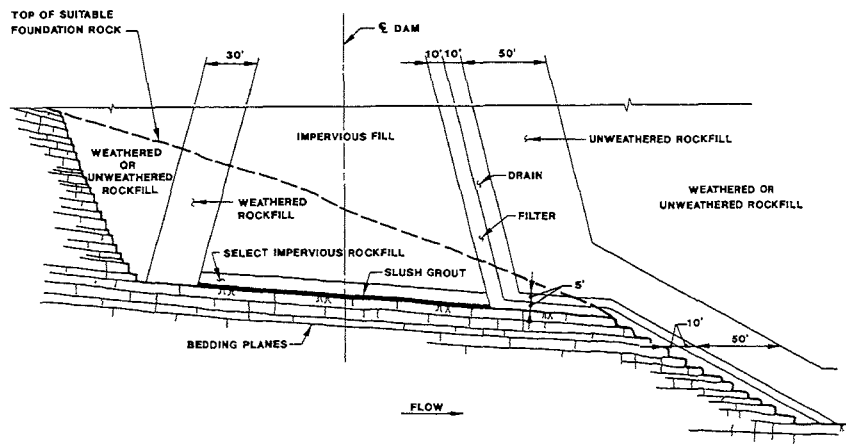
Fig. 13 BATH COUNTY PUMPED STORAGE PROJECT, VIRGINIA--UPPER DAM LEFT ABUTMENT TREATMENT AT TOPOGRAPHIC REENTRANT

Sharp topographic re-entrants on the left abutment created an adversely sloping foundation surface immediately downstream of the core. This condition exposed foundation bedding joints along which fines could conceivably move. A two-stage filter system was placed over foundation surfaces to prevent potential movement of foundation fines into the downstream shell (Fig. 13).

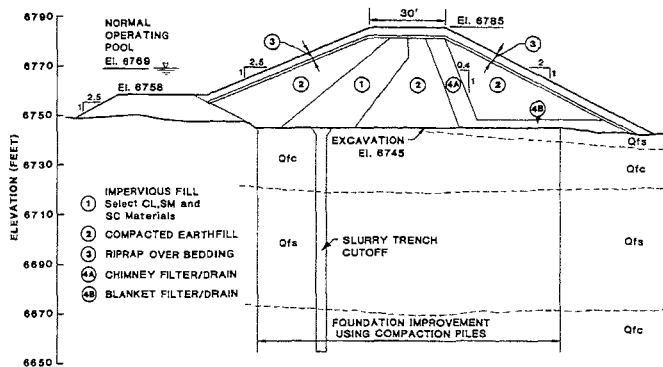
Fig. 16 JACKSON LAKE DAM, WYOMING—TYPICAL SECTION OF EARTHFILL DAM WITH FOUNDATION IMPROVEMENTS

material in the dam and in the foundation is susceptible to liquefaction as a result of seismic shaking. In-situ field tests by the Bureau have indicated that the foundation can be seismically improved by installing compaction piles on six foot centers.
