Geological Surprises at Itezhitezhi Dam, Zambia

Proceedings: Third International Conference on Case Histories in Geotechnical Engineering, St. Louis, Missouri, June 1-4, 1993, Paper No. 8.22

SYNOPSIS An outburst of warm springs together with the development of an extensive area of high pore-water pressures occurred during the first filling of the 50m high earth and rock fill Itezhitezhi Dam on the Kafue River in Zambia. These and other unanticipated events led to extensive geological and hydrogeological investigations that resulted in the implementation of unusual remedial measures. The remedial work was completed before the reservoir reached its full supply level. The dam has since performed successfully. The problems are reviewed in terms of the significance of the site geology. The hydrogeologic problems were found to be caused by the presence of a modified karstic terrane developed on a mineralized, faulted and deeply weathered bedrock of granite and associated rocks. Small differences between the river levels and the piezometric levels in deep porings contributed to a delay in problem identification. The problems encountered and their causes are thought to be without precede

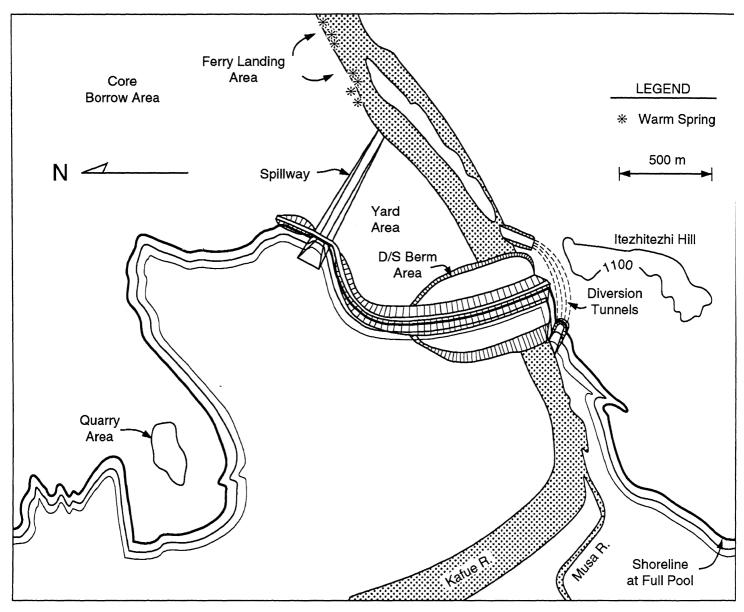
Figure 1. Plan view of the Itezhitezhi Dam site.

Just above the damsite the Kafue River makes a right-angled end. A tributary, the Musa, entered the Kafue River at this bend. he Musa valley, in which the major portion of the reservoir is cated, is aligned with the Kafue downstream of the bend. These lationships are shown on Figure 1.

To avoid the creation of erosion tunnels in the mudstone and in weathered granite just below the mudstone, it was apparent that the relief wells would have to be sealed to depths appreciably below the top of unweathered granite to ensure that the flow of water into the screened portions would occur only through sound granitic rock. Thus, in each relief well the hole above the top of the screen was sealed for a minimum of 5m into the sound granite. To prevent the occurrence of artesian flows, which could cause erosion during installation and development of the wells, the wells were installed from embankments high enough to assure a positive head at any stage of construction. As a further precaution, casing in each relief well was placed from the surface to a point just above the base of the mudstone and cemented into place before any drilling was done into the artesian aquifer below. In all, 30 wells were developed. Six were located on the downstream berm, five in the Yard area 600m downstream, and 19 at the Ferry Landing 1500m downstream (Figure 1).

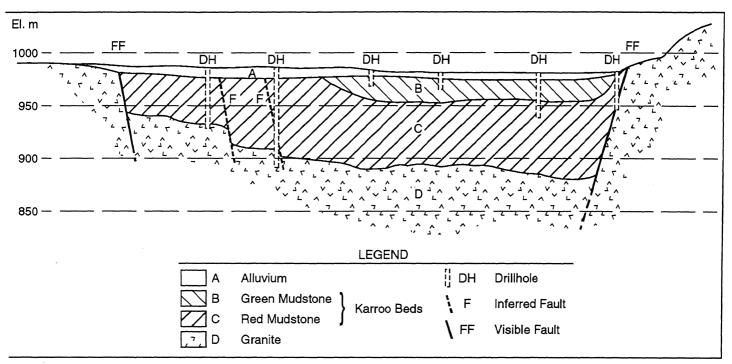
gure 2. Cross section through the valley along the axis of the Itezhitezhi Dam.

The surficial geology and the preconstruction borings made ong the axis of the dam indicated that the river flowed within portion of a rift valley characterized locally by a down-faulted, aben-like depression in the granitic rocks. The alluvium meath the floor of the Kafue valley is underlain in places by diments of the Karroo series. The sediments reached a thickss of about 100m beneath the axis. A section through the valley ong the axis is shown in Figure 2. Borings extending through e Karroo were generally terminated at or a few feet within the derlying granite, the top of which was often noted to have a ell developed weathering profile. Water levels in drillholes

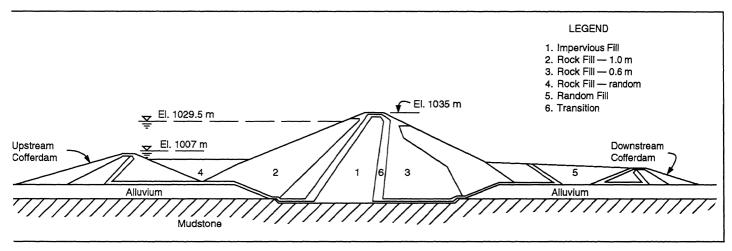
gure 3. Cross section through the Itezhitezhi Dam.

tezhitezhi Dam is a storage structure with a height of about 50m in the Kafue River in Zambia. The dam consists of rock fill hells, a core of residual clay, and suitable transitions.
