## Repair of Scour Holes and Levees After the 1993 Flood

## Repair of Scour Holes and Levees after the 1993 Flood

Paper No. 2.26

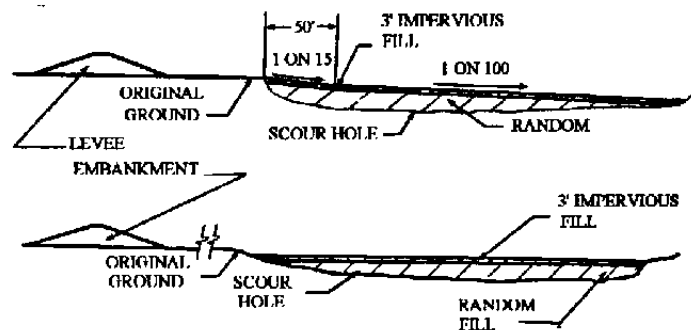
**Levee Unit L-400.** L-400 is located on the left bank between river miles 385 and 391.2, near Waldron, Missouri. The height of the levee varies between 12 and 20 feet. The levee was designed for a 100-year flood event with 2 feet of freeboard. During the 1993 flood, the levee was overtopped along the lower approximately 1,800 feet of its length causing breaches at three locations and erosions and scouring of the riverside levee slopes, foreshore and landward toe areas. The riverside scour hole cut through the pre-existing borrow area traverses, resulting in a scour approximately 200 feet wide and up to 35 feet deep that extended to within 50 feet of the riverward levee toe. The impervious blanket at this location consisted of lean clay approximately eight feet thick outside of borrow pits and five feet thick within borrow pits.

Two repair alternatives were analyzed. One was to construct a rockfill dike 100 feet from the levee centerline, having 1(V) on 1.5 (H) side slopes and a ten-foot wide crown. Granular material was proposed as backfill between the rockfill dike and levee slope. The upper five feet was to be constructed of compacted impervious material. A variation of this alternative was to replace the rockfill dike with granular material, constructing a platform to 160 feet from the levee toe that would be overlain with a five-foot thick layer of impervious material. A second alternative, selected as the most efficient, was to backfill the entire width of the scour hole with granular material on 1(V) on 100(H) slope and to reconstruct a three-foot thick impervious blanket on top of the sand backfill. Underseepage analysis required 140 feet wide underseepage berms along 350 feet of the landside toe. The repair of this scoured levee required 64,000 cy of cohesive material for the impervious blanket and the riverside levee slope, 157,000 cy of sand for the backfill of the scour hole, and an additional 3,000 cy of random material for the underseepage berm. Cross sections of the selected alternative are presented in Fig. 1.

Fig. 1 MRLS L-400, Sta. 233+17 to 267+17. Complete backfill of riverbank scour hole.

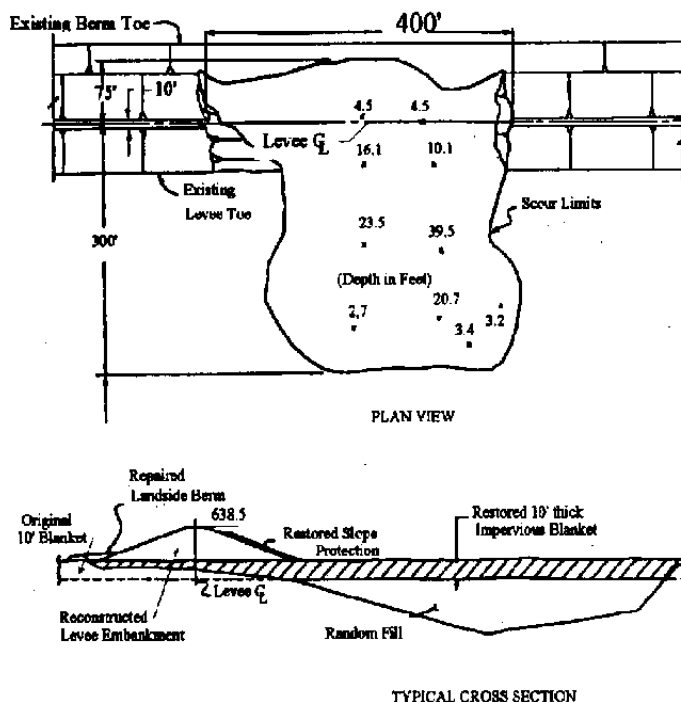
A breach at Missouri River mile 240 on L-246 created a 400-foot long scour hole that extended 300 feet riverward and 75 feet landward of the levee centerline. The maximum depth of the scour was 40 feet. The selected alternative for repair was to backfill the scour hole and reconstruct the levee embankment to its original geometry. Underseepage analysis, followed by economical analysis, determined the optimum thickness of the reconstructed impervious blanket, considering different widths of landside berm. The plan view of the scour hole and the repaired cross section are shown in Fig. 2.

Fig. 2 MRLS L-246, Levee Breach Stations 674+20 to 678+20

The repair required 4,500 cy of impervious material in the levee embankment, 24,500 cy of impervious material in the blanket, 23,600 cy of granular fill underneath the blanket, and 3,500 cy of random fill for the reconstruction of the existing underseepage berm.

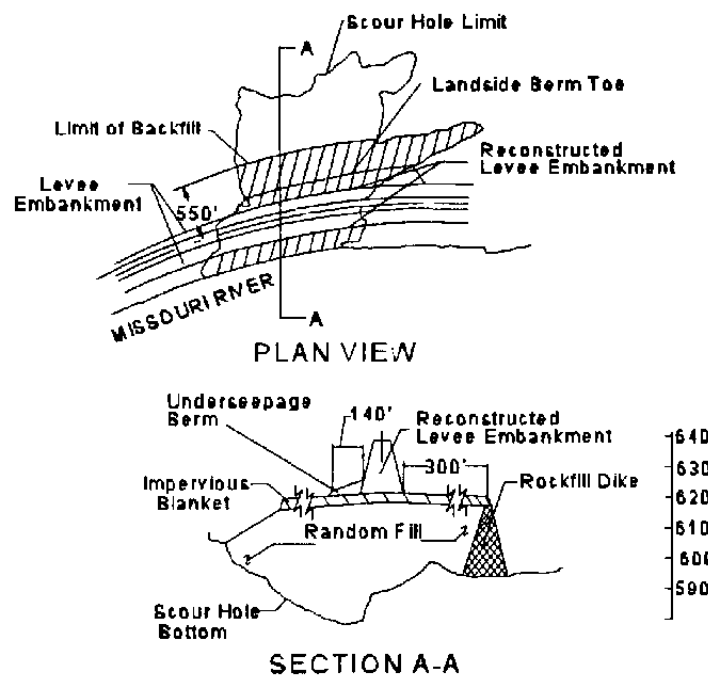
A second alternative was to construct a platform of dredged river sand in the scour hole from dredged river sand and reconstruct the impervious blanket and levee embankment along its original alignment. This alternative, which was economically comparable with the levee realignment and preferred by the levee sponsor,

was used for the rehabilitation. The platform was extended to the riverbank and 550 feet landward of the levee centerline. A rockfill dike was constructed at the riverbank between the upstream and downstream end of the scour hole. The rockfill dike has 1(V) on 1.5(H) side slopes and a five-foot wide crown. Sand dredged from the river was used for backfilling the scour hole behind the rockfill dike. Underseepage analysis determined the thickness of the impervious blanket constructed above the dredged sand platform and the width of the underseepage berm. The analysis indicated the need for a 140-foot wide landside berm and a blanket thickness of three feet. The blanket was constructed of silty clay from the nearby borrow areas. Random material used within the levee embankment and seepage berm consisted of the silty sand that was deposited by overbank flood flows. Seepage through the embankment was controlled with a five-foot thick impervious face on the riverside slope and a three-foot thick impervious cap on the levee crest. The riprap slope protection was reconstructed on the entire riverside slope of the levee. The alternative is shown in Fig. 3.

Fig. 3 Lower Chariton River Levee. Backfill of the Scour Hole and Reconstruction of the Levee at the Original Location

The repair required 8,000 cy of impervious fill and 25,000 cy of random material for reconstruction of the levee embankment and landside underseepage berm, 6,200 tons of riprap and 2,000 tons of bedding material to reconstruct the levee slope protection, 300 tons of aggregate surfacing for reconstruction of the levee crest road, 700,000 cy of dredged sand for backfilling the scour hole, 360,000 cy of impervious material for reconstruction of the impervious blanket on the top of the dredged sand, and approximately 8,000 tons of quarry run rock for construction of the riverside rock dike.

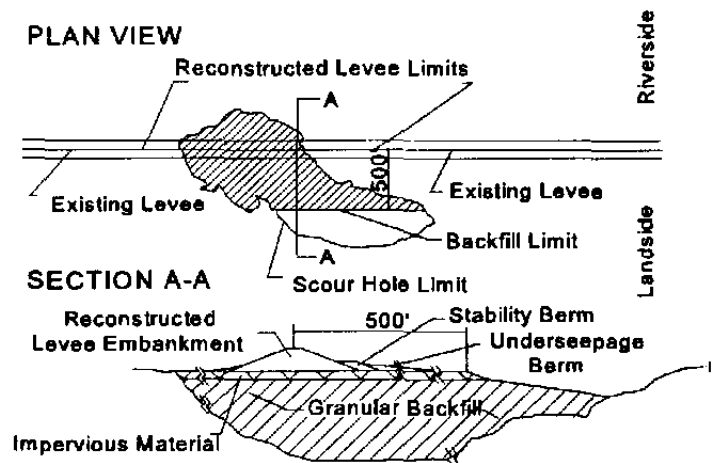
The selected alternative, constructed to the original alignment, is shown in plan view and cross section on Fig. 4.

Fig. 4 R-471/460. Backfill of the Upstream Scour Hole and Reconstruction of the Levee at Original Alignment

The scour hole was filled from its riverward extent to a distance of 500 feet landward of the levee alignment's centerline to ensure an acceptable gradient factor of safety. Although it was acknowledged that partially filling the scour hole would increase the seepage quantity on the protected side of the levee, the increased seepage would flow into designated ponding areas. The scour hole fill consisted of 501,500 cy of Missouri River dredge sands and 128,300 cy of hillside loess to reconstruct to the original four-foot thick impervious blanket. The original 180-foot wide underseepage berm and the 45-foot wide combination stability and underseepage berm were reconstructed to their original limits.

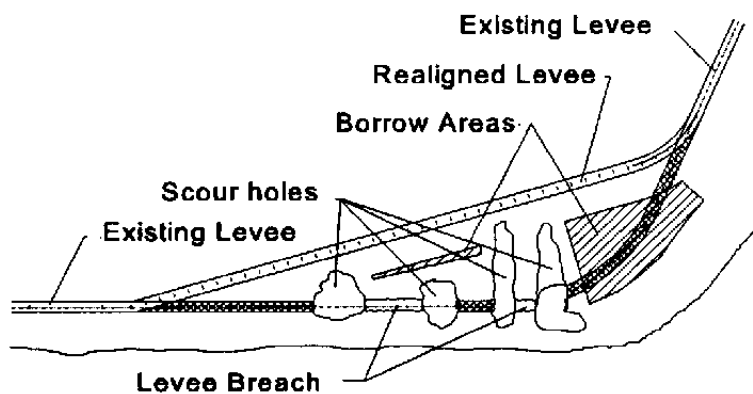
**Levee Unit L-246.** At river mile 250, L-246 sustained a series of breaches and scours along a 1,740-foot length of embankment. A scour hole at the upstream limit of the breach measured 340 feet long, up to 41 feet deep, and extended landward 250 feet and riverward 100 feet. At the downstream end of the breach a second 200-foot long scour hole with a maximum depth of 36 feet extended 175 feet riverward and 600 feet landward from the levee centerline. Two other shallow scour holes, approximately six and ten feet deep were present on either side of a remaining segment of the embankment. Various combinations of backfilling scour holes and reconstructing the embankment along the original alignment were studied. However, landward realignment was chosen as the most economical solution. The realignment began 1,220 feet upstream of the breached area and tied back into the existing levee approximately 1,850 feet downstream of the breached area. Because this realignment cut off a pre-existing

bend in the original alignment, its length was 650 feet shorter. A plan view of the levee rehabilitation is shown in Fig. 5.

Fig. 5 MRLS L-246. First Levee Realignment Around the Scour Holes on the Upstream Breach.

Underseepage analysis determined the minimum setback distance of 125 feet from the landside edge of the scour hole. The realignment left approximately 45 acres of previously protected land on the riverside of the setback alignment. The riverside slope of the reconstructed levee was protected with a two-foot thick layer of quarry-run rockfill on the downstream 1,200-foot reach. Quarry-run rock was also placed on the landward bank of the scour hole for erosion control. Remnants of levee embankments riverward of the realignment were used as borrow material for the reconstruction. The repair required 30,000 cy of impervious material and 45,000 cy of random fill for construction of the realigned levee embankment.

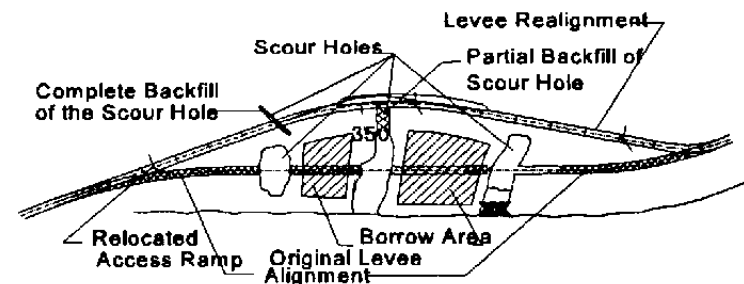
A second 300-foot wide breach approximately 3,000 feet downstream created a scour hole up to 42 feet deep and 400 feet wide. The scour hole associated with this breach extended from the riverbank 1,650 feet landward, where it narrowed to a width of approximately 250 feet. A third 1,050-foot wide breach occurred 300 feet farther downstream. At this location the scour hole through the breach was 41 feet deep and 400 feet wide and extended 300 feet riverward and 1,200 feet landward from the levee centerline. Numerous shallow erosions of the foreshore occurred between the riverward limit of the scour hole and the existing rockfill dike along the Missouri River channel. Backfilling of the three scour holes through the breaches and reconstruction of the embankment along the original alignment was studied. However, underseepage analysis indicated that

backfilling a minimum of 500 feet from the landside levee toe would be necessary to ensure the safe performance of the levee foundation and to maintain underseepage quantities at acceptable levels. Consequently, levee realignment landward of the three breaches was chosen as the most economical solution. The realignment tied into the original levee embankment 4,300 feet upstream of the first breach and 2,300 feet downstream from the edge of the third breach. The realigned levee is 9,760 feet long and is constructed to the same height as the original levee. Based on underseepage analyses, the minimum setback of the realignment from the landward edge of the scour holes was 300 feet for the upstream hole and 125 feet for the two downstream holes. Rockfill slope protection was constructed at areas where higher velocities could occur as a result of the realignment. Approximately 125 acres of land between the original alignment and the realigned levee were left unprotected by the realignment. The portions of the original levee embankment between the upstream and downstream ends of the realignment were used as a borrow source for the realignment. Quantities required for the repair of the levee at this location included 100,000 cy of impervious soil and 230,000 cy of random fill. The plan view of the repair is shown in Fig. 6.

Fig. 6 MRLS L-246. Second Levee Realignment Around the Scour Holes.

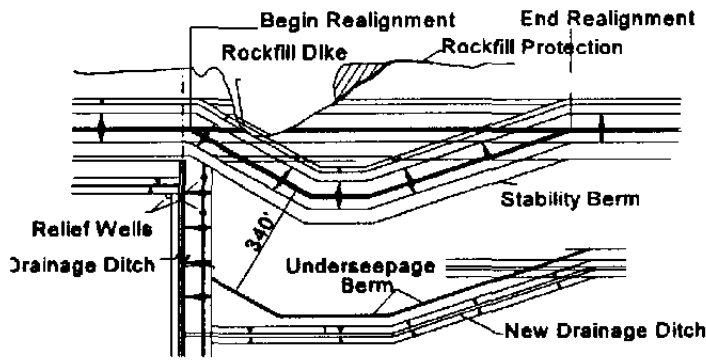
Another 400-foot long breach of the L-246 embankment occurred on the downstream tie back along the lower Chariton River. The scour hole extends from the riverbank 400 feet landward with depths up to 45 feet. A levee realignment landward of the scour hole was chosen as the most economical alternative. The realignment distance from the original levee centerline was limited by a drainage structure 185 feet upstream of the scour hole. A rockfill toe was necessary on the upstream end of the scour hole to assure the minimum stability safety factor of 1.5 because of the realignment's proximity to the scour hole edge. Underseepage calculations required construction of a 340-foot landside underseepage berm along the entire realignment. Two relief wells were also required on both sides of the drainage ditch to the structure. The necessary quantities for repair of this reach were 18,000 cy of impervious material, 80,000 cy of random material, and 6,000 tons of rockfill. A plan view of the repair is shown in Fig. 7.

Fig. 7 L-246, Chariton River Right Bank Tie Back Levee. Levee Realignment.

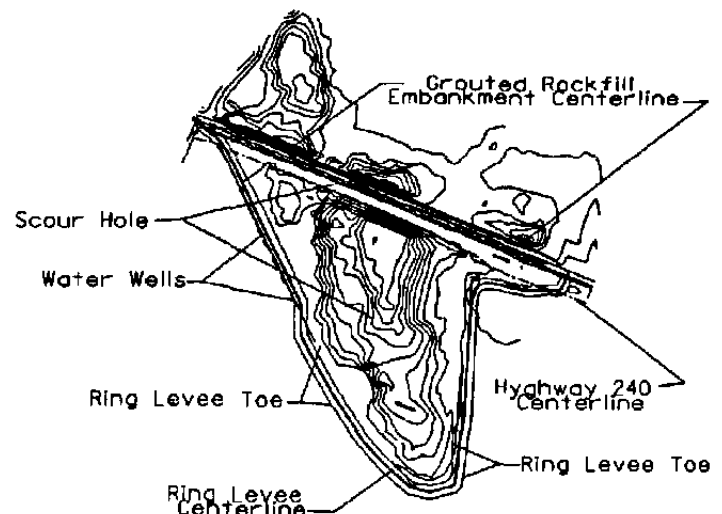
During a May 1996 flood, seepage through the embankment demonstrated that ungrouted "windows" still remained in the cut-off wall. Parametric seepage analyses were conducted with the head and tailwater conditions experienced during the floods before and after the grouting to quantify the amount of seepage reduction that had been accomplished by the grouting and whether additional grouting was justified. This analysis indicated that the grouted wall had significantly reduced the seepage through the embankment by as much as 70 percent and that further reduction was possible with additional grouting. However, no assurance could be made that additional grouting would reduce the seepage to a level acceptable to the local landowners. Consequently, other alternatives were examined that could assure a higher degree of confidence. These included partially backfilling the scour hole with dredged granular material and reconstructing a ten-foot thick impervious blanket on both sides of the railroad embankment. This alternative would have reduced the seepage through the embankment but was extremely expensive.

The most economical solution studied was to construct a ring levee landward of the scour hole that tied into the railroad embankment outside the limits of the breach. As part of the construction in 1997, Highway 240 will also be raised to the height of the ring levee. The plan view of the ring levee is shown in Fig. 8.

Fig. 8 Cambridge Levee and Glasgow-Saline Railroad. Grouted Rockfill Embankment and Landward Ring Levee.

The average height of the ring levee will be 14 feet, with a ten-foot crown and a 1(V) on 3(H) side slope. The ring levee will be constructed of random fill material consisting of silty sand

deposited by the river downstream of the scour hole with a five-foot thick impervious layer on the scour hole side and a three-foot thick impervious layer at the crest. Underseepage calculations determined the setback distance of the ring levee from the scour hole edge to eliminate the necessity of landside underseepage berms. The estimated quantities for the ring levee are 55,000 cy of impervious fill and 86,000 cy of random fill.
