Rapid Recovery of Demolished Young-Dong Highway 205.4km Due to Heavy Rain

RAPID RECOVERY OF DEMOLISHED YOUNG-DONG HIGHWAY 205.4KM DUE TO HEAVY RAIN

ABSTRACT

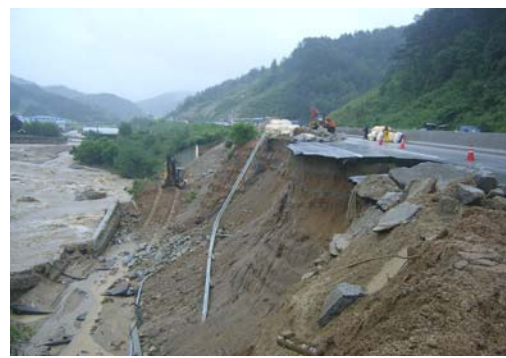
Walljeong stream has a small water volume except the rainy season, but heavy rainfall in the rainy season scoured the ground below concrete retaining walls, and retaining walls were overturned. A lot of water smeared into the embankment, and the two westbound lanes at 205.4km from west end of Yong-Dong highway contact on the stream were demolished. A sharpened S-shape flow line was detrimental to stability of the embankment. Length and maximum height of overturned concrete retaining walls were 114m long and 8m high, respectively. The lost soil amount of the embankment was about 19,000m³, and length of broken asphalt concrete pavement was 72m. Pic.1 shows the overturned concrete retaining walls, the broken asphalt concrete pavement, and guardrails. Pic.2 shows S-shape line of water, which flows turbulently and some equipment try to recover the destroyed highway just after the accident.

Pic.1 Destroyed embankment

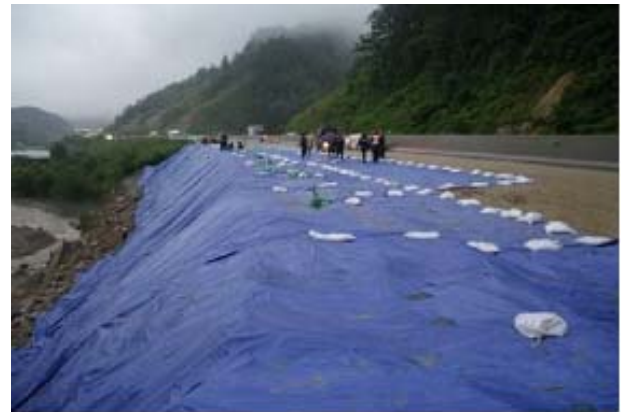
Pic.4 Vinyl mat was covered on the embankment

We also could check the stability of the rapidly constructed embankment by driving heavy vehicles on it. After making the embankment, a big vinyl mat was covered on it to prevent the embankment from washing out as Pic.4. Asphalt concrete pavement was made on the recovered area just after rain stopped. It took only two days to recover the demolished embankment and additional two days to pave the damaged highway with asphalt concrete.
