Soft Ground Tunnel Failures in Michigan

Jerome C. Neyer

Neyer, Tiseo & Hindo, Ltd., Detroit, Michigan

SYNOPSIS Three failures of non-reinforced concrete tunnels in Michigan have been investigated. Descriptions of the failures have been presented, together with geotechnical data for the sites. A probable failure mechanism has been described, as well as design concepts which need to be considered on future projects. Finally, construction procedures to be specified as part of the design process have been evaluated.

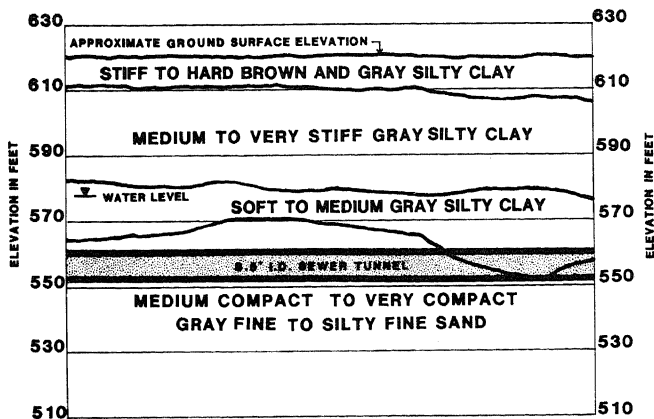
Fig. 2. I-696 Tunnel Soil Profile

Soil conditions at the project location were investigated by the drilling of test borings along the alignment. Figure 2 gives a generalized profile of subsurface conditions in the area where the failure eventually occurred. The contact between the upper impermeable clays and the lower water-bearing sands varied from several feet above the crown of the tunnel to several feet below the invert.

After a significant portion of the tunnel had been mined, concreted, and accepted by the project owner, ground settlement over the tunnel was noted in several places. Subsequent investigation disclosed that the tunnel had settled as much as 6 inches, had developed cracks, and was partially filled with sand.

Three sections of tunnel, each approximately 150 to 200 feet in length were replaced by deep open cut excavation techniques. In addition, many of the construction joints which were formed without waterstops were grouted to stop inflow of water and potential inflow of soil in other areas.

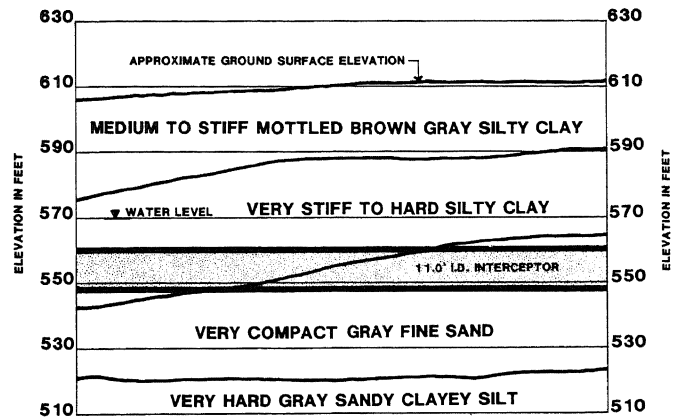
Fig. 3. Romeo Arm Soil Profile

Figure 3 presents a generalized profile of subsurface conditions along the Romeo Arm Interceptor. The upper clay soils are heavily overconsolidated and the lower granular soils are in a very compact state. The contact between the impermeable upper soils and the artesian aquifer varies from below the tunnel invert to above the tunnel crown.

On July 29, 1978, the tunnel collapsed in the immediate vicinity of the shaft. Since this sewer served an area of more than 55 square miles, its collapse presented a major threat to the environment and the health of the local residents. An emergency by-pass of the failed section was installed by contractors retained by

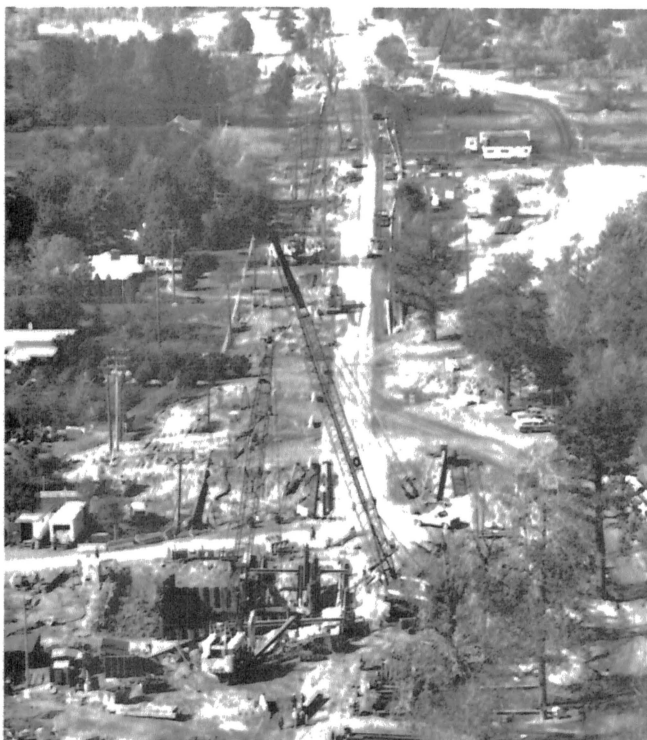
Fig. 4. Emergency Repair at Romeo Arm

the City of Detroit Water and Sewerage Department. As shown on Figure 4, this emergency repair required mobilization of considerable equipment and personnel.

In order to stop inflow of soils into the ruptured tunnel, a program of dewatering and grout injection was initiated. It was known that it would take at least several weeks to lower the level of the groundwater to a point below the tunnel. Pumping of cement-based grout, however, proved effective in halting the progressive collapse of the system within 7 days. Dewatering wells were able to eventually lower the groundwater level to below the tunnel.

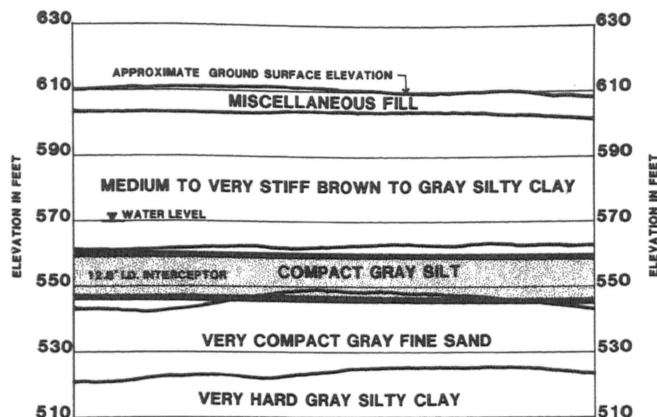
Fig. 5. Corridor Interceptor Soil Profile

The sewage flow from the Romeo Arm Interceptor joins with flow from eastern Oakland County and is conveyed toward the Detroit Wastewater Treatment Plant through the Corridor Interceptor. This 12-foot 9-inch sewer was constructed during the period from 1970 through 1972. As shown on Figure 5, the generalized soil profile for this tunnel is geologically similar to that at the previously discussed tunnels. However, at this location, a stratum of compact silt was encountered between the upper cohesive soils and the lower granular soils.

After being put into service in July of 1972, no problems were reported with the tunnel until January of 1980. During a walking inspection of the tunnel on January 27, 1980, three separate areas of structural distress were found in a 2,500 foot length of tunnel. In the worst area, the tunnel had settled approximately 3 feet and the concrete secondary lining had fallen out, exposing the steel ribs and timber lagging. Total collapse of the tunnel appeared to be imminent.

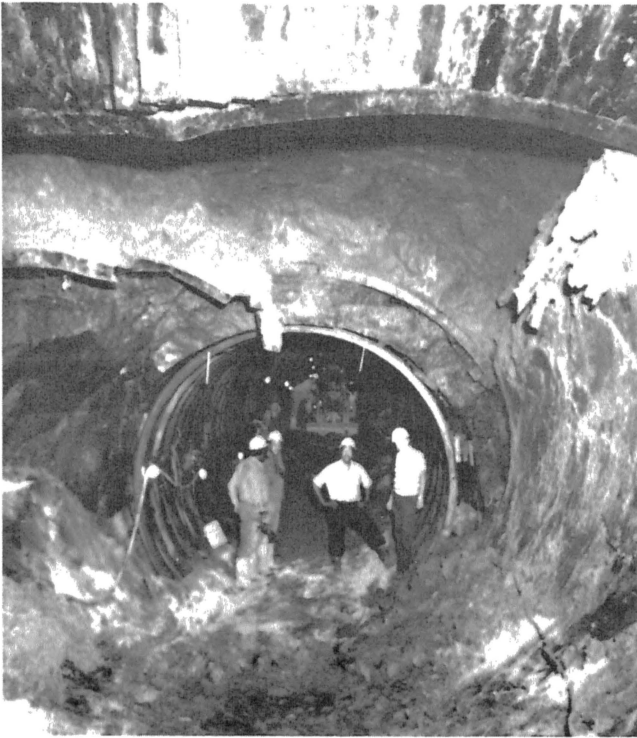
Fig. 6. Corridor Interceptor Tunnel Distress

The emergency procedures used to divert the flow around the distressed areas were similar to those used on the Romeo Arm project. However, in order to prevent further collapse of the tunnel during repair operations, the soil immediately above the worst distress area was frozen with a liquid nitrogen system. When the flow was finally diverted from the tunnel, the area of the worst distress appeared as shown in Figure 6.

- a. Seismic activity was not a factor.
- b. Concrete composition, homogeneity, and quality were not factors and there was no evidence of detrimental chemical reactions.
- c. At end of construction, the concrete liner contained open construction joints and/or cold joints at several locations.
- d. The fine to medium sands, silty sands, and silts will pipe through openings as narrow as 0.01 in. under water pressures less than 2 psi.

- e. After construction, the external water pressure on the tunnel invert ranged from 4 to 8 psi.
- f. Soil piped into the tunnel in varying amounts depending on the location of the strata of piping soil with respect to open construction joints and/or cold joints. As material piped into the tunnel, the tunnel lost bottom and side support.
- g. When loss of support occurred beneath the invert, the resulting loading caused the structure to crack circumferentially as was observed in Distressed Area No. 3.
- h. When loss of support occurred at the springline, the resulting nonuniform loading caused the resistance of the structure to be exceeded and initiated and pattern of ovaling and longitudinal cracking and spalling observed in all distressed areas.

The permanent repair of the Corridor Interceptor was accomplished by jacking a 9-foot inside diameter reinforced concrete pipe through the distressed areas. The annular space between the new pipe lining and the old concrete tunnel was filled with cement grout. In addition, an extensive program of grouting outside of the original tunnel was undertaken. Repairs in this area have now been substantially completed.

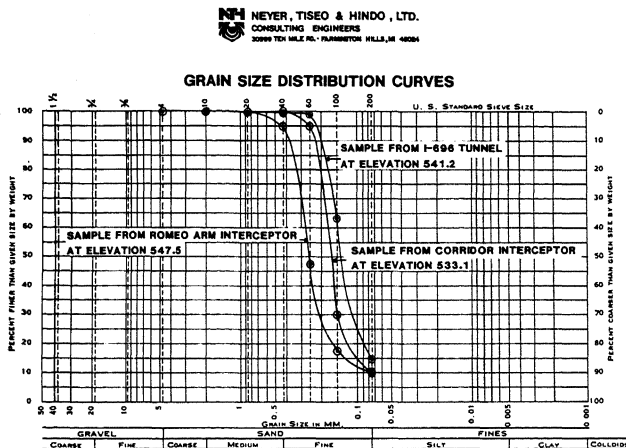
Fig. 7. Grain Size Distribution Curves

As shown on Figure 7, the soils near invert elevation at all three tunnels were fine sands. Studies have indicated that granular soils will flow through an slotted opening which has a width approximately equal to D_{70} of the soil. For the soils on these sites, this relationship would result in soil flowing through cracks as small as 0.008 inches.

Cracks in non-reinforced concrete are not an uncommon occurrence. Wherever a concrete pour is terminated by a bulkhead, a shrinkage crack is likely to develop. For this reason, it is recommended that designers specify water stops at all construction joints where soil and groundwater conditions appear likely to permit soil inflow. Waterstops should be designed to provide a total seal against water inflow at the joint.
