Kerrville Ponding Dam, Guadalupe River, Texas

SYNOPSIS: Kerrville Ponding Dam is a relatively small channel dam in the Guadalupe River in Kerrville, Texas. The dam is 22 feet (6.7M) high and 600 feet (183M) long and provides a water supply for the City of Kerrville. The dam was constructed during 1979-1980. Seepage problems in the abutments were observed during the initial filling of the reservoir. Some minor corrections to the problems were made at that time. In June 1981, after a moderate flood flow passed over the dam, additional seepage problems occurred. The downstream slope protection was displaced to the extent that cracks appeared in the concrete. This damage led to a more significant amount of repair. On December 31, 1984 the dam was overtopped by a flood to a depth of 10.5 feet (3.2M) above the spillway elevation. The dam suffered severe damage including loss of a portion of the concrete cap and significant erosion of the clay core over approximately one-third of the length of the dam, and seepage related damage at both the abutment areas. Figure 1 shows the conditions of the structure in January 1985. The dam suffered a "Type 1 Accident" as defined according to Internat

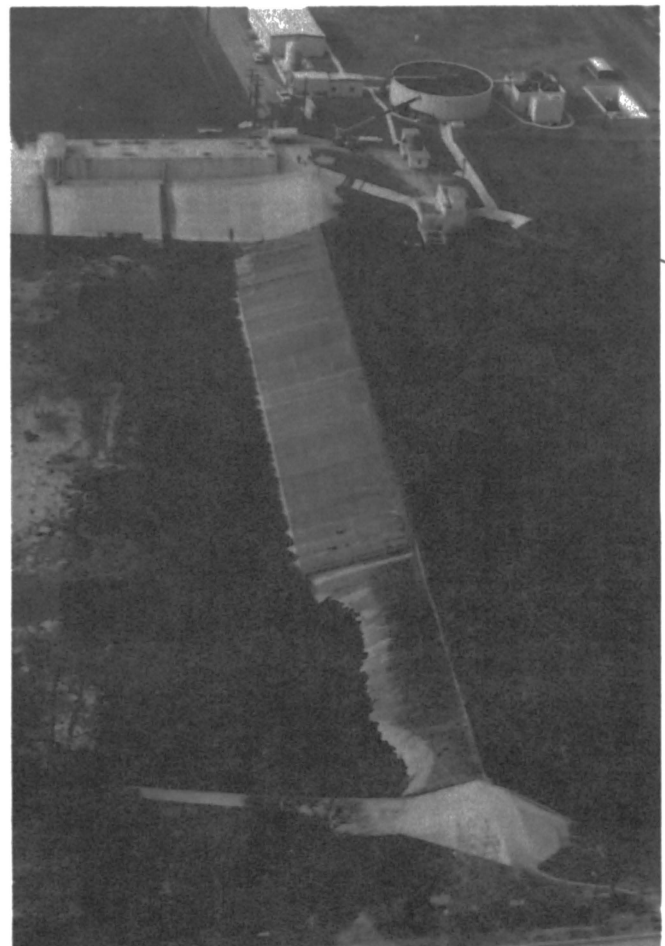
Fig. 1 Kerrville Ponding Dam, Jan. 1985

During the night of December 31, 1984 the dam was overtopped by a flood to a depth of approximately 10.5 feet (3.2M) over the spillway section. The dam suffered extreme damage, including complete destruction of the downstream concrete slope protection. Approximately one-half of the concrete was completely removed from the left spillway section. The clay core eroded in some places as far as 10 feet (3.0M) beneath the remaining concrete paving slab on the left one-third of the dam. The concrete paving slab adjacent the south (right) abutment was cracked and displaced upwards as much as 1 foot (300mm). A significant amount of filter material was eroded from beneath the slab for a distance of 60 feet (18M) from the south abutment. A photograph showing the scope of damages is shown in Figure 1. The dam was not breached, so the incident could be classed as an ICOLD TYPE 1(1A) Accident. The reservoir was drawn down to elevation 1613 msl to alleviate further damage and yet maintain a water supply source for the City of Kerrville and, except for occasional rises of the river during the investigation and repair phase, was maintained at that level until repairs to the structure were completed.

1. The defects in the cut-off walls provided direct access of significant quantities of water under excess head from the reservoir into the filter materials in the area downstream of the crest of the dam. The sum of areas providing relief for the water flows was significantly less than the sum of inlet areas. Consequently the filter materials became overloaded, high hydrostatic pressures developed beneath the paving slabs, thereby lifting and disrupting the slab. Once the slabs were displaced and broken, the rush of water over the crest completed the destruction shown in Figure 1.

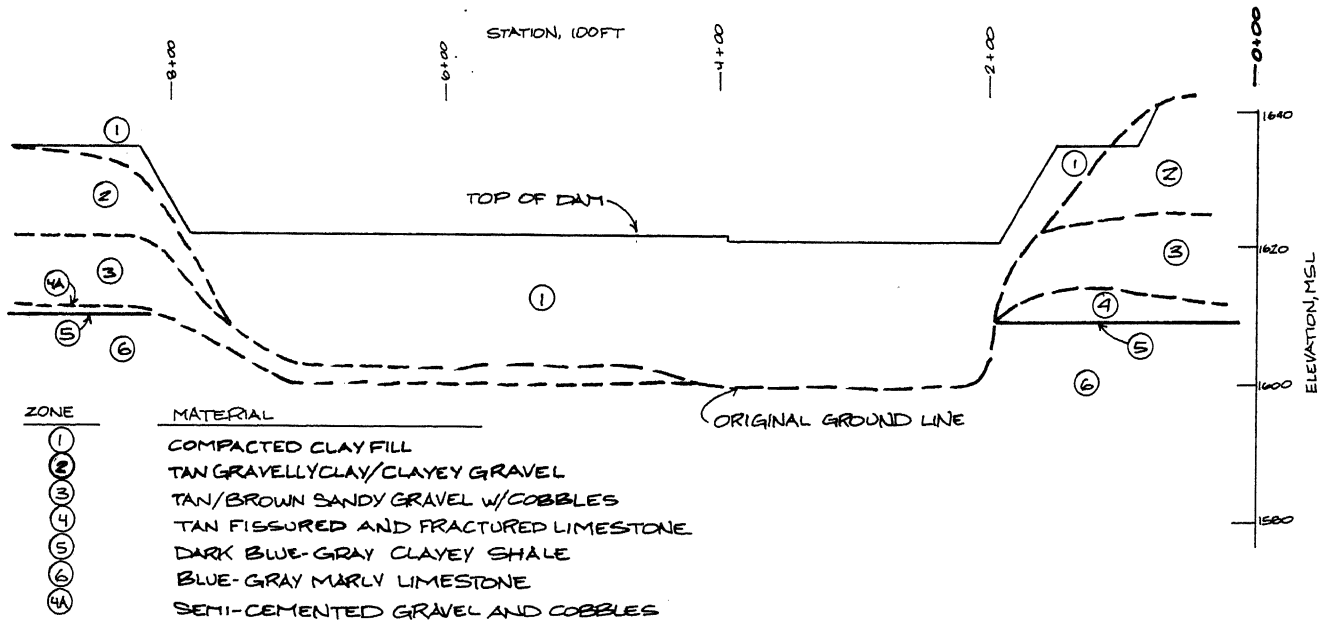
Fig. 2 Subsurface Profile

A typical subsurface profile along the axis of the dam, showing the riverbed formation, the natural abutment materials and the rolled filled embankment is depicted in Figure 2. Kerrville Ponding Dam is built almost entirely within the Guadalupe River channel. The river bed exposes a marly clay shale (argillaceous limestone) of the Glen Rose formation, Cretaceous System. The fresh, unweathered limestone is dark bluish-gray in color, is intact, and contains no fissures or fractures. The rock rises approximately 10 feet (3M) above the incised river channel. In the north abutment the upper 5 feet (1.5M) of the limestone is less marly, more earthy, and is highly fissured and jointed with the fissures and joints principally oriented parallel to the

river flow. These fissures and joints are as much as 3 inches (76mm) wide and extend entirely through the upper limestone bed. On the south abutment, the sound marly limestone is overlain by a poorly cemented, highly vuggy and porous, gravelly and cobbly conglomerate which varies in thickness from 1 to 3 feet (0.3 to 0.9M). A thin bed of high plasticity clay, varying in thickness from 3 to 6 inches (25 to 150mm), lies between the sound rock and fissured rock in the north abutment and between the sound rock and the conglomerate in the south abutment.

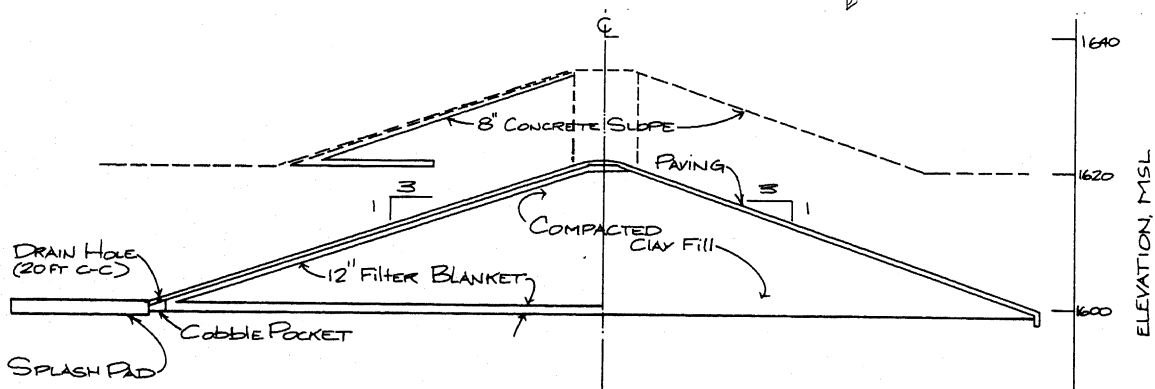
Fig. 3 Typical Embankment Section

Typical embankment sections are shown in Figure 3. The earth embankment consisted of moderate plasticity clay having liquid limit values ranging from 50 to 60. The clay was compacted to not less than 95% Standard Proctor density.

Slope paving extended up the abutments to the crest of the non-overflow section as shown by the dashed-line embankment in Figure 3. A crest width of 10 feet (3M) was established for the non-overflow section. Slope paving was extended land-ward until its elevation of 1635 msl met natural ground surface. The cast-in-place concrete cut-off was constructed in open ditches excavated with a back-hoe through the cohesive and non-cohesive abutment materials.

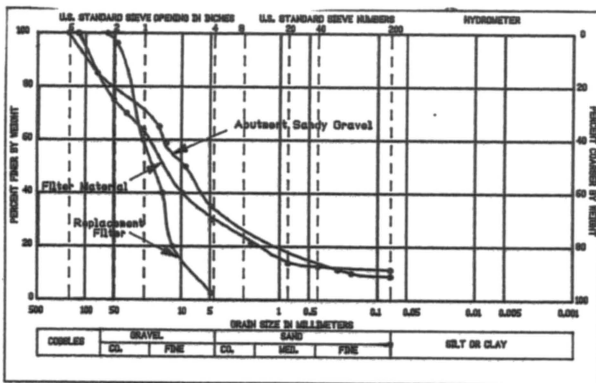
Fig. 4 Grain-Size Curves, Natural and Filter Materials

Samples of the undisturbed filter materials used in constructing the dam were obtained for testing. Grain size analyses showed percent fines (-No. 200 sieve) varying from 5 to 18 percent. Atterberg limits tests indicated plasticity index values on the order of 8 to 15. A typical grain size curve for the filter material is shown in Figure 4.

Bulk samples of the natural gravel stratum were obtained from large diameter test holes dug into the abutments both upstream and downstream of the embankment. Grain size analyses typical of the materials are also shown in Figure 4. It is obvious that these materials have very similar grain size characteristics. Analyses of grain size curves indicate that the materials are of a suffusion character. The D_{60}/D_{10} ratio are well in excess of 20 which according to U.S. Army Engineer Waterways Experiment Station Report "Design and Construction of Granular Filters for Embankment Dams" by Edward B. Perry, indicate the materials are internally unstable and susceptible to internal migration and possible loss of the finer particles.

2. It is noted that the so-called filter material violated several of the recognized filter criteria when using the gravel as the base material. It can be said that the structure did not have a filtration or pressure reducing system in-so-far-as the more permeable base materials were concerned. Also, the filter materials were quite variable as to percent fines. This produced a great variation in filter permeability. Much of the filter contained significantly more fines than are usually permitted in a well designed filter material.

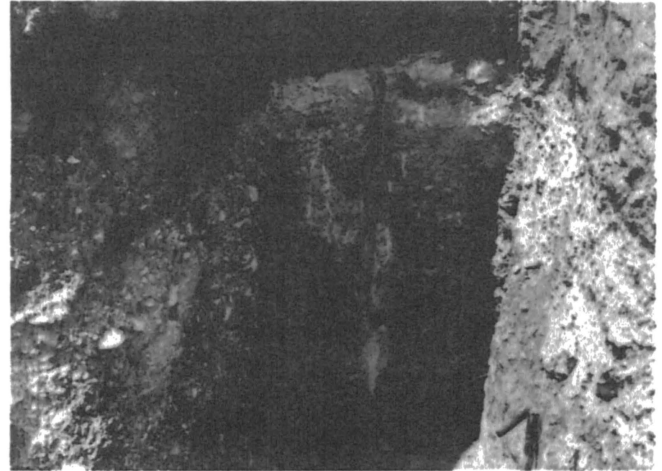
Fig. 5 Defects in North Cut-off Wall

Trenches were excavated into both abutments at locations where the cut-off trench could be exposed for inspection. On the south (right) abutment it was found that the concrete cut-off bottomed some 4 to 8 inches (100 to 200mm) above the sound rock. Very loose coarse gravel was found in the void between the concrete cut-off and the rock. In the north (left) abutment a void ranging from 2 to 6 inches (51 to 152mm) was found between the concrete and the fissured rock. Additionally, it was found that the concrete had been cast in three separate sections with coarse gravel intruding into the

Joints in the concrete. The triangular joint in the center of the two right pieces of wall is about 6x8 inches (152-203mm) in size. This condition is depicted in Figure 5. A 36-inch (0.9M) boring was made upstream of the cut-off to inspect the juncture between the original cut-off and the extended cut-off. It was found that an approximate 2-inch (51mm) vertical gap existed between the two walls. The gap was filled with loose coarse gravel and tree roots up to 1-1/2 inches (38mm) in diameter.

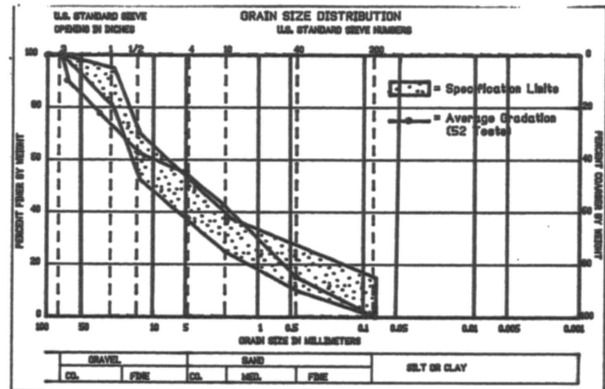
Fig. 6 Roller Compacted Concrete Gradation

compacted concrete. Specification limits for grain size distribution were established as shown in Figure 6. Also shown are the average results of grain size analyses tests conducted on 52 samples taken from the mix plant during construction.

Grain-size analyses of pit-run materials, and visual examination, showed that the various producers were all mining essentially the same materials. Grain-size distribution curves of materials "scalped" over a 3-inch screen were compared with curves reported by other RCC users and were found to conform quite well. Trial mixes showed that adequate strength, and durability could be obtained with moderate amounts of cement. Both Wetting-and-Drying and Freezing-and-Thawing (ASTM D559 and ASTM D560) on laboratory molded specimens showed losses ranging from 6 to 10 percent. Tests also indicated that the molded materials would develop compressive strength ranging from 1100 to 2000 psi at 28 days age on materials containing from 5 to 10 percent portland cement, by weight. The durability and quality of the aggregates themselves were well established by their use in numerous projects throughout the area.

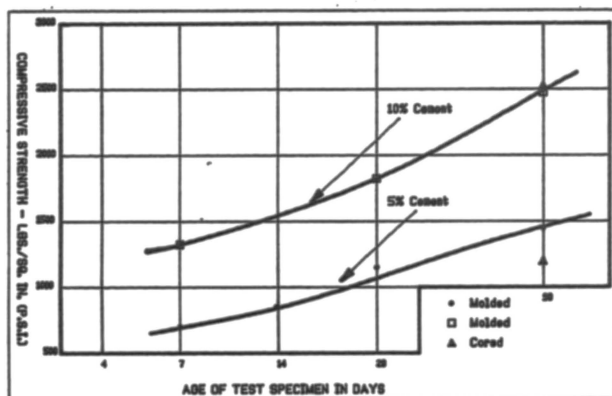
Fig. 8 Strength of RCC

Moisture and density control were conducted on a daily basis. Additionally, laboratory molded specimens were made from the materials being placed. Results of strength tests of laboratory molded specimens are shown in Figure 8. After the dam was completed both 6-inch (152mm) and 10-inch (250mm) specimens of in-place RCC were obtained with a diamond core barrel. Strength tests were conducted on specimens of the core. Results of these tests are shown in Figure 8 for comparison with laboratory molded specimens. Down-hole permeability tests were conducted in the core holes. Permeability values obtained from these tests ranged from 1×10^{-5} to 1×10^{-7} cm/sec.

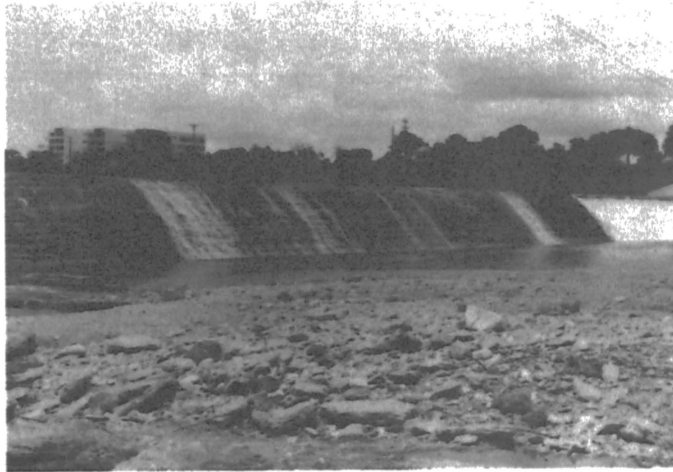
On July 17, 1987 the dam was overtopped to a depth of 17.2 feet (5.24M). This was reported to be the largest flood in the past 40 years in this reach of the Guadalupe River. At the dam the flood reached elevation 1638.2 msl or 3.2 feet (1.0M) above the paved abutment sections. No damage was experienced by the embankment nor its downstream training walls. The only damage suffered by any of the Upper Guadalupe River Authorities' facilities was erosion of soil above the slope paving on the north (left) abutment and the loss of a head-wall and one section storm drainage pipe downstream of the south (right) training wall. Photograph of the dam taken after the July 17, 1987 flood is shown in Figure 9.

Fig. 9 Completed Dam, July 1987
