Recognition and Delineation of a Landslide, Turkey

Lester M. Tyralla

Stone & Webster Engineering Corporation, Boston, Massachusetts

SYNOPSIS: Geological mapping, geophysical surveys, test pits, and shallow borings were used to identify and evaluate a site containing a landslide complex. An investigation was performed to characterize the extent and nature of the complex, determine the susceptibility to movement, and the potential for impact on a nearby proposed reservoir and dam.

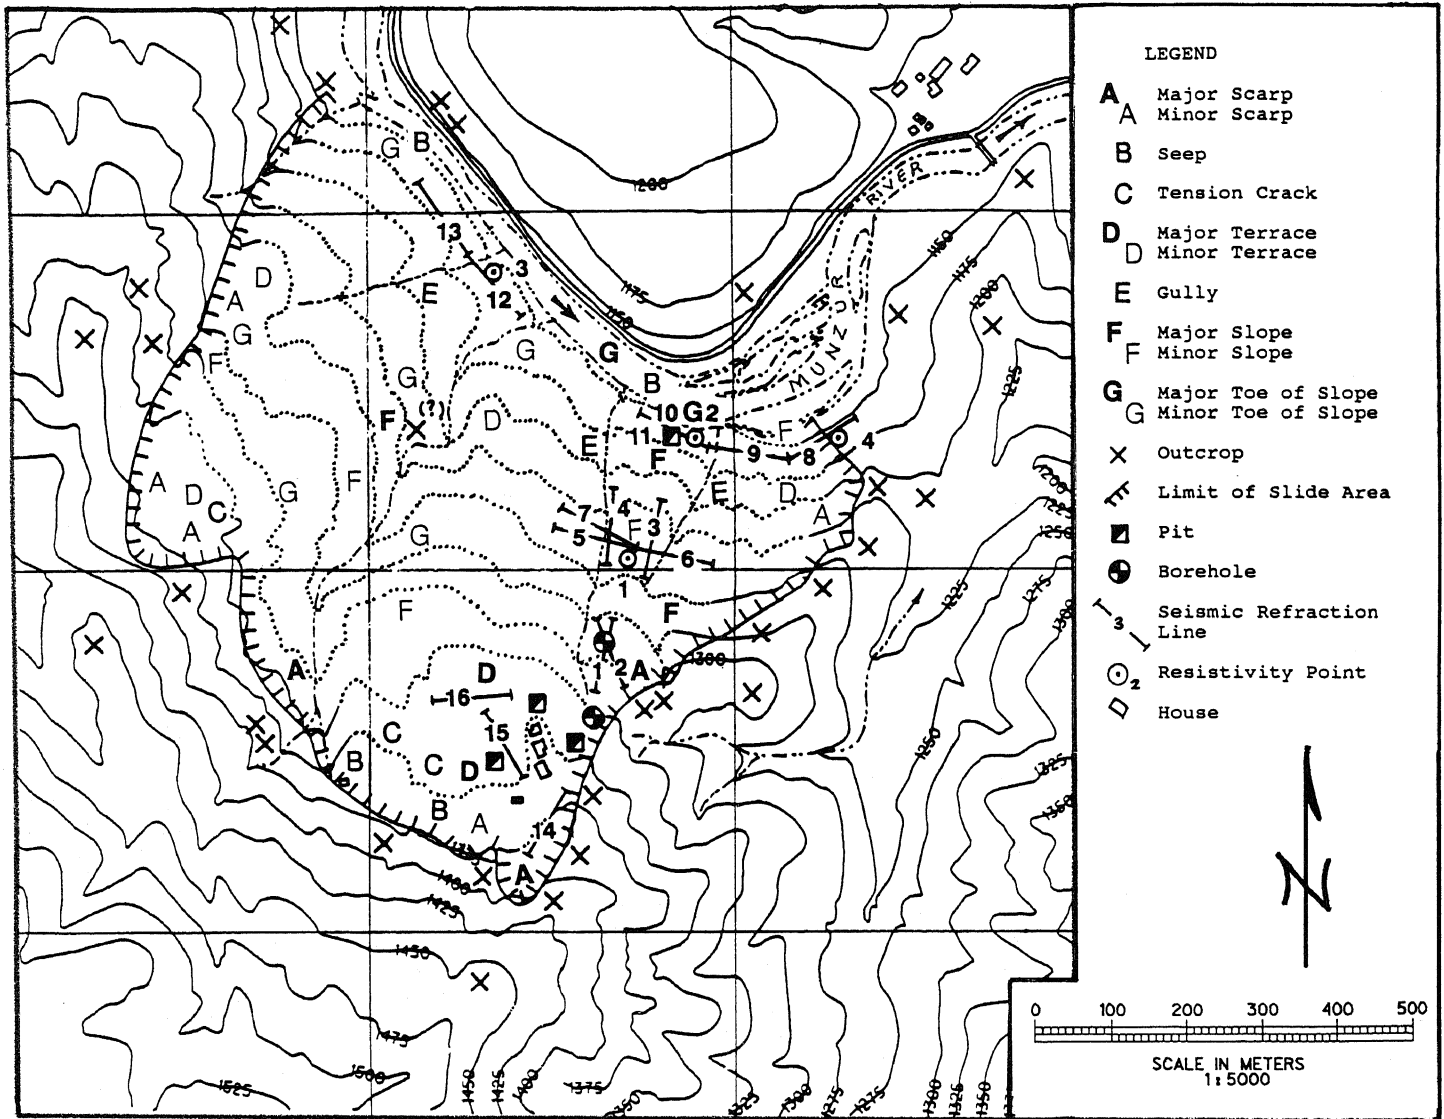
Figure 1. General Map of the slide area, geologic-morphologic features, and locations of exploration activities

The morphological features of the slide were used to plan line placement in order to investigate the thickness of disturbed materials at different locations (Figure 1). The majority of the survey lines were oriented approximately parallel to the strike of the slope in order to minimize the adverse influence of elevation changes. Where that orientation was not possible and the slope inclination was reasonably constant, the lines were oriented approximately perpendicular to the slope. Refraction and resistivity lines were situated on the scarps, terrace, slopes, and the toe of the slide complex.

Two borings, SA-1 and SA-2, were drilled on the slide (see Figure 1) to confirm its nature and extent using N-size equipment, standard split spoon sampling, and diamond coring. Boring locations were chosen on the bases of morphologic features, geophysical interpretation, and physical restrictions imposed by the terrain (Figure 1). Boring SA-1 was sited to determine the depth to the basal failure surface in an area near a scarp, and boring SA-2 was sited to verify the depth to bedrock at the intersection of two crossing refraction lines.

Boring SA-1, close to the houses at Kort, penetrated 13 m of disturbed soil and rock and 6 m of bedrock. Boring SA-2, about 100 m downslope from SA-1 on one of the slope terraces, penetrated 16 m of disturbed materials and 6.5 m of bedrock.
