## Identification of Potential Seepage Locations Along the Herbert Hoover Dike, Lake Okeechobee FL., by Electromagnetic Geophysical Method. Prediction and Confirmation.

*U.S. Army Corps of Engineers, Jacksonville, Florida*

## Identification of Potential Seepage Locations along the Herbert Hoover Dike, Lake Okeechobee FL, by Electromagnetic Geophysical Methods. Prediction and Confirmation.

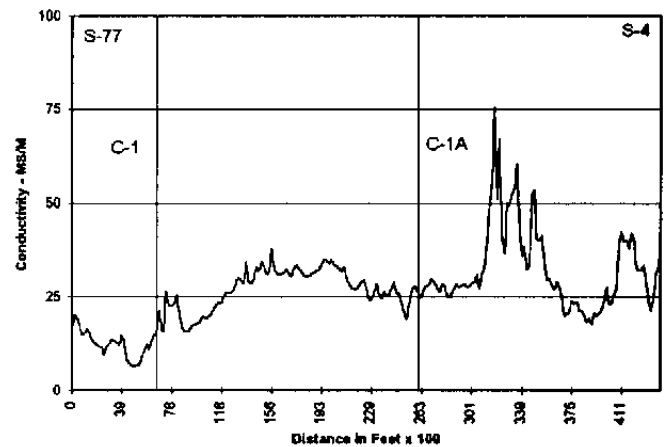
Fig. 4. EM results from S-77 to S-4.

Figure 4 represents data along the section from S-77 to S-4. Only one area in this section was considered for future study. The sustained peaks from distance 301 to 339 represent anomalous conditions in the foundation. Some of these areas registered a high in-phase measurement, indicating metal pipes in the subsurface.

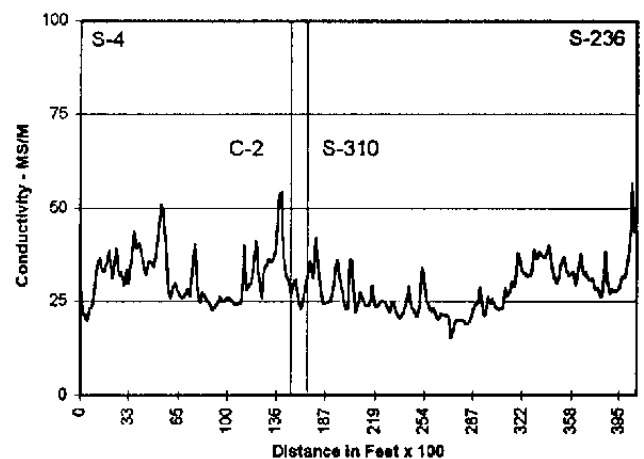
Fig. 5. EM results from S-4 to S-236.

**Section from S-4 to S-236.** Figure 5 represents the middle eight miles of data collected. Cross section MRR2-E is also representative of this section. The geologic conditions in this area are similar with sand overlying layers of shell and limestone. This area represents a transition with increasing silt in the upper sand layers and lenses of peat at the natural ground surface. Anomalies from about distance 20 to 60 and at 135 were noted as significant. Also noted was the increase in background conductivity to about 35 MS/M, indicating a broad lateral change in the subsurface moisture content or changes in the groundwater surface elevation. Anomalies from distance 332 to 395 are characterized similarly, with a noted increase in background conductivity.

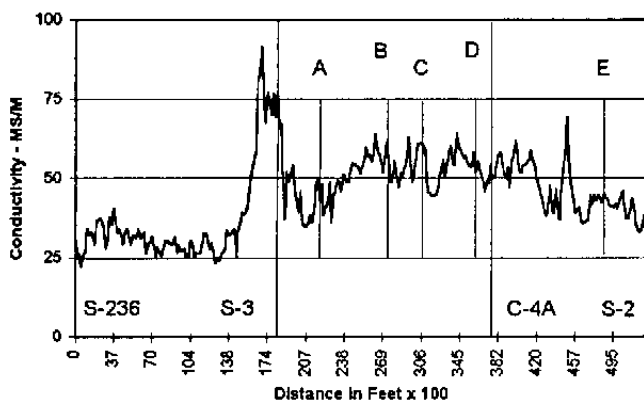
Fig. 7. EM results from S-236 to S-2.

The most apparent feature of the EM data in Fig. 7 is the pronounced sustained peak at distance 174. These large anomalies with conductivity values from 75 to nearly 100 MS/M indicated largely saturated subsurface conditions. This also inferred that larger hydraulic conductivities existed at depths below the region of inquiry. The background conductivities of 30 - 40 ms/m between S-236 and S-3 are a result of the generally higher ground water table along this portion of the embankment.

The area at distance 174 was investigated by both core borings and downhole video in September, 1995. The limestone was chalky and very porous with a unit weight of 105 pounds per cubic foot (pcf). Competent limestone in this area is generally 130 to 150 pcf. Visible flow was observed in the video. Clouds of silt and some sand particles were observed to move laterally at different levels within the limestone. Sand and shell that fell into the bottom of the boring were observed to "boil" from flow at the bottom of the

A broad area of numerous anomalies were encountered east of S-3 in Fig. 7. Conductivities from 45 to 75 MS/M were common, with a background of approximately 50 MS/M. This is representative of very saturated subsurface conditions and an elevated groundwater table. Many of the peaks were located in regions of visible groundwater seepage. Note that at this time, the lake level was at 16.4 feet and the existing ground surface in this area (section MRR3-A) was approximately elevation 15.0. This section was expected to demonstrate the highest hydraulic conductivity.

Damage to the embankment is defined as excessive seepage or piping. Damage was observed in Reaches 1 and 3. Since Reach 1 was not part of the EM survey, only damage to Reach 3 will be relevant to this comparison with one exception. There were five main areas of damage in Reach 3. They are labeled in Fig. 7 as "A", "B", "C", "D" and "E". Other areas

**Point A.** This was an area where a large volume of seepage was exiting along the downstream berm at elev. 15 ft for about 200 feet. There was no piping of material (flow was clear); however, the quantity of seepage was excessive and cause for concern.

**Point B.** This was an area about 1500 feet long where there were several dozen pipes exiting into the toe ditch with significant movement of material. This area had the most severe damage. Several of the pipes had caved in, causing depressions to extend from the ditch into the toe of the embankment about 25 feet away. Several small and one large sinkhole developed on the crest of the embankment. The large sinkhole was 3 feet in diameter by 6 feet deep. Probing with a steel rod indicated a cavity for an additional 5 to 6 feet before resistance was encountered. Sinkholes were also found in the crest of the embankment between points B, C, and D.

**Point C.** This area was approximately 2500 feet long where the downstream slope of the embankment experienced varying degrees of seepage without movement of material.

**Point D.** This was an area where several seeps exited the berm and a boil developed at elevation 15.5 ft. The boil piped material at first and then flowed clear. It is interesting to note that the embankment section was measured at 280 feet from the lake shore to the boil with a head of approximately three feet. This indicated that there was almost a direct connection to the lake, with less than three feet of head lost in almost 300 feet.

**Point E.** This was an area where two different types of problems emerged. Through seepage exited the slope at the berm and flowed clear. Also, in the adjacent ditch two areas were flowing into the ditch at the toe of the embankment. There was a strong sulfur odor and a white stain covered the organic soils in the area. This water was likely from below the confining silt layer, indicating flow from the foundation rock below through an open conduit that had formed by fracturing the silt layer below the peat.

Core borings were obtained in December, 1995 at each of these sites both in the crest and at the landside toe. Piezometers were also installed. Temporary repairs at the Lake Harbor sites consisted of removing 2 - 4 feet of peat off the landside berm. The berm and drainage ditch were then backfilled with filter stone. At point E on Fig. 7, a line of relief wells 12 inches in diameter and 10 feet deep were drilled along a 300 foot section and backfilled with filter stone. The stone columns were connected by a 3 foot by 3 foot ditch to drain into the existing ditch.

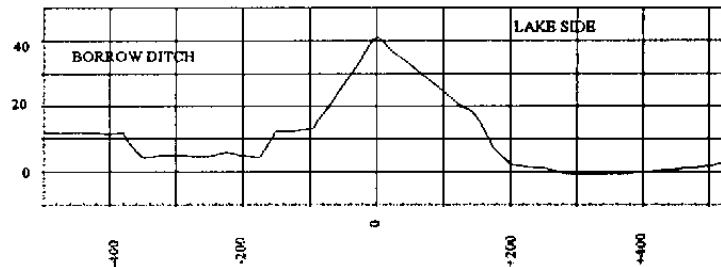
Fig. 8. Cross section MRR2-G. Distances and elevations in feet.

hole. Another significant factor at this site was the large borrow ditch shown in Fig. 8 at cross section MRR2-G.

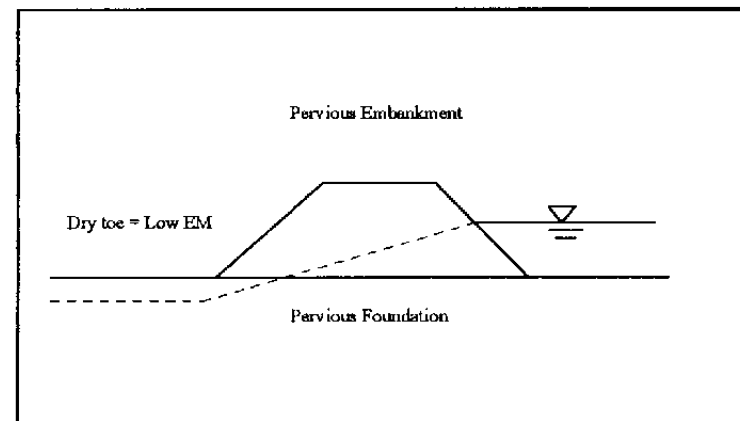
**Case 1.** In the western portion of Reach 2 from S-77 to S-4, the EM values are low, indicating a dry toe. Both the embankment and foundation are composed primarily of pervious shelly materials which drain the seepage into the foundation and keep the embankment toe dry as shown in Fig. 9.

Fig. 9. Case 1. Pervious embankment over pervious foundation.

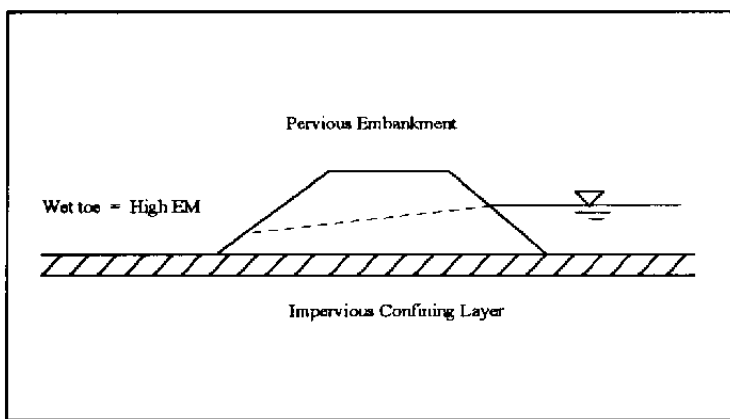
**Case 2.** From S-4 to S-236, the readings are increasing slightly. There is a pervious to semi-pervious embankment overlying a confining layer. This is the general condition existing in Reach 3. Water from the lake, seeping into the embankment can't drain into the foundation because of the confining layer. The seepage is forced to exit the toe of the embankment. This results in a wet toe and high EM values as shown in Fig. 10.

Fig. 10. Case 2. Pervious embankment over impervious foundation.

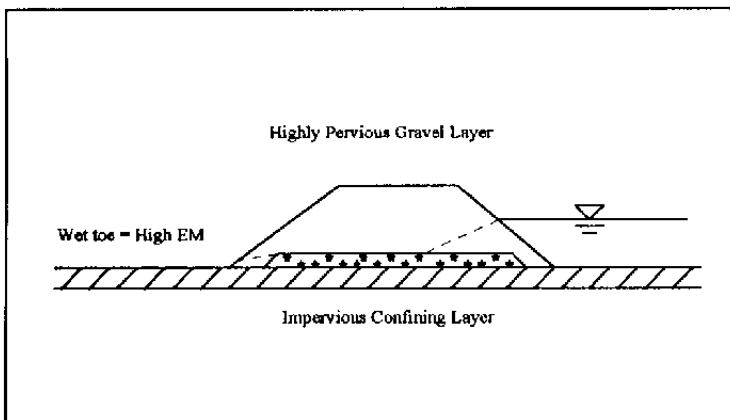
**Case 3.** From S-3 to C-4A a dramatic change takes place. Gravely layers within the embankment are highly pervious and serve as conduits to supply seepage water directly to the toe of the embankment. This results in a wet toe and very high EM values as shown in Fig. 11. This condition is also particularly hazardous since a significant head drop occurs in a short distance across the downstream portion of the embankment.

Fig. 11. Case 3. Highly pervious gravel layer in embankment.

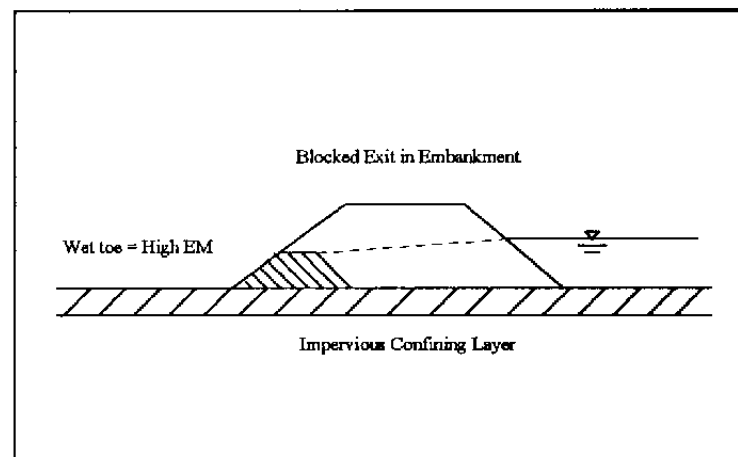
**Case 4.** Based on experiences from core borings and piezometer readings in Reach 1, a fourth condition can be presented. This condition exists sporadically along the embankment where the toe was constructed of clayey or silty materials. This material acts as a downstream impervious blanket which raises the piezometric level within the embankment as shown in Fig. 12. This results in a wet toe and high EM values.

Fig. 12. Case 4. Blocked Exit.

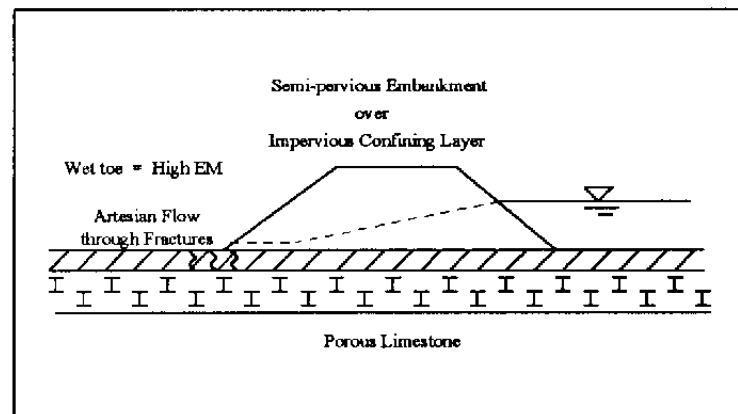
**Case 5.** Another local anomaly which can be detected is artesian flow from limestone layers beneath the embankment. This occurs where the confining layer has been heaved or fractured (usually in a ditch bottom). These fractures serve as conduits for seepage up through the confining layer into the toe of the embankment. This results in a wet toe and high EM values as shown in Fig. 13.

Fig. 13. Case 5. Artesian Flow.
