Mississippi River Road Gabion Wall/Slope Stabilization

MISSISSIPPI RIVER ROAD GABION WALL/SLOPE STABILIZATION

Lee County widened Mississippi River Road north of the Keokuk, Iowa in the early 1990s, removing material from the toe of slopes along the alignment. Gabion walls were constructed to provide grade separation. Significant precipitation occurred in the spring of 2010, and two (2) wall sections (about 100 feet each in length) failed. Based on our site exploration and instrumentation monitoring data, the gabion wall sections appeared to fail due to additional lateral load from a soil mass sliding on top of the shale bedrock and a buildup of high ground water levels. To support the additional load of the soil mass, reestablish the gabion wall/slope, and to keep the road open to traffic, a tied back, closely-spaced drilled shaft wall was designed to remediate the slide and augment the original gabion wall. This paper describes the investigation, analyses and the design and construction of the remedial measures adopted.

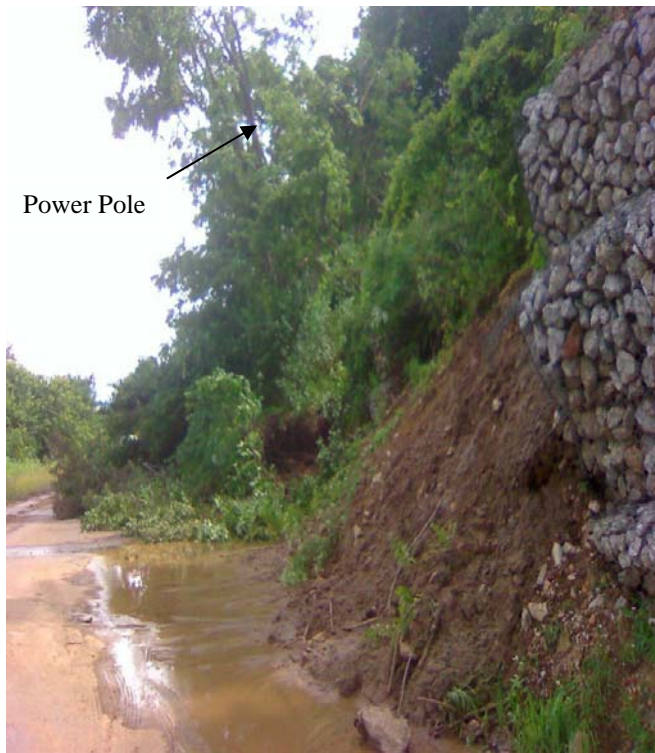
Fig. 2 - 2010 Slide

Movement in two sections of the gabion wall, each about 50 to 100 feet in length, was first noticed about June 1, 2010 (Fig 2.). At that time, the north wall section (about Station 56+50) showed some outward movement (bulging) while the south wall section (about Station 55+50) showed noticeable rotation about the toe with the wall leaning towards the road. The south wall section subsequently failed on July 24 or 25, 2010. The ground surface in front of the failed wall section at Station 55+50 was noticeably raised above the curb elevation and extended laterally over the curb. In addition, the top of the bottom level gabion cages were barely above the ground surface. The condition of the ground surface and lower gabion cages was similar at the north wall section (Station 56+50) that was still intact.

The owner of the property above the failed wall sections reported observing tension cracks in the slope above the wall. According to the property owner, the tension cracks developed the spring of 2010. During a site visit of the area above the referenced wall sections, several tension cracks and slumped areas were observed. One crack extended up the slope from the area where the power pole (Fig. 2) is leaning noticeably towards the road. A bench in the slope was also observed up on the slope and appeared to be a previous road or trail.

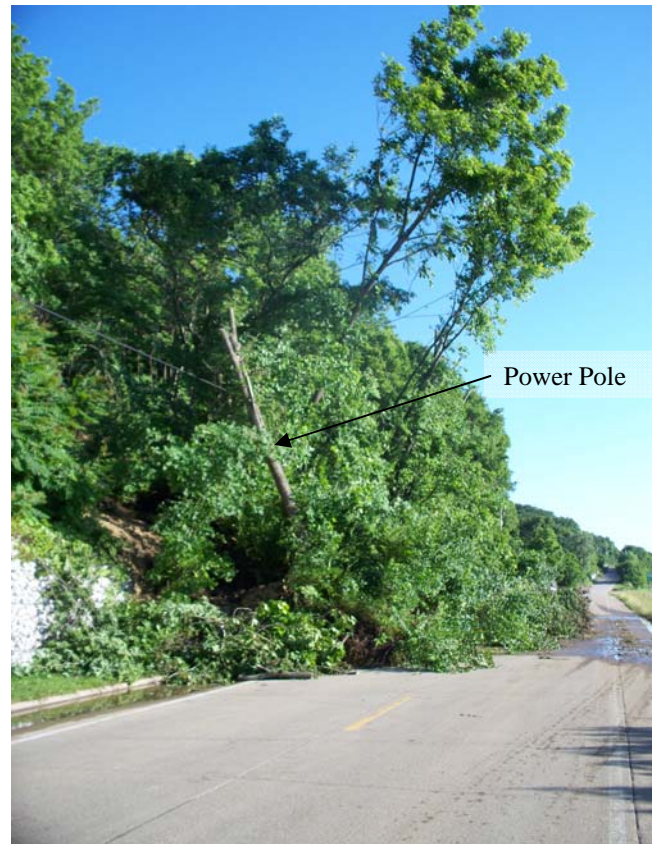
Fig. 3 - 2011 Slide

Additional slope movement occurred in June 2011. The primary area of additional movement was located on the south end of the 2010 slide mass, which includes the power pole on

the south end of the 2010 south slide area (Fig. 3). The power pole moved down the slope as a result of the 2011 slide. As opposed to the 2010 slide, which caused lateral movement of the gabion wall, the 2011 slide mass moved over the wall and into the road. The 2010 and 2011 areas represent progressive movement within a larger slide mass.

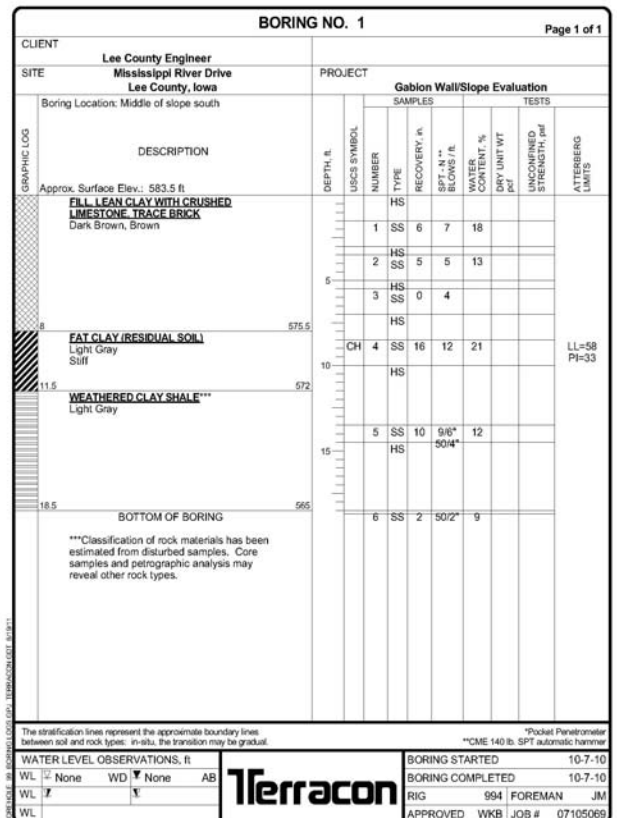
Fig. 5 – Stratigraphy

Four (4) borings extending into the shale bedrock were performed in October 2010 at the approximate locations shown on the Boring Location Plan (Fig. 4). Slope inclinometer guide casing was installed in Boring 1; PVC well casing was placed in Borings 2 through 4. Subsurface conditions at the boring locations generally consisted of fill overlying native soils, underlain by residual soil above shale bedrock. The thickness of the fill and residual soils overlying the shale bedrock beneath the slope surface varied from about 11 to 11½ feet. Figure 5 indicates the stratigraphy of the slope.

Although slope movement can occur in any of the soil layers above the bedrock, the limited slope monitoring data indicated that the slope movement was occurring near the interface of the residual soil (fat clay) and weathered shale. During widening of the road, removal of the soil from the toe of the slope perhaps contributed the most toward slope instability. The gabion wall did not have the weight or internal strength to replace the large volume of soil removed from the toe. In addition, the fill present in the upper parts of the slope was likely placed as dumped fill with low in situ density and strength. As visible from field observations, there was excessive water seeping out of the slope and near mud flows were visible at the toe of the slope.

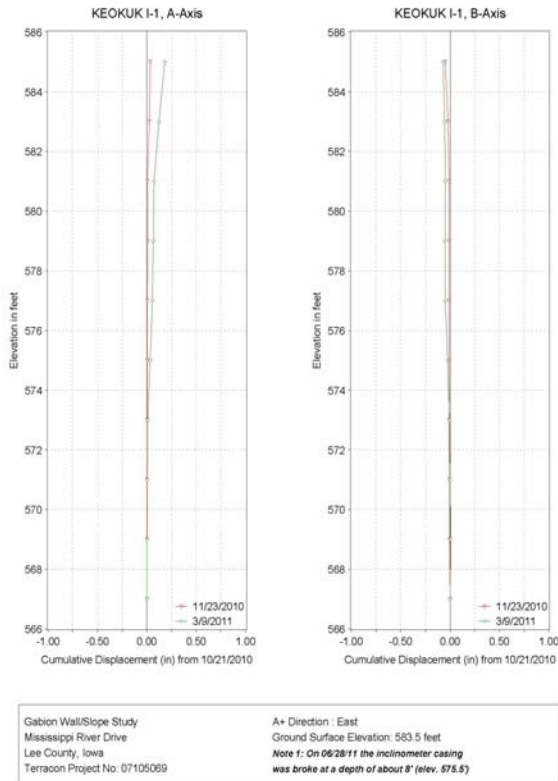
Fig. 6 - Inclinometer Plots

The slope inclinometer provided valuable information pertaining to the movement of the slide at this site. Representative plots showing cumulative and incremental movements along the 2-foot intervals of the measuring probe are shown in the Inclinometer Plots (Fig. 6). As shown in the plots, movements at the location of Boring 1 was noted at about the 11 to 12 foot depth. Unfortunately, the slope inclinometer casing moved during the 2011 slide to the extent that further readings are not possible. The primary movement appears to be near the interface between the residual soil and the shale; however there are likely additional shallow failures within the slide area as the ground break-ups and excess rains saturated the undulating ground on the slope.

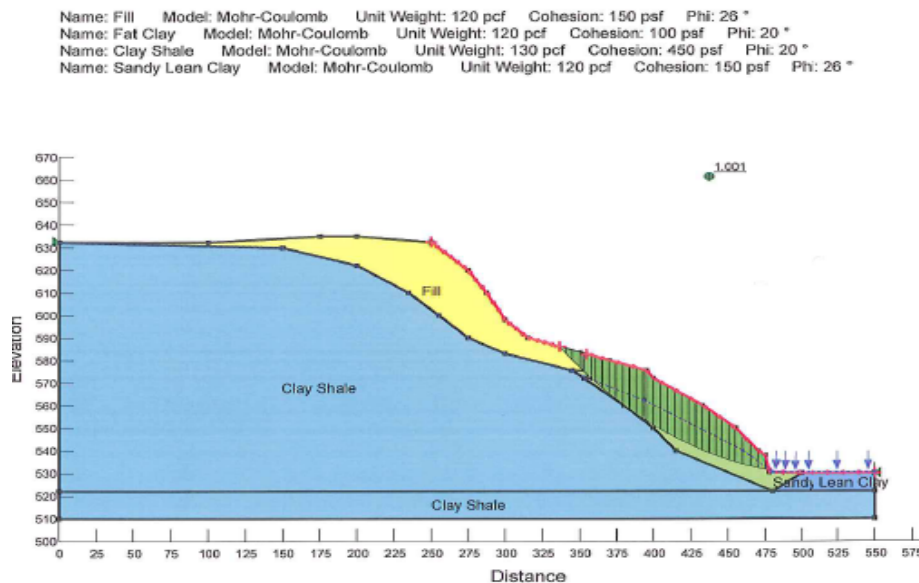
Fig. 7 - Subsurface Cross Section Station 53+78.8/Back Calculation

Although the original wall failure was located closer to Station 55+50, the cross-section selected for our analysis (Station 53+78.8) (Fig. 7), was based on the location of the inclinometer. Considering the results of the borings and the 2011 slope movement, the cross-section at the failed gabion wall section may differ from the cross-section selected, and in particular, the thickness of the fill/residual soil; however, for the purposes of our analysis, this cross-section was used. The location of the failure surface was approximated from the visible toe of the slide, surface cracks, and the inclinometer readings.

The slope stability analyses were performed using computer programs SLOPE/W and STABL. Both of these programs use limit equilibrium methods (LEM) of analysis. The failure surface estimated from the limited data obtained from the geometry provided by the County and the inclinometer readings is indicated in the Subsurface Cross-Section (Fig. 7).

The cross-sectional model shown in Fig. 7 was used as the basis for our analyses to evaluate shear strengths along the known failure surface that would result in a FOS close to 1.0. Fig. 7 shows the results of back analysis indicating an incipient failure in the slope with the current geometry. The water level (piezometric pressure) was estimated from the water levels observed at Borings 2 through 4 as shown in Fig. 7. Based on the back analysis, the average shear strength parameters for the various stratigraphic units were estimated as shown in Table No. 1. below:
