Observations of Site Amplification and Liquefaction in the Jun 23, 2001, Southern Peru Earthquake

OBSERVATIONS OF SITE AMPLIFICATION AND LIQUEFACTION IN THE JUNE 23, 2001, SOUTHERN PERU EARTHQUAKE

ABSTRACT

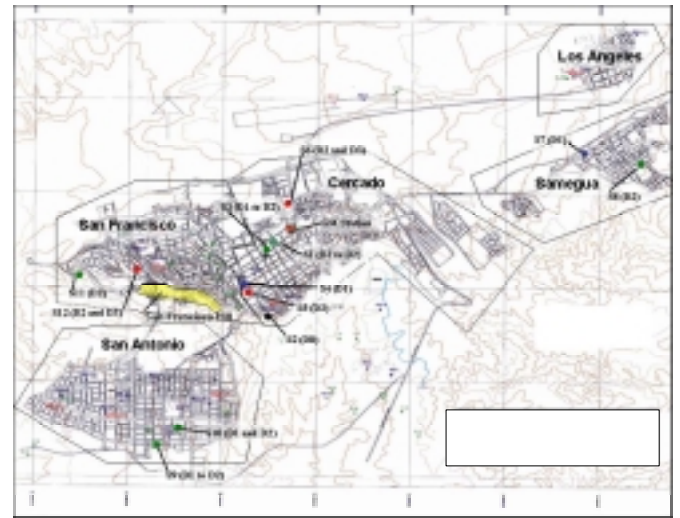
Fig. 2. Map of Moquegua showing locations of evaluated buildings. Damage index is shown in parenthesis. Buildings are described in Table 1.

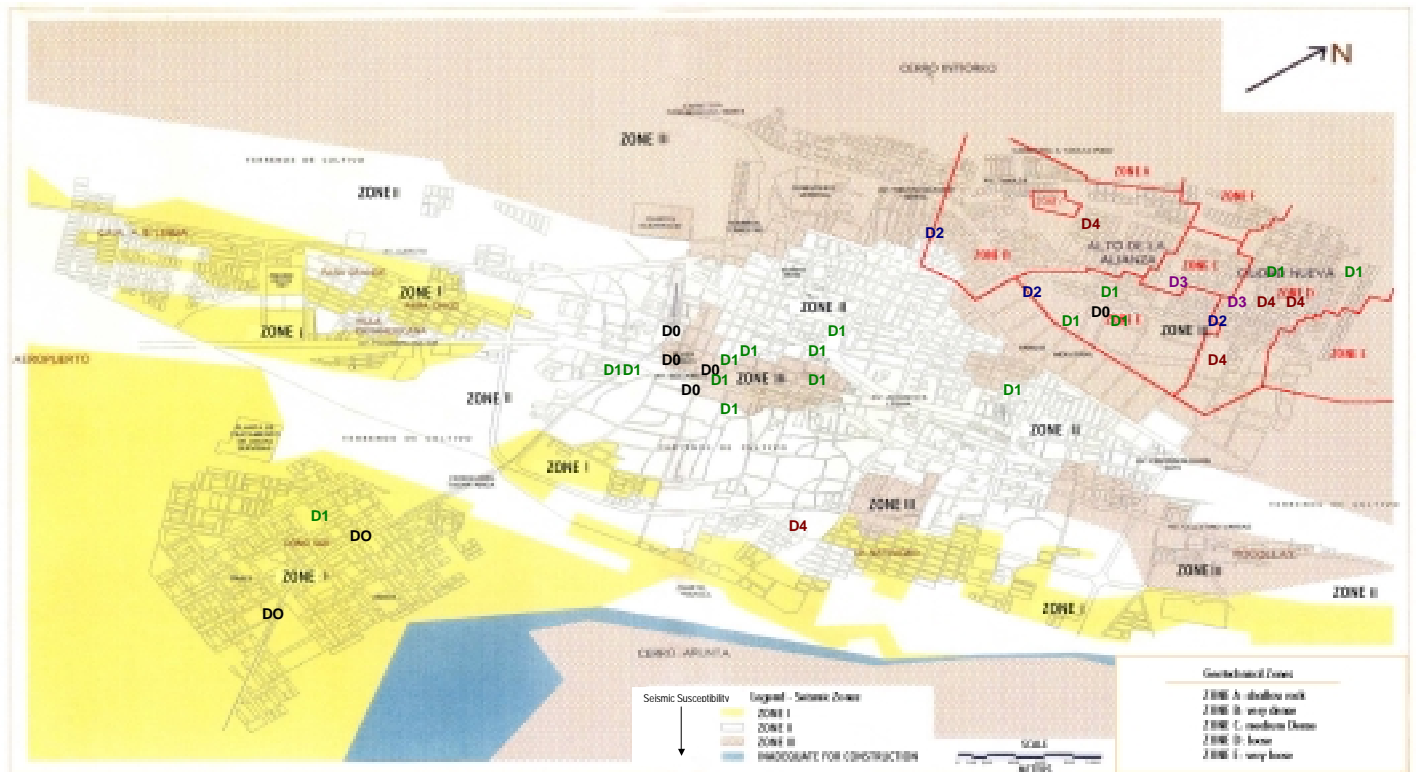
Fig. 3 Damage survey sites in Tacna. Damage scale ranges from no damage, D0, to partial or complete collapse, D4 (base map from Cotrado and Siña 1994).

The damage distribution clearly indicates that concentration of structural damage was relatively high in areas underlain by the volcanic tuff (Zone III), while areas underlain by the alluvial gravel deposits (Zones I and II) had less damage. By means of a general observation of all structures, it was apparent that a very limited number of structures (less than 1 percent), other than adobe-type construction, suffered damage that would be indexed at the D2 level or greater in the areas underlain by the dense alluvial gravel.

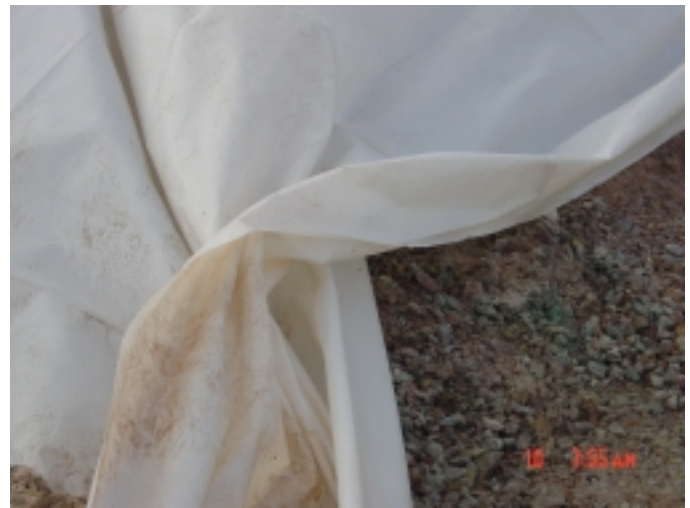
Several heap leach pads exist at the Cuajone mine, one of which failed during the earthquake. Figure 5 shows damage and lateral spreading resulting from liquefaction of the uppermost lift of a heap leach pad liquefied at the Cuajone mine, located about 60 km east of the city of Moquegua (Fig. 4). This uppermost lift was being leached at the time of the earthquake. The pad was lined with a 100-mil high-density polyethylene (HDPE) geomembrane bottom liner. The pad consists of 2-m thick lifts, each of them underlined by a thin (20-mil) geomembrane interlift liner. The ore consists of agglomerated minus 12-in. material (Fig. 6). The liquefied material and leaching solution flowed downstream of the pad. The surface of the liquefied fifth lift suffered considerable deformations (Fig. 7). The likely cause of liquefaction at this heap leach pad was a high solution application rate, combined with the relative fine gradation of the ore and the presence of an underlying interlift liner that inhibited dissipation of pore fluid pressure. To the best of the authors' knowledge, this is the first occurrence of liquefaction in a leach pad and points to the need to consider this potential failure mode due to the potential damages associated with flow failures in leach pads. It is noted that several other geosynthetic-lined heap leach pads exist at Cuajone mine, all of which remained stable.

Fig. 6. . Ore at failed heap leach pad at mine.

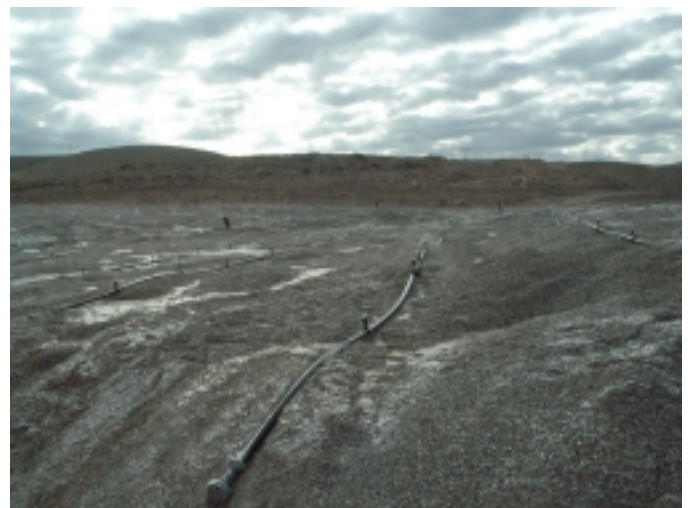
Fig. 7. Failed heap leach pad at Cajone mine.

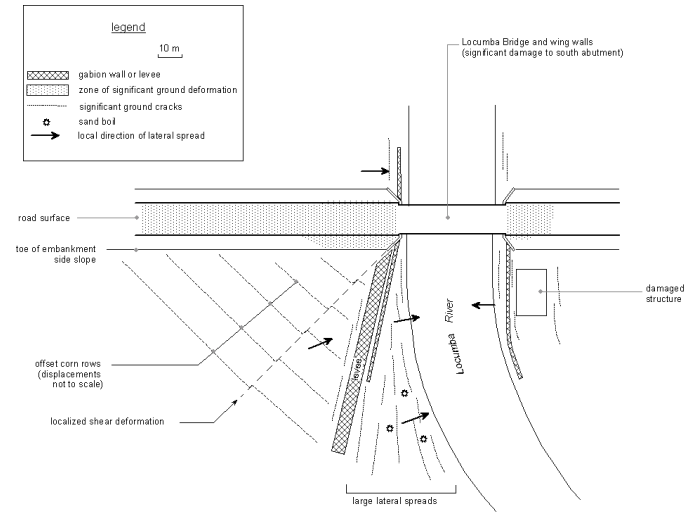
The south river bank spread noticeably toward the free face of the river (Fig. 8). Localized horizontal displacements at the shear zone closest to the river were as large as 1.2 m, and gradually tapered to about zero at a distance of 51 m from the wing wall.

Fig. 8. Liquefaction-related damage at the Locumba bridge site.

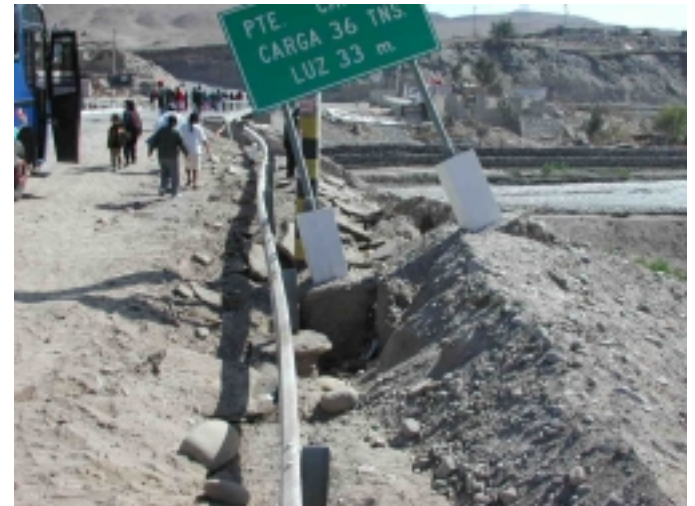
Fig. 9. Liquefaction-related damage at the Locumba bridge site.

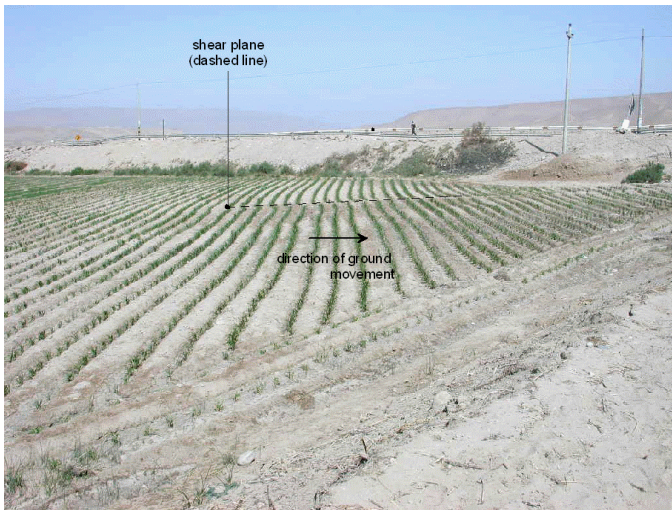
Fig. 10. Southeast view from a levee on the south bank of Locumba River showing ground deformation in a cornfield and damage to the south approach embankment.

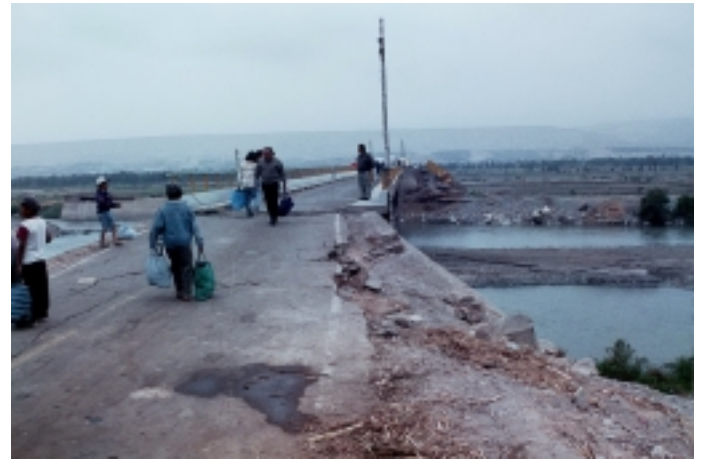
Fig. 11. El Fraile Bridge, damaged by liquefaction, was closed to vehicular traffic. A collapsed structure is faintly visible across the river to the right of the bridge.

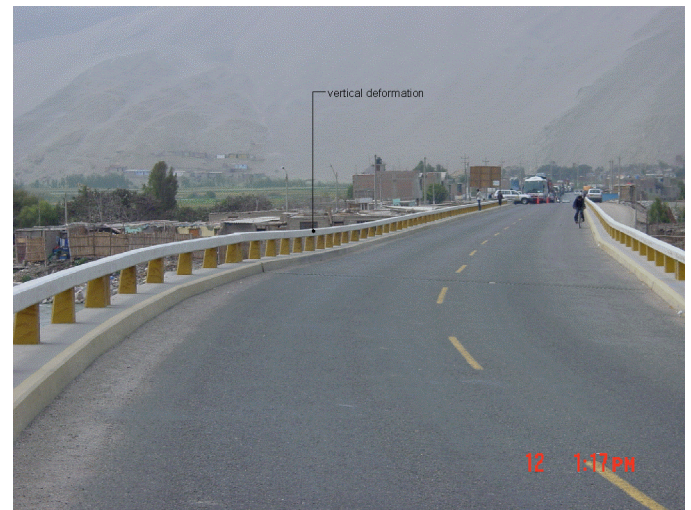
Liquefaction was also suspected as the cause of structural distress to the Ocoña bridge on the Pan-American Highway just north of Camaná (Fig. 12). The bridge is a relatively new 5-span reinforced concrete box beam structure. The mid-span support piers were likely founded on driven precast concrete piles, though this was not confirmed. Highway officials closed one lane of the bridge to traffic because of suspected structural damage. Liquefaction in the river valley was confirmed by the presence of numerous sand boils in cornfields upstream from the bridge site. Local residents reported similar occurrences of liquefaction on cornfields further upstream from the river, suggesting widespread liquefaction along the river channel. A drop in the road surface was seen near a mid-length support pier located below the bridge deck. The deformation patterns in the structure suggested that one or more of the middle support piers might have experienced a partial loss of foundation support, causing a significant vertical displacement. It appeared that little, if any, lateral displacement of the support pier occurred.

Fig. 12 Vertical deformation in the Ocoña Bridge probably resulted from liquefaction-induced foundation movements.
