(1988) - Second International Conference on
Case Histories in Geotechnical Engineering

A Soil-Structure Interaction Analysis of a Damaged Building

R.F. Wilson-Fahmy

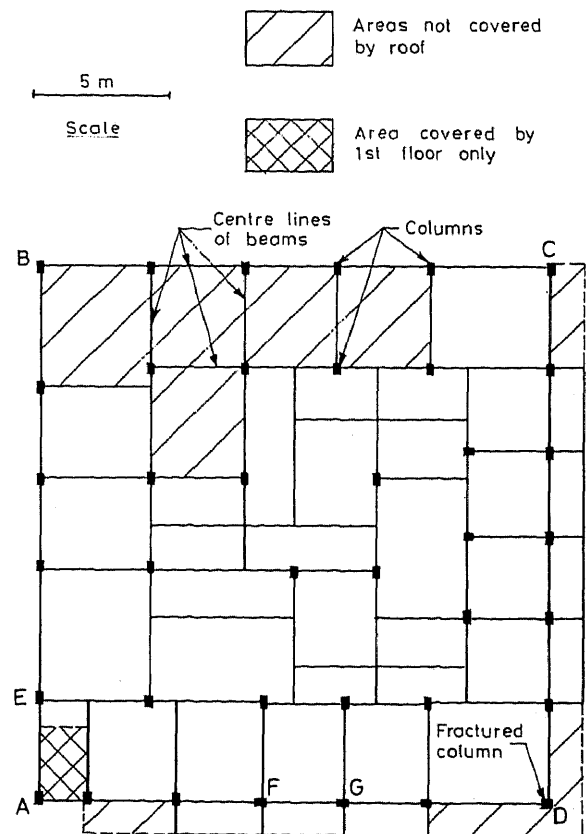
Fig.1 Locations of Columns and Beams

The building suffered from fracture of the ground floor corner column marked D in Fig. 1 after about 20 years in service. After the incident, the first floor was extensively supported by timber props to stop further deterioration of the building resulting from the column fracture.

Inspection of the fractured column indicated that it was weakened due to drilling of several relatively deep and large holes through the concrete for the purpose of fixing a heavy steel door.

Visible cracks in the reinforced concrete elements were limited. Serious cracks appeared only in the column marked B in Fig. 1 which is located at the farthest point from the fractured column. The cracks could be seen in all the floors just below the intersection of the column with the beams.

Inspection of facade AD (Fig. 1 and 2a) indicated that the building was leaning towards the fractured column. The horizontal movement of the point marked E in Fig. 1 and 2a at the roof was nearly 100 mm measured with reference to the adjacent building. The movement decreased downwards to reach a zero value at ground floor.

Settlement of the ground inside the building area was another sign of damage. The settlement was particularly irregular near side AD, Fig. 1. In the zone between columns F and G, the ground settlement was greater than in the surrounding area by about 150 mm. This figure may be indicative of the order of magnitude of the settlement and differential settlement of the foundations.

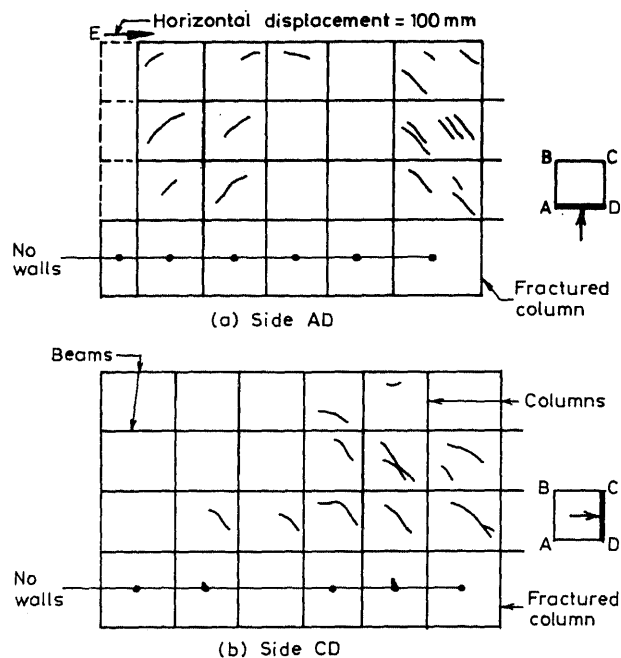
Fig.2 Cracks in Exterior Walls

The whole building was affected by the column fracture as evidenced by the wall cracks appearing everywhere in the building. Fig. 2 shows the pattern of cracks in the exterior walls at the faces AD and CD of the building. The inclination of the cracks indicates that the walls were subjected to shear deformations. As with the exterior walls, most cracks in the interior walls were also inclined. The crack width exceeded 10 mm in various parts of the building.

The predicted results shown in Fig. 6b for the wall panels in frame AD follow in general the same trend as those of frame CD. The observed crack pattern shows, however, some difference. Cracks are absent in panel P3 and P4 and the inclination of the crack in Panel P2 (Fig. 2a) contradicts that predicted. This is probably due to the high differential settlement between the columns in this zone. As previously mentioned, ground settlement in the region between columns F and G, Fig. 1 is greater than that in the surrounding area. Higher settlement of the columns in this zone with respect to the neighbouring columns could cause shear strains of signs opposite to those predicted in Fig. 6b and hence could be responsible for any local deviation from the overall pattern of deformations of the frame. It may be noted that the predicted direction of crack in wall panel P1 is in agreement with that observed, again, at low values of the modulus of subgrade reaction.

No predictions are made for the crack directions in panels M6 and P5 in Fig. 2a. It is interesting to note, however,

that the direction of the cracks in these panels would have been at right angle to those observed if related only to the deflection of the supporting beams which are acting more as cantilever beams after column fracture. This shows that the walls are probably subjected to the deformation mode shown in Fig. 5c as a result of the horizontal sway suffered by the building.

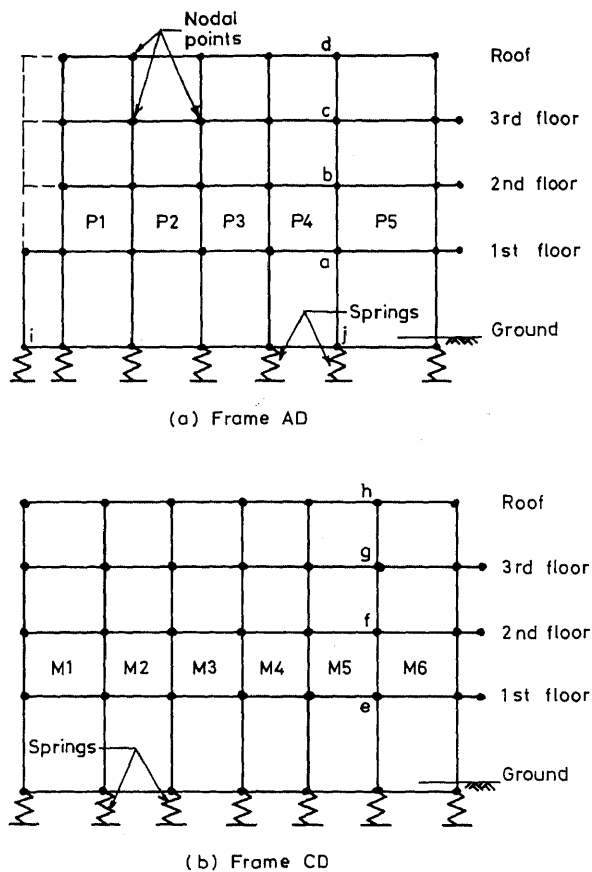
Fig.3 Idealisation of Frames AD and CD in Frame Analysis

The plane frame analysis was applied to the two exterior frames AD and CD intersecting at right angle at the fractured column, Fig. 1. The idealized representation of the two frames in the analysis are given in Fig. 3. The effective flange widths of T-beams and L-beams and the loads transmitted from the slabs to the beams were determined according to the Egyptian Code of Practice. The moment and shear just to the right of the nodal points marked a, b, c, d, e, f, g and h in Fig. 3a and b after column fracture were calculated in an approximate manner by treating the slab with the two beams originally supported by the column (Fig. 1) as a plate supported on two sides. The tables compiled by El-Behairy (1974) for plates under different support conditions were used in the calculations.

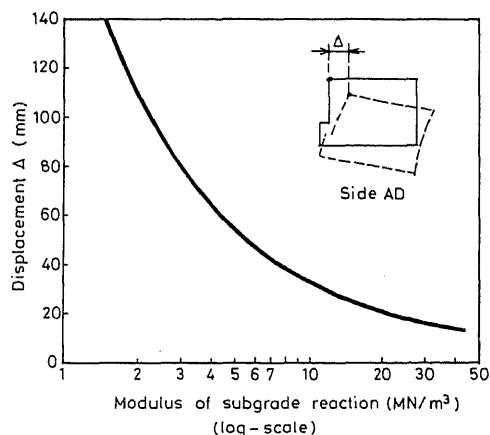
Fig.4 Relationship Between Modulus of Subgrade Reaction and Horizontal Displacement of Frame AD at Roof Level

The predicted relationship between the horizontal movement at the top of frame AD and the modulus of subgrade reaction k after column fracture is given in Fig. 4. It can be seen that the horizontal movement decreases greatly with the increase of the modulus of subgrade reaction k . The limiting case corresponding to unyielding supports gives a value of 6.5 mm only which is considerably smaller than the measured value (100 mm). Referring to Fig. 4, the modulus of subgrade reaction corresponding to this latter value is 2.2 MN/m³. The corresponding predicted settlements at nodes i and j , Fig. 3a are 2.7 and 13.2 mm respectively. These values are of the same order of magnitude of the observed ground settlement inside the building area.

The predicted horizontal movement at the roof level in the plane of frame CD is less than that in the plane of frame AD at all values of k . For example at k equal to 2.2 MN/m³, the former value is 51 mm while the latter is 100 mm. Unfortunately, verification of the ratio between the horizontal movement of frames AD and CD was not possible since no measurement was made of the movement in plane CD. Surveying instruments would have been required for taking the measurement.

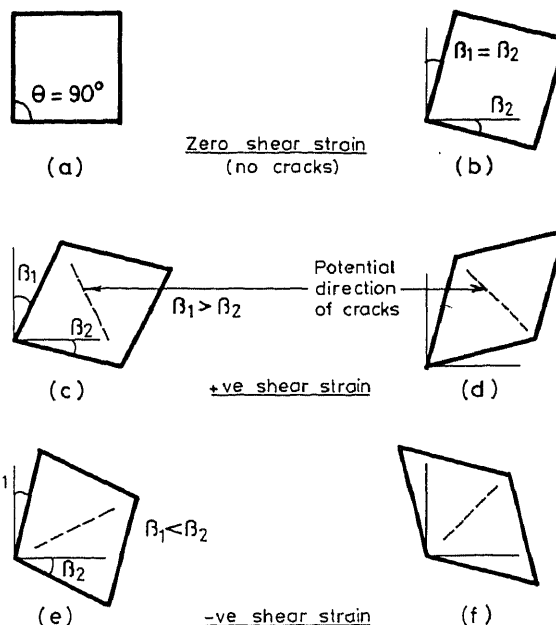
Fig.5 Wall Distortion and Potential Direction of Cracks

In order to overcome the difficulties involved in relating cracks solely to foundation settlements, the method shown in Fig. 5 is used. Each wall panel is considered as an element undergoing shear strain. The potential direction of cracks in the wall will depend on whether the angle θ , Fig. 5a, increases or decreases with reference to its initial value (90°). The increase or decrease of θ is assumed equal to the shear strain experienced by the wall element. Various modes of deformations and tilt are shown in Fig. 5 together with the corresponding potential directions of cracks and the sign convention adopted.
