Interaction with Nearly Environment and Old Structure for a Deep Excavation. Case History in Bucharest

INTERACTION WITH NEARLY ENVIRONMENT AND OLD STRUCTURE FOR A DEEP EXCAVATION. CASE HISTORY IN BUCHAREST

The paper presents the influence of a deep excavation performed in Bucharest on the adjacent ground and on some old buildings around it; the damages and effects appeared during the excavation and the remedial measures are presented in detail, too. The excavation was designed to be 16.15 meters deep, sustained by a slurry wall enclosure of 60 cm thickness and pre-stressed anchors, and steel struts. Due to an accident that occurred to the trench walls, a thorough monitoring by instrumentation started. The results of this monitoring are shown.

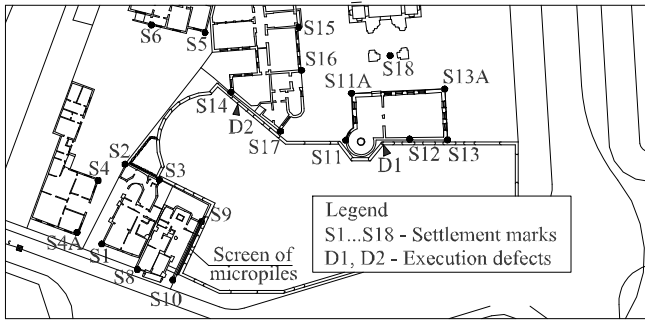
Fig. 5. Surveying marks and technological events location

The Fig. 5 shows the location of the principal settlement marks, installed on the most sensitive buildings.

The most important technological incidents were:

- the execution of the anchors (5 levels A1-A5) below the underground water level was done with important loss of water and granular material (fine sand) during the drilling; it was approximated that volumes between 0.50 to 1.00mc of lost material remained uncompensated for each anchor;
- defects in the slurry walls, located between 13.50m and 16.15m deep, consisting in openings (holes) 0.30m to 0.50m wide (D1, D2); because of the high hydraulic gradient and of the corresponding pressures of the saturated ground (about 100kPa), important volumes of water and solid material flooded into the excavation area.

Analyzing the two types of technological incidents it results that the excavation influenced the surrounding area, especially the foundation ground of the old buildings, with very sensitive structures.

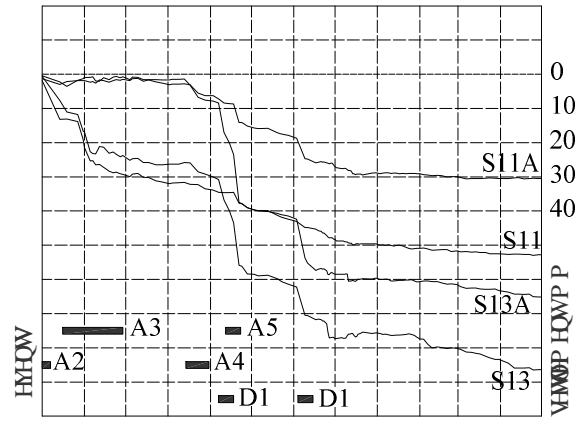
Fig. 6. Settlements evolution Armenian Library

In the Figures 6, 7 and 8 is represented the evolution of the settlements related to the mentioned technological incidents, leading to the following conclusions:

- for the Armenian Library, the drilling of the 3rd level of anchors (-10.55m) and the excavation, lead to an increment of settlements from 2.50 to 3.00cm; it is important to notice the strong influence of the defect in the slurry wall (D1), leading to an increasing of the settlement from 3.00 to 3.50cm (see Fig. 6);
- for the Armenian School, starting with the execution of the 3^d (-10.55m) and 4^h (-11.95m) level of anchors some increase of settlements have been recorded, from 1.00 to 1.50cm; the defect (D2) in the slurry wall had a strong influence, the settlement increased with 6 cm (see Fig. 7);
- for the Armenian Church, situated at about 20.00m distance from the excavation, the major defect D1 in the slurry wall had an important effect, with an increment in settlement of 2.50cm (see Fig. 8); the drilled anchors had less effect (settlement recorded were about 0.50cm).

After the remedy measures, the slurry wall enclosure remained stable, and the settlements of the affected buildings recorded a stabilization trend during December, 2001 (see Figures 6, 7, 8).

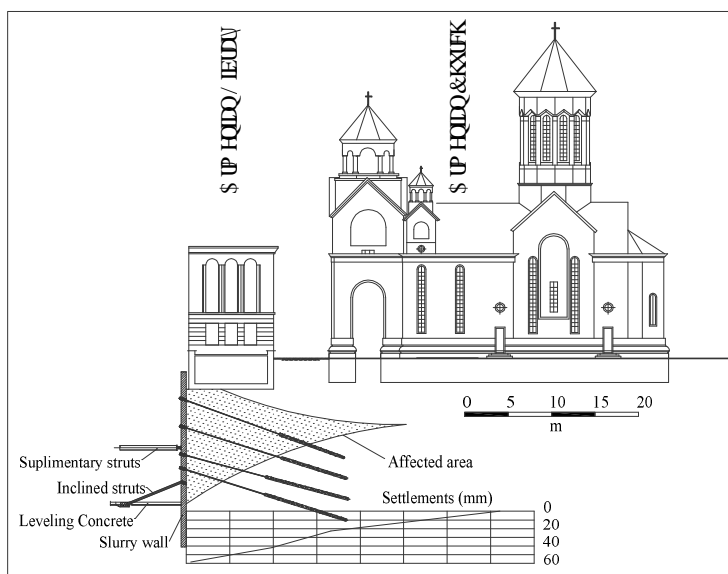
Fig. 9. Average settlements, influence of the defect D1, affected soil area

In the presented case, the major defects in the slurry walls, positioned unfortunately in the most sensitive area, lead to important loss of material and implicitly to settlements and damaging of the adjacent buildings; the influenced area was up to 20-25m from the excavation (Fig. 9).

- In order to restore the ground characteristics in the excavation surrounding area, a soil grouting program has been established, using a grid of vertical injectors from 6.00m to 8.00m deep; this program was based on the results of repeated dynamic penetration tests made on site, showing the most affected areas after the technical incidents (Fig. 9).
