(1998) - Fourth International Conference on
Case Histories in Geotechnical Engineering

A Slope Instability Case History Involving Swelling Clay in Southern Brazil

A SLOPE INSTABILITY CASE HISTORY INVOLVING SWELLING CLAY IN SOUTHERN BRAZIL

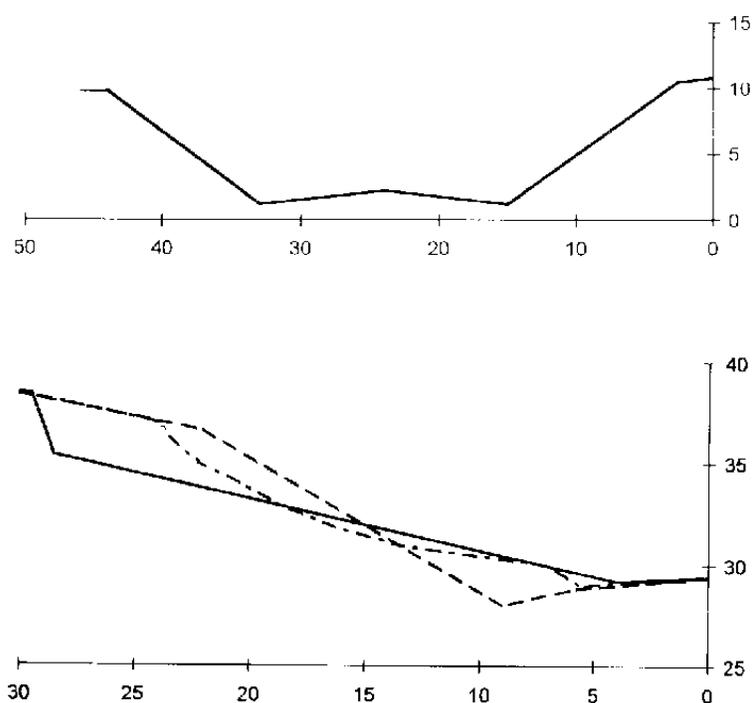
In 1993, during the construction of RS-736, a single-carriage road in the center of Rio Grande do Sul state, 2 cuts were made through 3 sedimentary layers near the town of São Jerônimo. The first cut was 340-m long and the height was about 9 m. The second cut was about 180-m long and 8-m high. During construction, the cutting operation was difficult, suggesting high *in situ* shear strength. As a result, relatively steep slopes (about 40°) were built. Some time after road opening both cuts showed increasing signs of slope instability. The second cut failed completely about one year after construction. Figure 1 outlines the cross-section of both slopes. The change of geometry of the second slope - which was monitored over a 4-year period - is also shown in Fig. 1.

accumulation of rain-washed debris near the slope base. Blocked surface drains was the main consequence of debris accumulation. Once each wedge had moved, undisturbed soil was exposed, and the degradation process was renewed. As a consequence, the slope geometry near the base slowly changed until a second, more significant failure mechanism was triggered. This consisted of a larger, deep-scated failure with low shear strength mobilized along the slip surface. The third failure mechanism was the subsequent toppling failure of the upper stronger layers. The whole process was retrogressive, becoming active mainly after heavy rainfall and also after debris accumulated on the road were cleared (see Fig. 1).

Fig. 1 São Jerônimo slope failure: cross-sections of both cuts.

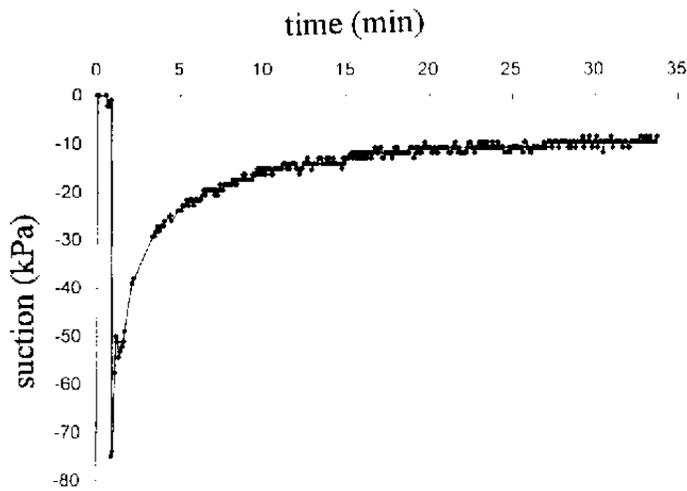
diameter cutting tool (described by Ridley and Burland, 1995) was afterwards used to excavate a small extension to the bottom of the initial borehole. The suction probe was inserted in the PVC tube and then carefully lowered into contact with the soil. In order to achieve good contact between the probe ceramic disc and the soil, this disc was previously coated with a kaolin paste. This procedure caused a small amount of disturbance to the local suction, and this took about ½ hour to approach the in situ value (Fig. 2). Equilibrium suctions were low, with values between 10 kPa and 14 kPa. These measurements were made after the 1996 end-of-winter heavy rainfalls. At that time, the failure process was particularly active in the second cut.

Fig. 2 Layer 2: measurement of suction.

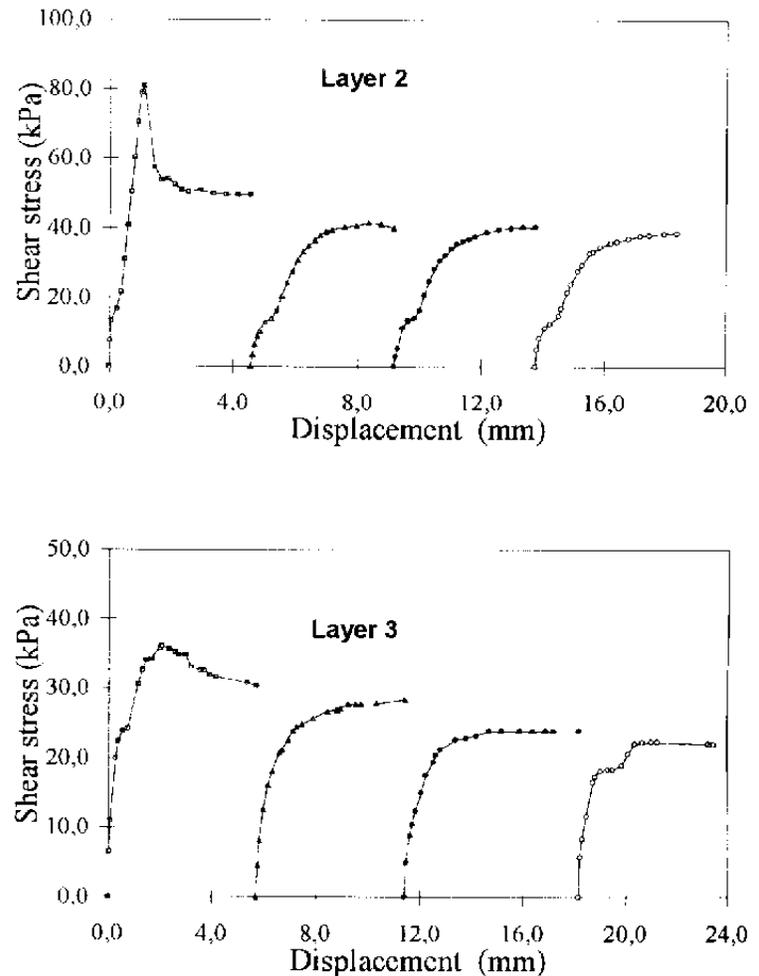
The second series of laboratory tests was carried out using undisturbed samples taken from the second cut (for layers 2 and 3). This series included the evaluation of residual shear strength for both layers. Direct shear tests were performed according to the multiple reversal technique suggested by Skempton (1964). At least 3 shearing reversals were applied to each specimen, as shown by Fig. 3. It can be noticed that layer 3 has a very clear post-peak decrease in shear strength, up to a total displacement of about 25 mm. For layer 2, there

is a smaller post-peak decrease in shear strength, stabilizing after a displacement of about 10 mm.

Fig. 3 Shear stress x displacement curves obtained with multiple reversal direct shear tests (for $\sigma'_n = 50$ kPa).

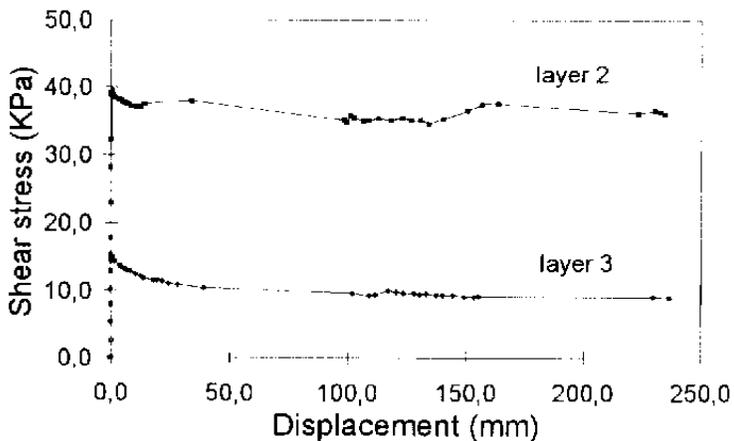
Further tests were carried out using Bromhead's ring shear apparatus (Bromhead, 1979). Results of these tests are shown in Fig. 4. For layer 2, little loss of strength was observed even after a total displacement of 250 mm. On the other hand, layer 3 showed a significant reduction of shear strength for large displacements, characterizing the mobilization of residual shear strength. The residual angle of internal friction of this layer was about 14° (as evaluated by direct shear tests) or 11° (as evaluated by ring shear tests).

Fig. 4 Shear stress \times displacement curves obtained with ring shear tests (for $\sigma'_{vn} = 50$ kPa).
