International Conference on Case Histories in Geotechnical Engineering (2008) - Sixth International Conference on Case Histories in Geotechnical Engineering

Horizontal Translational Failures of Levees Due to Water Filled Gaps

HORIZONTAL TRANSLATIONAL FAILURES OF LEVEES DUE TO WATER FILLED GAPS

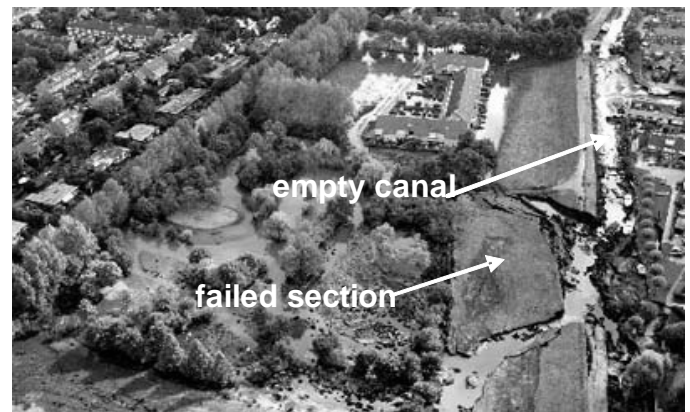
In the summer of 2003, a peat dyke at Wilnis in the Netherlands failed during a very dry period. The failure mode was not a Bishop type circular failure used in routine dike stability analyses in The Netherlands, see figure 1.

The failed dike segment was displaced horizontally over 6 m. The failure plane was found to lie at the boundary between peat and the underlying sand. It was concluded that a chain of events including weight loss and shrinkage of the peat, due to the dry weather conditions, are considered important factors causing failure. Analyses of peat behaviour made it clear that several processes, controlled by hydrological conditions in the unsaturated and saturated zones in the embankment, resulted in fracturing of the peat. The fracturing, along with a very high-strength anisotropy of the peat, resulted in a connection between the water in the canal and the water in the sand,

meters, allowing the dike to simply 'float' away for over 5 m, pushed by the water in the canal. A detailed description of this failure can be found in Bezuijen et al. (2005).

Fig. 1. Failed canal dike at Wilnis, August 2003.

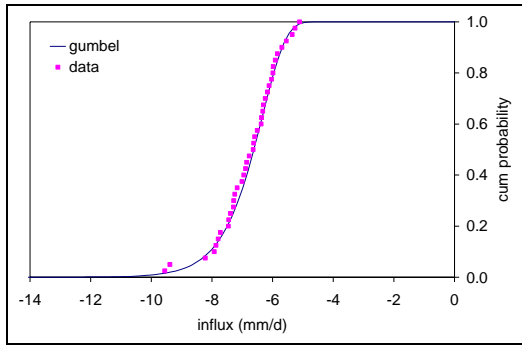
Precipitation and evapo-transpiration data were analyzed over a period of 40 years. For each year, maximum net precipitation and maximum net evapo-transpiration data were assembled in a histogram. Figure 5 shows the cumulative frequency distribution of maximum values of daily outflux data per year and the fitted cumulative Gumbel distribution.

Fig. 5. Extreme daily inflow data

The maximum difference in position for extreme loading occurring only once every 400 years gives a difference in the position of the water table of 1.3 m.

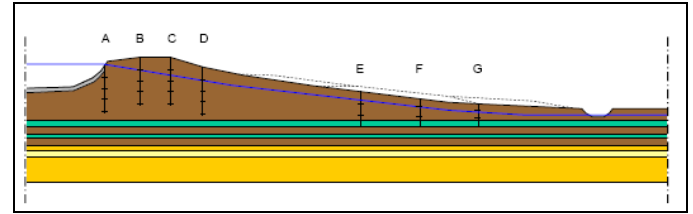
The question remains whether or not a shrinking crack in a longitudinal direction can initiate a stability problem. Therefore, for the Wilnis case, a number of FEM calculations have been made with cracks from 2 to 4 m deep (see figure 6); the cracks are numbered with letters A to G.

Cracks E, F, and G reduce the initial stability; but due to the deformations, these cracks will close with little influence on the final stability.

Fig. 6. FEM calculation, A to G represent cracks in geometry.

The influence of water in Crack B is studied. If the crack is fully filled with water, the influence on the calculated safety factor is a reduction of 16%, which is a substantial reduction.

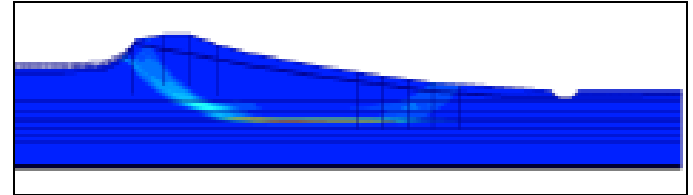
In figure 7 the shear strain is shown for the situation without cracks. Cracks A and B give a small reduction of 2 to 3% in the safety factor; for Cracks C and D the reduction is 1% or less. Furthermore, the calculations show that Cracks C and D will close due to deformations. This means that during a real stability problem in the levee, Cracks C and D will also close.

Fig. 7. Calculated shear strain.

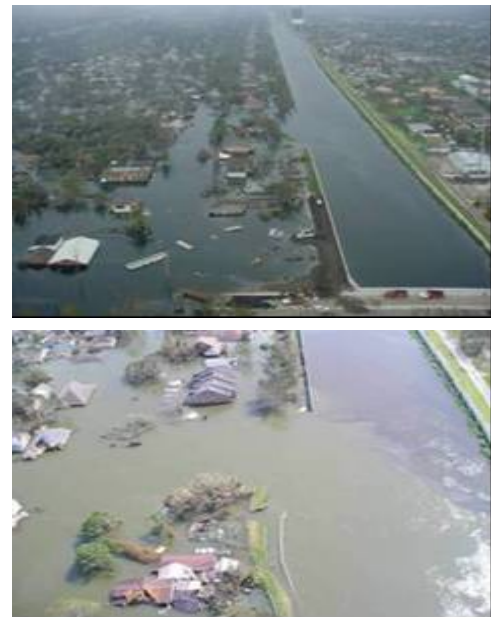
Observations made of the breach at the 17th Street Canal show that the most likely cause of the breach is a soil foundation failure. Figure 10a shows an aerial photo of an approximately 450-ft (140-m) breach in the floodwall along the east side of the 17th Street Outfall Canal south of the old Hammond Road Bridge. Figure 10b shows that a section of levee has moved more than 40 ft (12 m) inward to the landside. It appears that the water flowing through the breach washed away the remaining levee section making up the breach. The top of the I-wall section of the floodwall in the breach can be seen adjacent to the levee section that moved into the landside.

Fig. 10. (a) aerial view of breach, (b) aerial view showing I-wall and embankment translation.

After the emergency closure was complete and the water levels were drawn down, large blocks of the marsh were found strewn in neighborhoods surrounding the breach. A close examination of the marsh blocks revealed that an approximately 1-ft (0.3-m) clay layer was attached to the bottom of the marsh blocks. In order to inspect the failure plane or zone, a backhoe trench was excavated to expose a vertical surface through the slide block. Observations made in the trench confirmed that a portion of the clay layer, which was initially located beneath the marsh layer, was displaced upward and over a portion of the marsh layer by the lateral displacement that occurred during the failure. The failure plane of the slide block was within the clay under the levee, and the failure plane came upward through the marsh layer further landward.

Eyewitness reports indicate that the breach began to develop about 6:00 a.m. on Monday, 29 August 2005, and was fully developed before 9:00 a.m. Field evidence, analyses, and physical model tests show that the breach was due to instability caused by shear failure within the clay in the foundation beneath the levee and the I-wall with a rupture surface that extended laterally beneath the levee and exited upward through the marsh layer. A key factor in the failure was the formation of a gap between the wall and the levee fill on the canal side of the wall, which allowed water pressure to act on the wall below the surface of the levee. Another important factor was the low shear strength of the foundation clay beneath the outer parts of the levee and beyond the toe of the levee.
