International Conference on Case Histories in Geotechnical Engineering (1993) - Third International Conference on Case Histories in Geotechnical Engineering

## Geotechnical Problems in the Construction of Underground Structures

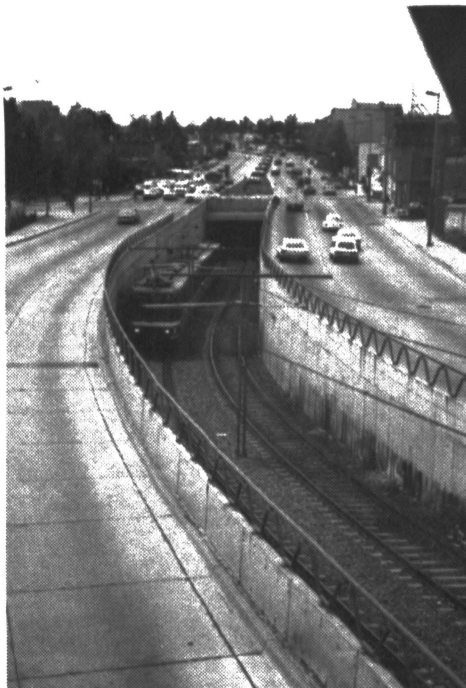
The government of the State of Jalisco, constructed in its capital city, Guadalajara, the line 1 of the urban electric train in which development was a tunnel of approximately 8.0 km from which were constructed 7.0 km in the first step and the rest during 1987 (Fig.1) in which it had to work in bigger depths than groundwater level that is why since the construction began, there were very serious problems.

Fig. 1 Tunnel in Operation

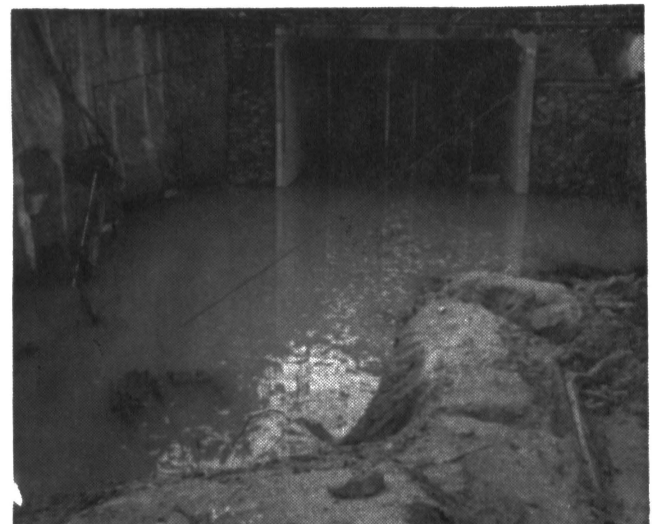
Due to the presence of high subterranean water volumes (Fig.2) solutions, as to place rockfills in some places, in other, fillings surrounding to the tunnel were grouted, install of pumping equipments and place a section of a diaphragm wall formed by cast in situ piles, had to be improvised.

Fig. 2 Water Inflow during Constructive Process

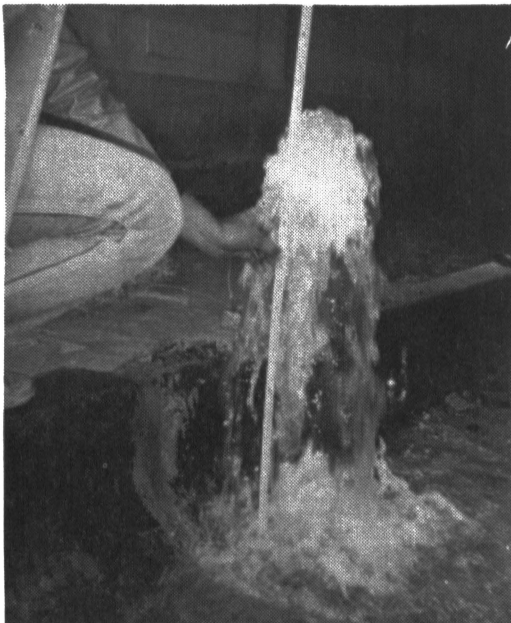
The water continued entering through the construction joints or openings of the false work - bad plugged, with a pressure that was making the access conduits more extended and with a major volume through the floor slab (Fig.3) and through the walls up to an approximately height of 3.0 m.

Fig. 3 Water Inflow Into the Tunnel

Due to the above, the conclusion is that the water streams toward the interior of the tunnel, caused the dragging of solid particles of the surrounding soils to the structure, this began in the discontinuity that formed the border between a rigid medium (concrete walls and floor) and the soil, which fine particles begin to displace within the soil matrix toward fissures, cracks or coarser layers, that if it continue progressing could collapsed the structure.

After these proofs, with the drain system working, the complete box was impermeabilized, the joints cracks and orifices, etc. were sea-

led to preserve dry the interior of the tunnel, as to oblige the water to flow through the drainage system.

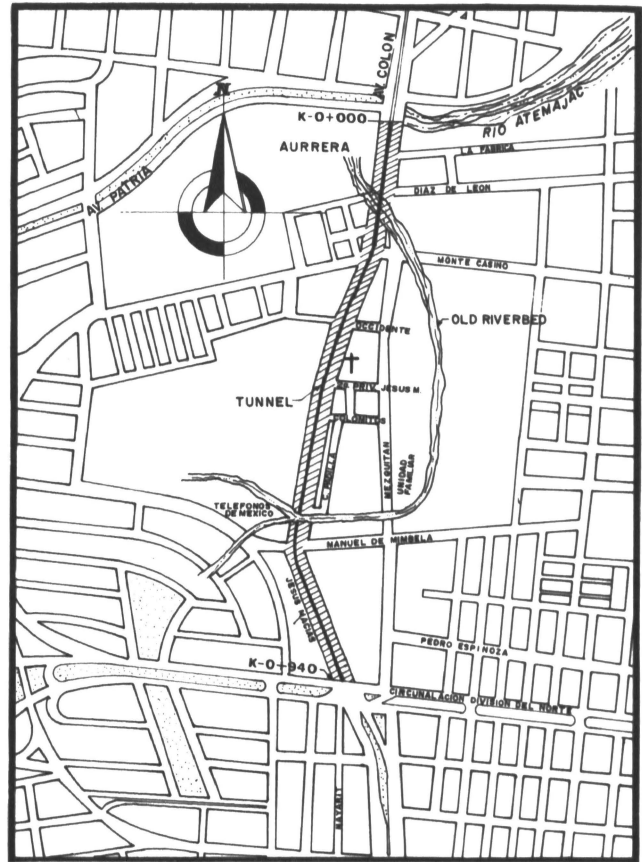
The analysis of the air photos, taken in 1941, - showed that in this area it existed an important stream (Fig.4) affluenty from Atemajac River, in which development crosses twice the outline of -

the tunnel, and is observe tracks of its stream bed, west of the structure. During the excava - tions a bridge that was used to cross the stream mentioned, was founded.(Fig.5)

Fig. 4 Location of the Tunnel and Old Riverbed

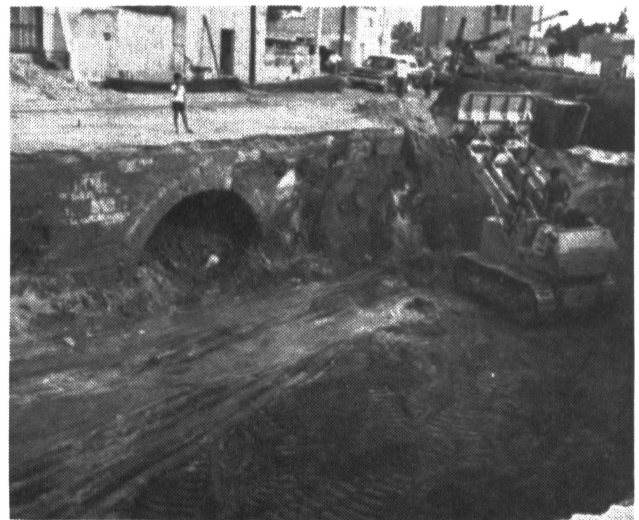
Fig. 5 Buried Old Bridge

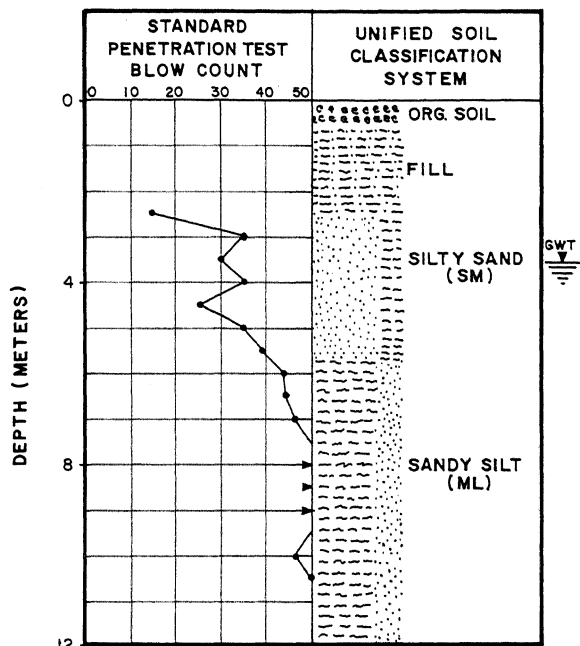
From the studies of the subsoil exploration previous to the construction a typical profile is shown (Fig.6), in which can be seen the superior part of the subsoil formed by urbanization fillings with depths of 2.0 to 5.0 m, and from this level a layer of silty sand of medium relative density (12 to 30 blows standard penetration test) of approximately 3.0 m of thickness and from this cotta up to the finals of the boring, a sandy silt formation, light brown and relative density medium to high (more than 40 blows) is founded. The groundwater level was founded in a medium depth of 3.5 m.

Fig. 6 Typical Soil Profile

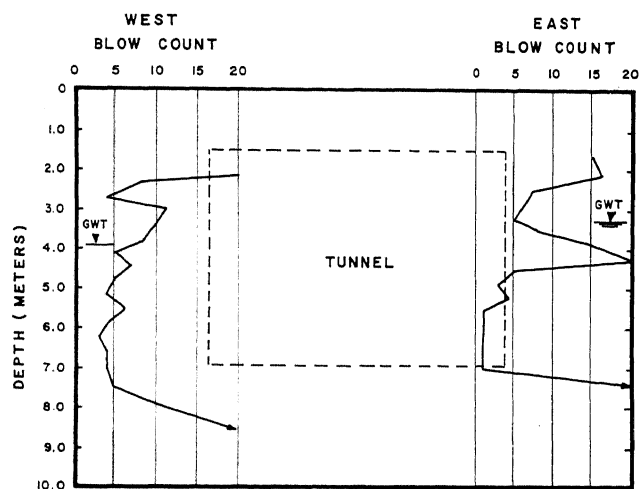
In relation with subsequent borings in Fig.7, are presented the standard penetration tests, performed in the surrounding soils of the tunnel, to analyze the grade of compaction of the fillings. The graphic study, showed that the relative density is very heterogeneous with low values in some zones, where the measured resistance in these tests, tended to zero, being more critical the east side of the structure.

Fig. 7 S.P.T. Results on Tunnel Surrounding Fills

For the surrounding soils to the tunnel with the data of the realized tests and considering a piezometric height of 3.50 m on the floor level, the estimate factor of safety, FS, varied from 0.54 to 1.59 with a medium value of 1.02,

this indicates that in some zones there was dragging of solid particles.

Even if the compacted fillings remained up to its maximum density, this would not be sufficient to avoid the hydric erosion, so in this case, it should be very convenient to make the fillings of the tunnel with a soil-cement mix.

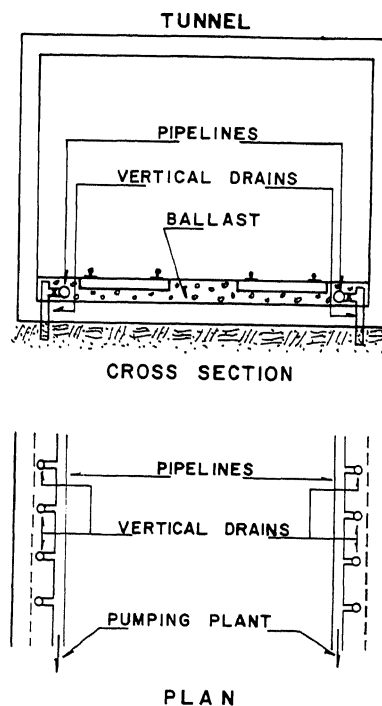
Fig. 8 Drainage System

The first implemented solution was taking advantage of the ballast bed (0.50 m), that covers the floor slab of the box, to install two lines of verticals drains connected to the longitudinal pipe lines, that discharged in the pumping deposits, where the water dislodges to be used in the irrigation of gardens. (Fig.8)

The drain consists in a vertical perforation through the floor slab down to a depth of 1.0 m. In which is inserted a perforated steel galvanized pipe of 0.025 m, diameter and wrapped in geosynthetic to avoid the migration of solid particles as the prompt obstruction of the pipe.

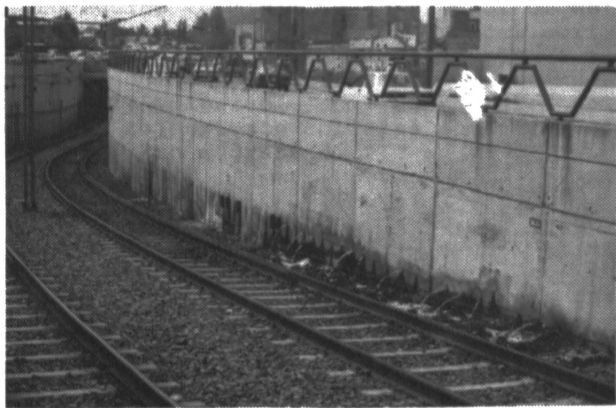
The tunnel has been functioned for four years and the operation of the urban electric train have not been interrupted (Fig.1) but there are problems that have been solved in the best possible way, as some settlements on the pavement of Calzada del Federalismo, due to displacements of the fillings that are being repaired with asphaltic mixture. Other situations were presented when the drainage system had to be suspended temporarily, due to failures in the pumping deposits, because water begins to flow immediately to the interior of the box, as shown on Fig.9.

Fig. 9 Water Inflows Into the Access Ramp
