## Damage of Governmental Building Due to Geotechnical Properties (Case History)

## **DAMAGE OF GOVERNMENTAL BUILDING DUE TO GEOTECHNICAL PROPERTIES (CASE HISTORY)**

This paper is a case study for a governmental building in a site located at Katamia zone (an extension of Great Cairo, Egypt). The site is belonging the Great Cairo Bus Station under the authority of Ministry of Transportation. It consists of two buildings and a shed for buses cleaning and lubrication. The buildings had been constructed since 15 years. However after two years of construction many cracks were noticed in the main building. Furthermore, after another few years, sever cracks had appeared in different parts of the building and the concrete water tank on the roof of same building had suffered from failure. The aim of this study is to know and examine the reasons of these cracks and damages which happened to the building, particularly the other building suffered no cracks or damages although it was built on the same soil and under the same conditions. Observation of the building movements were recorded over several years as well as soil investigation around and under the building. A structural analysis and

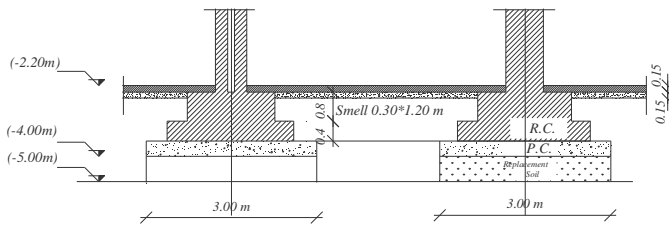
Fig.( 2 ) Excavation around foundation

Around representative number of footings excavation were made until the replacement soil. It was found that the level of plane concrete is 5.5 m below the ground surface. The thickness of replacement soil was about 0.75-1.0m beneath the foundation which consisted of sand and gravel (coarse gravel and medium sand). It was found mixed with water and oil. The reinforced concrete was strip footing, Fig. (2).

As well as no field tests were performed on it. This resulted in an engineered fill with low relative density. Moreover, the replacement soil has absorbed water and oil from changing the oil and washing of the buses which infiltrated in the soil and was collected under the foundations. Also the seepage of water from the ground water tank near the building increases the problems to this stage.

The water and the oil were mixed with the replacement soil and lose a big part of its strength and it settled due its small relative density. As a result, the soil under the foundation had no clear trend, as noticed from the patterns of cracks and deformation which happened to the super structure in the form of swelling and /or settlement and rotation.

The thickness of soil replacement is considered as an effective way in reducing the effect of swelling provided that it must be compacted to the required relative density and must be horizontally confined.

All precautions must be undertaken to prevent water and other liquids to infiltrate to foundation soil and/or replacement soil.

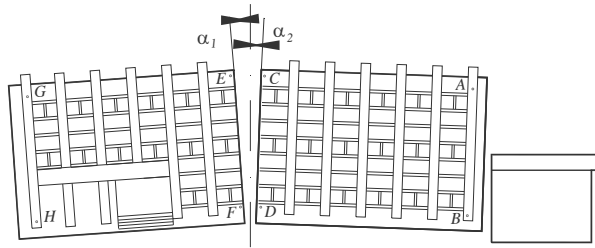
Fig.( 5 ) The Locations of The monitoring Points as well as The Direction of movement of the Building

The building has two expansion joints which were divided into three parts. Twelve points have been used for monitoring the deformation and vertical movement of the building as shown in Figs. (4&5). For the third part, the vertical movement of points (1,2,3,and 4) was greater than the other two parts.

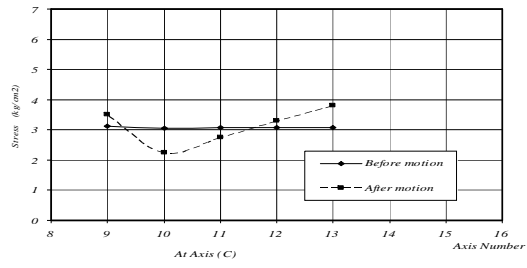
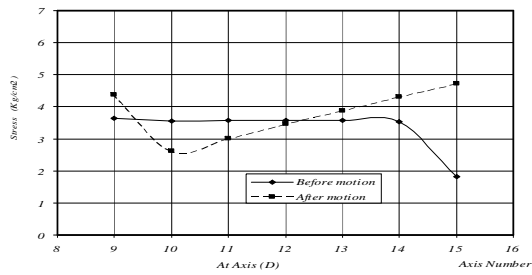
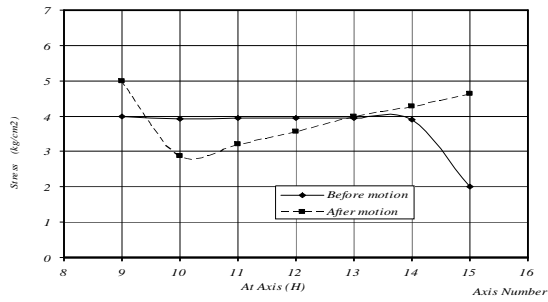
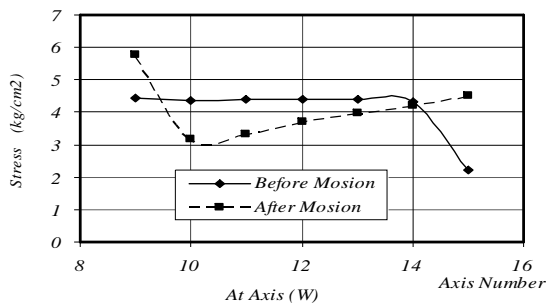
Fig. 8. Stresses before and after movement

As it was noticed the biggest settlement occurred at points 3 and 4 on axis number 15, where there was a big change in stresses. An increment nearly about 50% and sometimes is more than that. For the column at point (1) beside the expansion joint at axis number 9', it was broken near the beam as shown in Pho. ( 2).

The volume change of soil resulted in movement of the building and caused the expansion joint to open and displaced at the top by 43 cm, the inclination, Pho. (1) This combined movement caused the redistribution of loads and stresses under the foundation as shown in Fig. (7) which caused some concrete elements to break Pho. (2). This was the main reason that caused the damage to the building and the failure of the upper water tank Pho. (3). Beside, the lack in the number of ground beams (semelles) connected to the foundation, especially those near the expansion joint resulting in decrease the rigidity of the foundations.

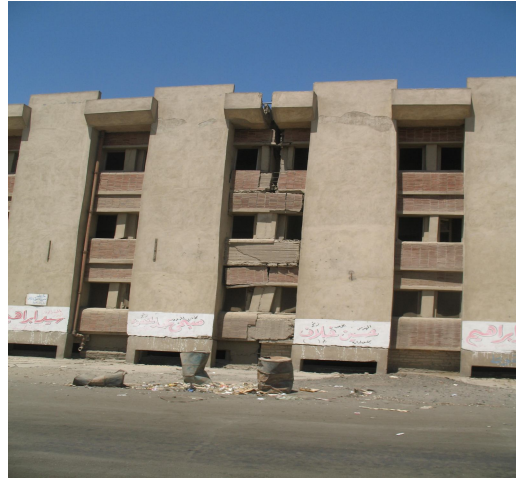
Hundreds of cracks appeared in the brick walls and some concrete elements of the building as shown in Pho. ( 1, 2 & 3). In addition to the big displacement of the expansion joint of the building not only wide opening with significant damage to wall and concrete element were recorded, but also adjacent rupturing of the conduits and other services in the building were found. This analysis of crack pattern in the walls proved to be crucial in order to judge the cause of the problem.

Photo 1 An increase of expansion joint

Intensive care should be paid to assure that the foundations are adequately tied together, especially near the locations of expansion joints. This would result in the increase of the rigidity of the foundations and consequently, the overall rigidity of the structure to resist differential settlement.

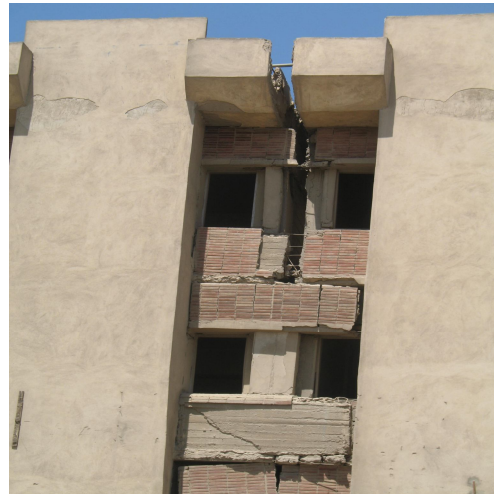
Photo 2 Break of beam and column near expansion joint.

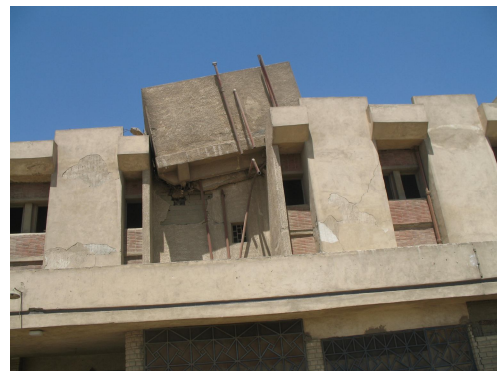
Photo 3 Failure of tank at the roof
