Failure of an Embankment on Soft Clay

M. K. Yegian

Hugo Perez Lasalvia

SYNOPSIS The failure of an embankment during its construction on soft clay foundation is investigated. Field and laboratory data are used in conventional slope stability analyses to explain the cause of the failure and to evaluate the in-situ undrained shear strength of the clay which was later used in the design of the replacement dike. The results indicate that whereas the stiff embankment having a well compacted core was initially stable on the soft clay, subsequent cracking of the core due to undrained deformations reduced the shearing resistance of the dike thus, initiating the failure. The dike was eventually reconstructed in stages allowing enough time between stages for the foundation clay to consolidate and increase its shear strength. In the new dike a granular material was used in order to provide flexibility and to prevent cracking of the dike. In addition, long berms were placed on both sides of the dike to increase its stability. Field instruments including piezometers and inclinometers were used to monitor the rate of the stage construction of the new dike.

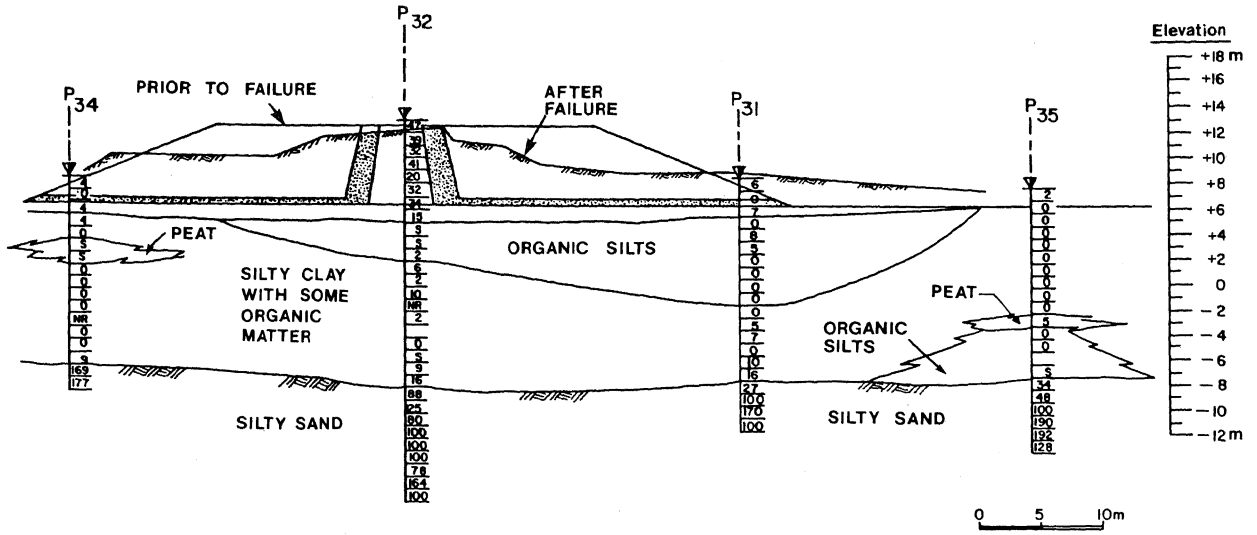
Figure 1 Cross-section of Dike Prior to and After Failure

Two and a half months after construction had started, a large section of one of the dikes, failed by sliding into the lagoon. The height of the 400 meter long dike at the time of failure was about 7 meters, (4 meters below the final design crest elevation). The dike consisted of a well compacted clay core and shell of sand, gravel and rocks. Immediate attempts made by the contractor to reshape the dike and to continue its construction resulted in similar failures in the same zone as that of the initial failure. Following these failures, extensive field and laboratory investigations were made, including; soil boring, sampling, testing and installation and monitoring of field instruments. The information obtained from this subsurface exploration program was then utilized in geotechnical engineering analysis and the causes of the failure of the dike were identified and an alternate design and construction procedure was adopted and the

Immediately after the failure of the dike, topographical data was acquired and the extent of the failure of the dike and its shape after failure were established as shown in Figures 1 and 2. Following this, standard penetration tests were made using a sampling spoon of 2-in OD with a 140 lb. weight hammer falling 30 inches. Figures 1 and 2 show the locations of a few of the bore holes and their corresponding logs. In addition to the Standard Penetration Tests, geophysical investigations were conducted along a number of traverses and the thicknesses of different soil layers were estimated as shown in Figures 1 and 2.

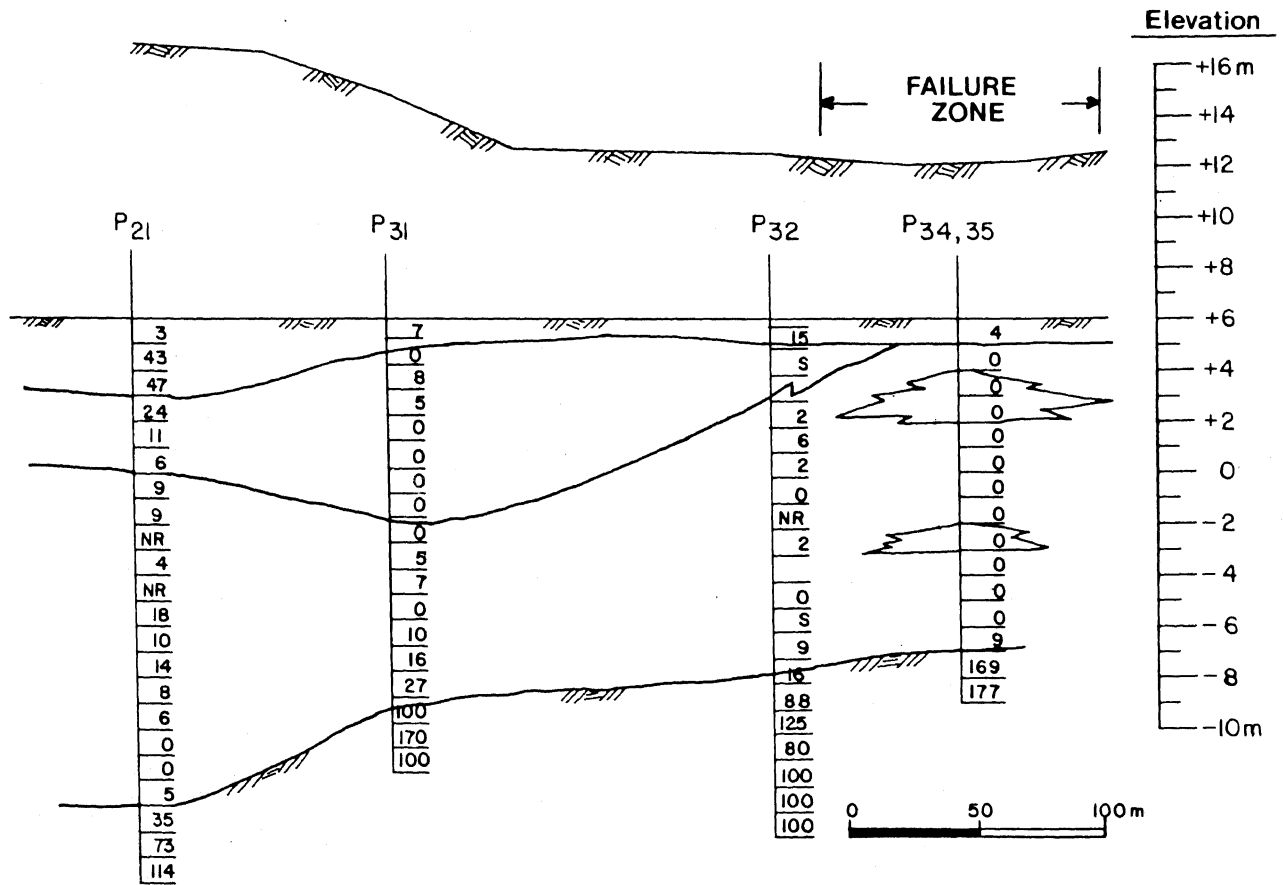
Figure 2 Subsurface Profile Along the Longitudinal Axis of Dike

Based on these field investigations and visual inspections of samples of soil retrieved from the field tests soil profiles were prepared as shown in Figures 1 and 2. In summary, the site consists of flood-plain deposit of low-to-medium plasticity silts and silty clays containing some organic matter and interrupted by layers and

pockets of peat. In many of the bore holes the clay foundation soil was so soft that the standard penetration tests could not be performed. Underlying this 14 meter thick foundation soil is a very dense silty sand.

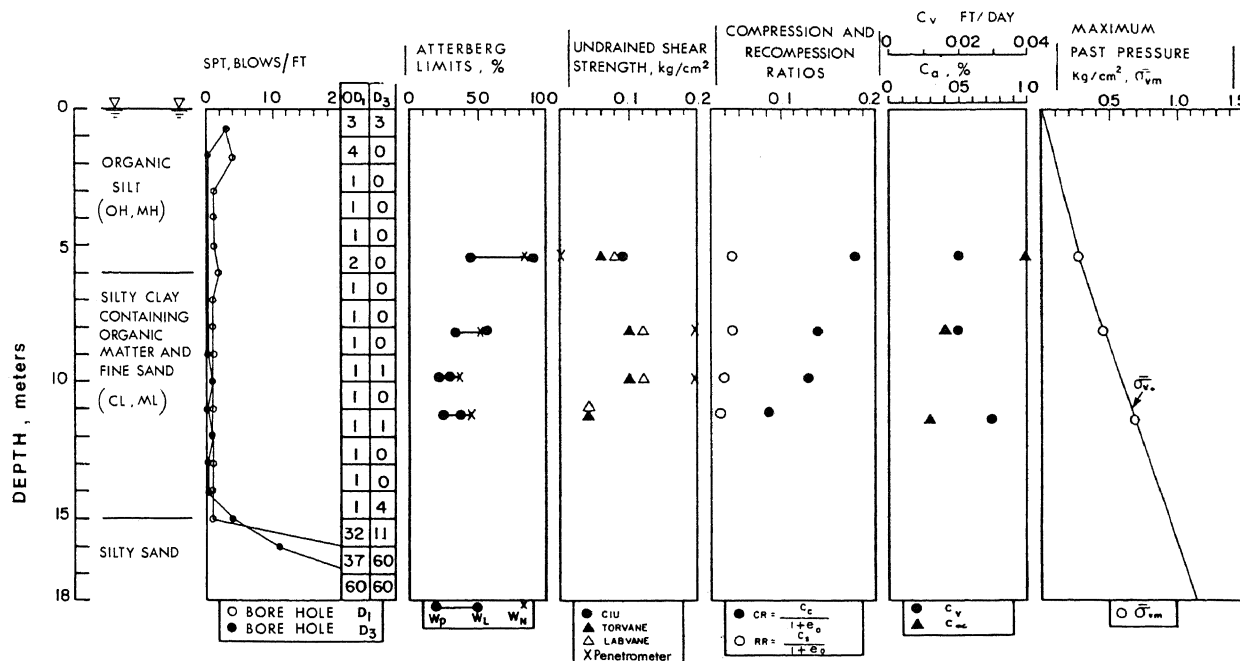
Figure 3 Summary of Results from Laboratory Soil Tests

For purposes of laboratory studies, undisturbed soil samples were obtained using 3-inch diameter Shelby tubes. The laboratory testing program included the determination of: Atterberg limits, strength tests, consolidation tests, organic content and clay mineralogy. Figure 3 summarizes the laboratory test data. Based on these tests it is concluded that the silty clay encountered in the foundation of the dike is very soft and may even be "underconsolidated" at shallow depths. The undrained shear strength of the clay normalized with respect to the vertical normal effective stress is estimated to be about 0.25. The effective stress strength parameters of the clay are estimated to be, cohesion intercept, $\bar{c} = 0$ and friction angle, $\bar{\phi} = 26^\circ$.

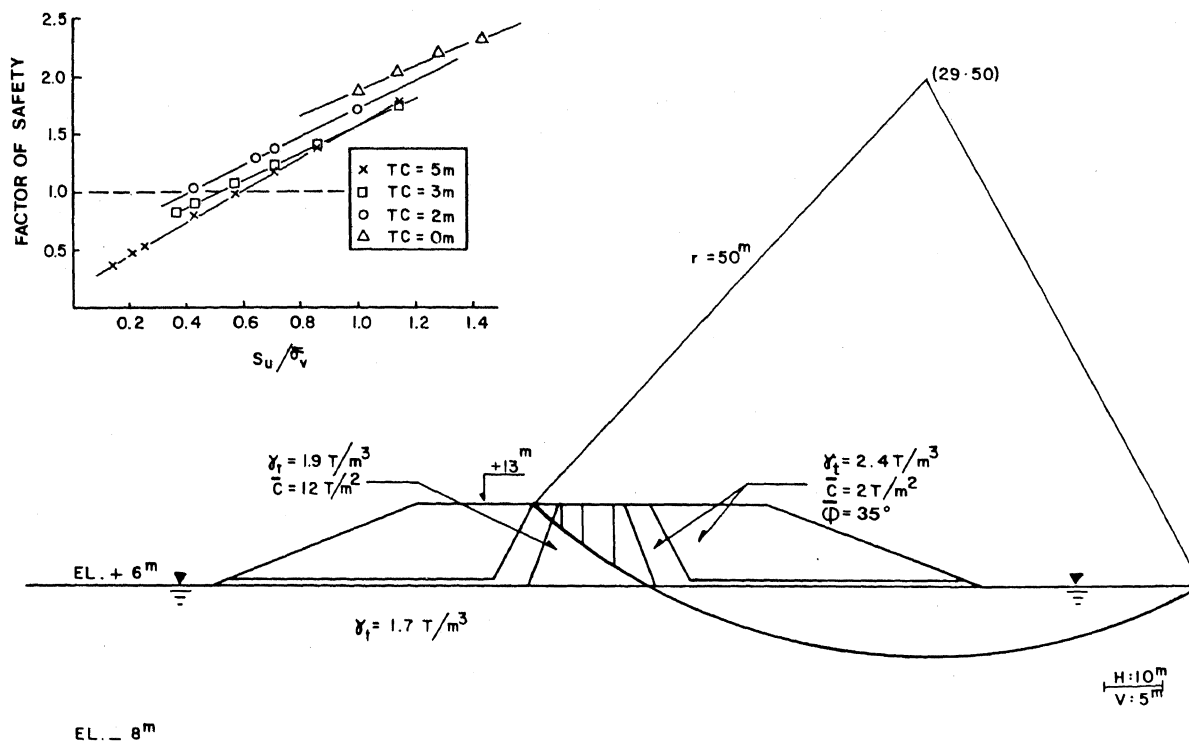
Figure 4 Total Stress Stability Analyses of the Dike, Prior to Failure

In order to explain the cause of the failure of the dike and to evaluate the in-situ undrained shear strength of the foundation clay, total stress stability analyses were made using the original design cross section of the dike prior to the failure. Figure 4 shows the cross section analysed and the material properties used. In view of the fact that the dike at this stage of its construction failed, the factor of safety must have been less than unity (F.S. < 1.0). Thus, in order to estimate the in-situ undrained shear strength of the clay, the factors of safety against instability were computed for different possible values of the undrained shear strength. Since the clay is normally consolidated, the undrained shear strength was assumed to increase with depth by a constant ratio of $S_u/\bar{\sigma}_{vo}$. The undrained strength at elevation +6M (top of the clay deposit) was assumed to be zero at the time of the failure. The field survey data taken after the failure of the dike showed the presence of tension cracks as deep as 4 to 5 meters in the core of the dike. Therefore, in the stability analyses, the presence of cracks was also considered. Figure 4 shows the results of these stability analyses. Based on these results, it is concluded that prior to the failure, when the core was intact, the stiff

dike was stable and in a way floating on its large base over the saturated clay. But, as the construction of the dike proceeded, the resulting large undrained deformations initiated the cracking of the core, thus, reducing the shearing resistance of the core and ultimately causing failure. Also, since the dike did fail (F.S. < 1.0), from the results of the stability analyses it is concluded that the undrained shear strength ratio $S_u/\bar{\sigma}_{v0}$ for the clay should be less than 0.5.

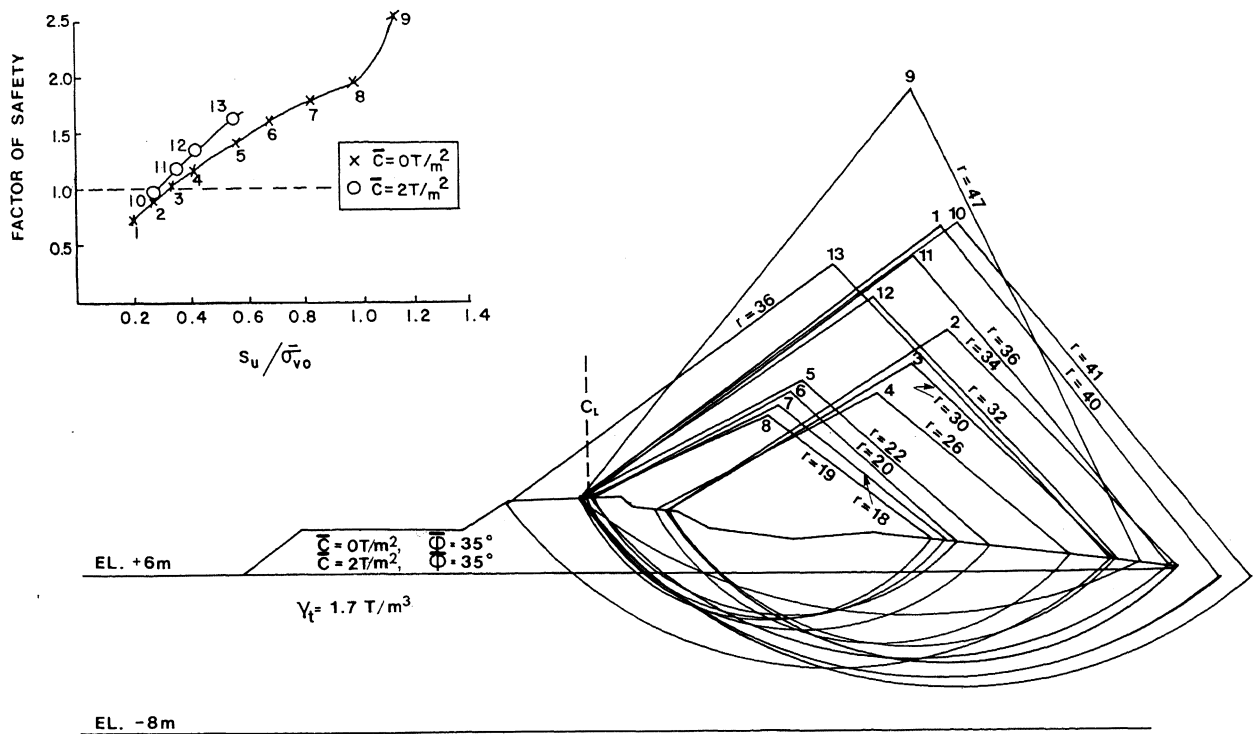
Figure 5 Total Stress Stability Analyses of the Dike After Failure

The total stress stability analyses were repeated using the cross section of the dike after failure determined from topographical surveys. Figure 5 shows a cross section of the dike observed after failure. The stability analyses of the dike were made searching for the critical failure circle and considering a tension crack of 5 meters extending through the core. Since, after the failure, the factor of safety was greater than or equal to 1.0, from these analyses, it is concluded that the undrained shear strength ratio $S_u/\bar{\sigma}_{v0}$ should be greater than 0.3.

In summary, the results of the stability analyses of the failed dike for conditions immediately before and after the failure indicate that the embankment material was well compacted and thus, the shear strength of the fill provided enough resistance against immediate major stability failure during the early period of its construction. However, as the dike underwent deformations due to continued undrained loading, it started to crack, thus losing shearing resistance and initiating failure. The undrained

shear strength ratio $S_u/\bar{\sigma}_{v0}$ of the foundation clay as determined from laboratory tests was 0.25. Based on the results of these stability analyses it was concluded that this ratio determined from laboratory tests is small because of sample disturbance and is more likely to be 0.3, which agrees better with published values for similar soils. This value of $S_u/\bar{\sigma}_{v0} = 0.3$ was later used in the analyses made for the reconstruction of the failed dike.

For the reconstruction of the dike, alternate methods were investigated considering various constraints including: Construction timing and scheduling, required materials, cost of construction and reconstruction technique. In view of the fact that there was a delay in the completion of the alumina plant and therefore the dike would not be needed for another two years, and also the permeability of the foundation soils as indicated by the piezometers was larger than estimated in the laboratory, it was decided to adopt a stage construction procedure. By this method, the construction of the dike proceeded in stages allowing enough time between stages for the clay to consolidate and gain the required strength to achieve safety against stability failure. In addition, in order to permit construction to proceed during the "high water" seasons and to provide a flexible embankment, a granular material was used in the dike and the compacted core was eliminated. Furthermore, 13m berms were placed on both sides of the new embankment in order to provide additional stabilizing forces.

In order to predict the safe height of the dike for each stage of construction and to make estimates of the required duration in time of the different stages of loading, total stress stability analyses were made. Based on these results it was concluded that the dike could be raised to a minimum required height of +14^m in time for the operation of the plant. In addition, effective stress stability analyses were made to determine the limiting pore water pressures in the foundation clay below which the dike would be safe at each stage of construction.
