Evaluation of Damage to a Road and Sports Complex on Expansive Clays

M. B. Mgangira

CSIR Built Environment, Pretoria, South Africa

P. Paige-Green

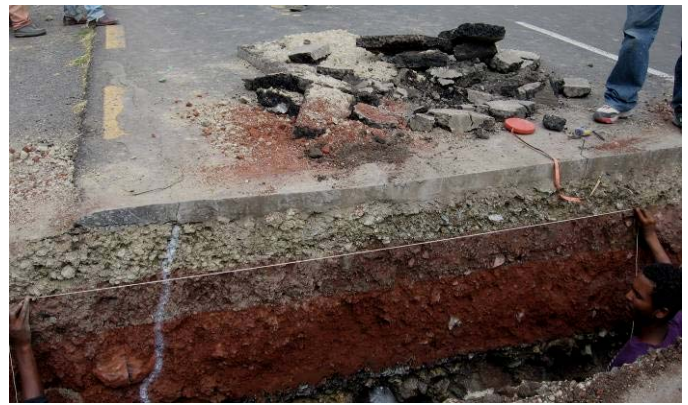
Test pit observations. Figures 3 and 4 show the crack propagation with depth as observed in two of the test pits. Figure 3 shows the crack at a shoulder location while Fig. 4 shows the crack propagation underneath the carriageway near the outer wheel track. The cracks pass through all of the pavement layers. While the cracks could not easily be discerned in the roadbed itself, the highly slickensided structure was indicative of the seasonal movement taking place within the clay.

Fig. 4. Crack propagation in outer wheel track

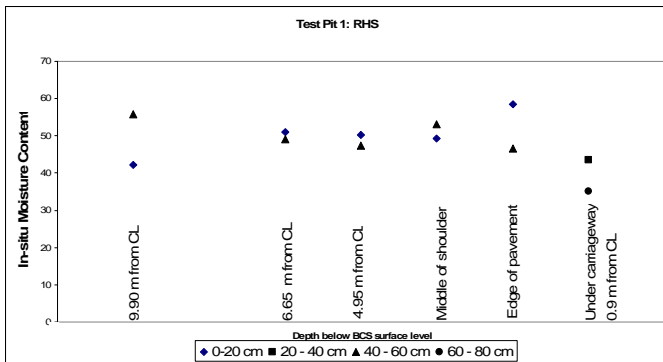
Fig. 5 shows the moisture content data point distribution within the in-situ BCS at one of the test pits. Similar moisture content data profiles were obtained for all the points of investigation.

Fig. 5. Lateral moisture content distribution within the BCS roadbed

The results generally showed a variation of the moisture content. Fig. 5 shows that at a depth of about 20 cm below the BCS, the moisture content was higher at the edge of the pavement than in the shoulder.

These values were, however, higher than at the toe of the embankment. At a depth of more than 40 cm, within the BCS, the shoulder was wetter than the side of the embankment as well as the edge of the pavement. Lower moisture content values were obtained from samples collected under the carriageway. The roadbed was also generally wetter under the embankment surface than under the carriageway, suggesting a vertical moisture migration from the embankment surface towards the roadbed.

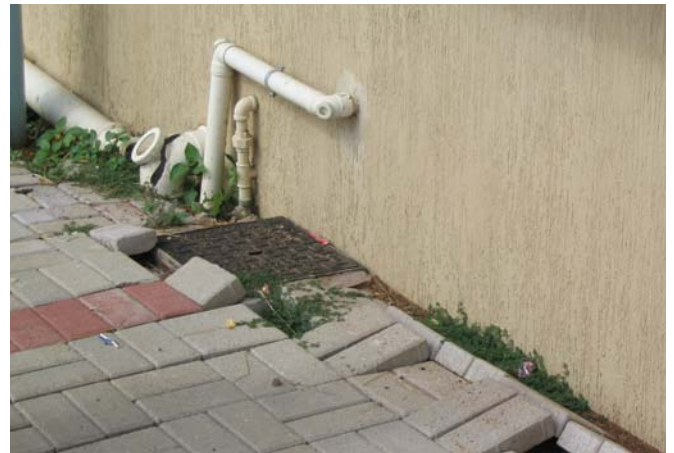
Although the wet services made use of flexible joints, the placement of concrete slabs and block paving against them “locked” them in and resulted in failures and subsequent leakage (Fig. 8).

Fig 8. Damage to wet services as a result of leaking paving

Aspects such as the placement of the block paving and/or concrete slabs adjacent to the wet services, the location of irrigation systems and drainage of water from air conditioning units need to be carefully considered. These measures are usually implemented at the end of the project under subcontract by people without a full understanding of the consequences of the actions.

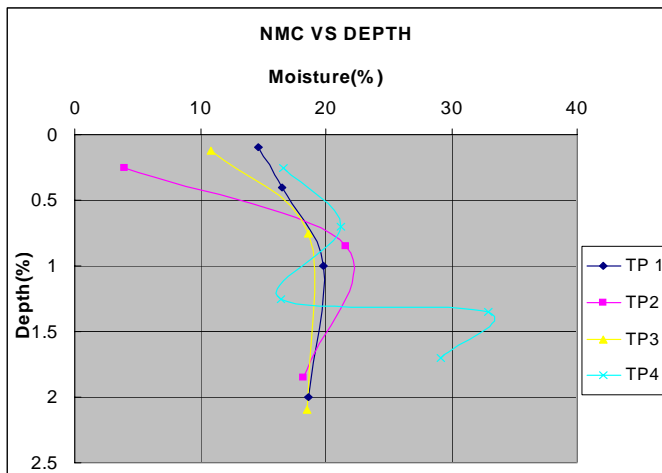
In general the moisture contents tend to increase with depth as would be expected from soils sampled during the early stages of the dry season. The wettest soil was recorded at TP4 which was excavated one meter away from the foundation of the Administration building. The pit was located on the south side of the structure in an area that received little direct sunlight during the day. Fig. 10 illustrates the relationship between the moisture content and depth.

Fig. 10. In situ moisture content versus depth

The “equilibrium” moisture content (into the dry season) appears to be about 18 to 20 per cent. The wet material from TP4 had a moisture content of about 30 per cent, which is probably close to the equilibrium moisture content during the wet season but is somewhat lower than the data determined for the road in Ethiopia (Case I) where the average moisture content at a depth below one meter was closer to 50%. This is in line with the generally higher Liquid Limits and Plasticity Indices determined on the Ethiopian materials. The moisture content of the oedometer samples after full saturation varied between 30 and 44 % with a mean of 38 %, indicating that volumetric changes would typically occur on site as the moisture fluctuated between about 18 and 30 %, unless full saturation at depth occurred and was constant, which is unlikely.

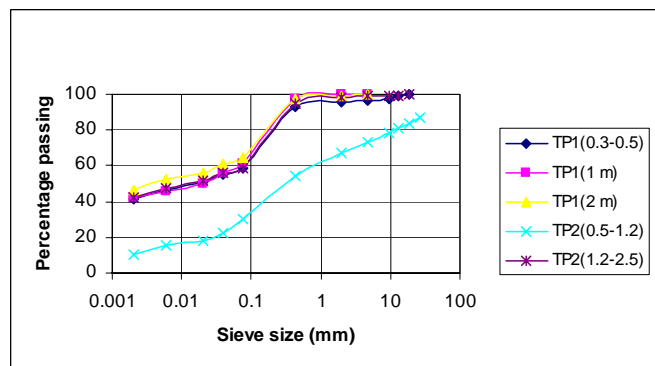
The particle size distribution curves are given in Figs. 11 (TP1&TP2) and 12 (TP2, TP3 & TP4).

Fig. 11: Particle size distribution of test pit samples

The results show that except for the imported materials from TP2 and TP4; which were classified as silty or clayey gravel and sand; the rest of the materials tested were classified as clayey soils with greater than 35 per cent passing the 75 micron (No. 200) sieve. The materials are classified as A-7-6 using the PRA Soil Classification System.

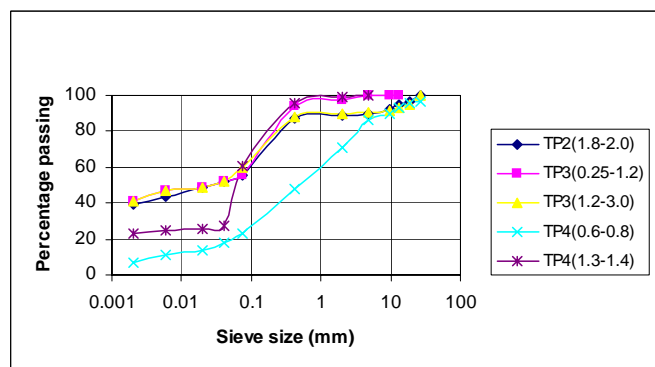
Fig. 12: Particle size distribution of test pit samples

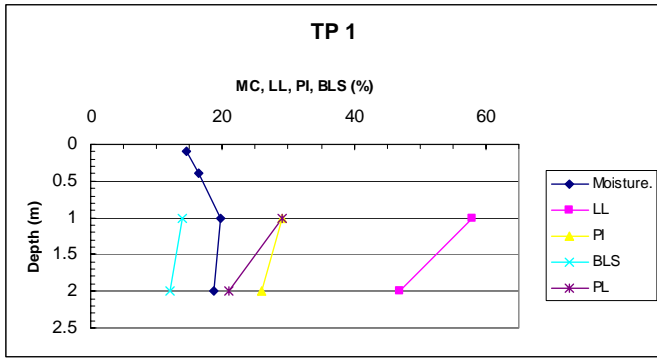
Fig. 13: Moisture content and Atterberg limits versus depth for TP1

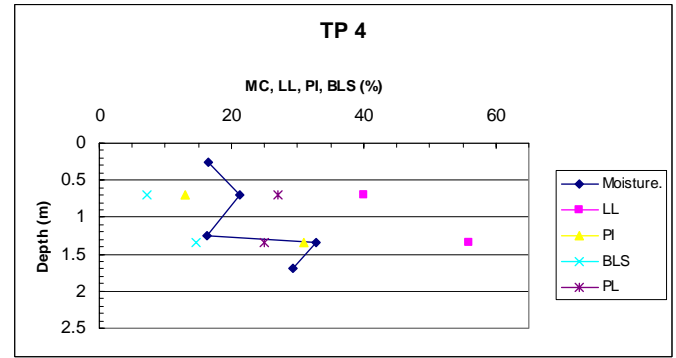
Fig. 16: Moisture content and Atterberg limits versus depth for TP4

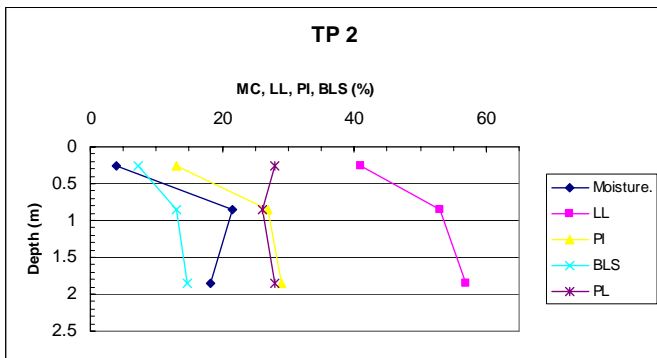
Fig. 14: Moisture content and Atterberg limits versus depth for TP2

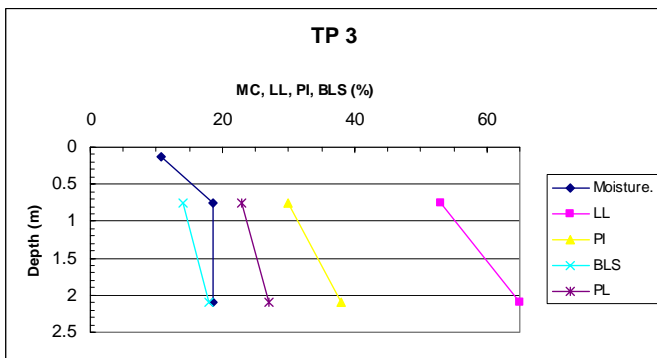
Fig. 15: Moisture content and Atterberg limits versus depth for TP3

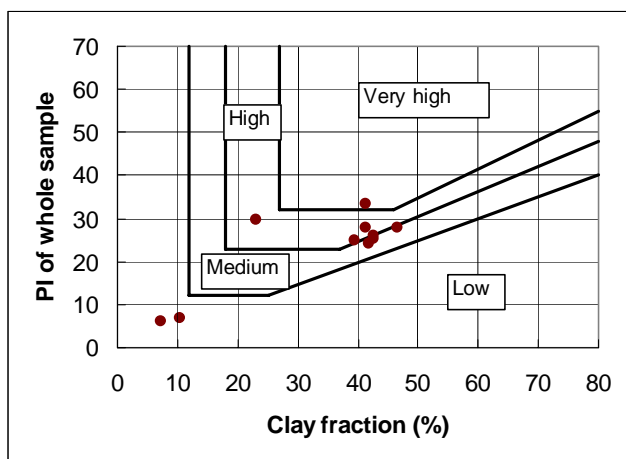
Fig. 17: Plots of predicted heave using modified van der Merwe chart
