(2013) - Seventh International Conference on  
Case Histories in Geotechnical Engineering

## Repair of Sunken Floor by Integrated Approach: A Case Study

## REPAIR OF SUNKEN FLOOR BY INTEGRATED APPROACH: A CASE STUDY

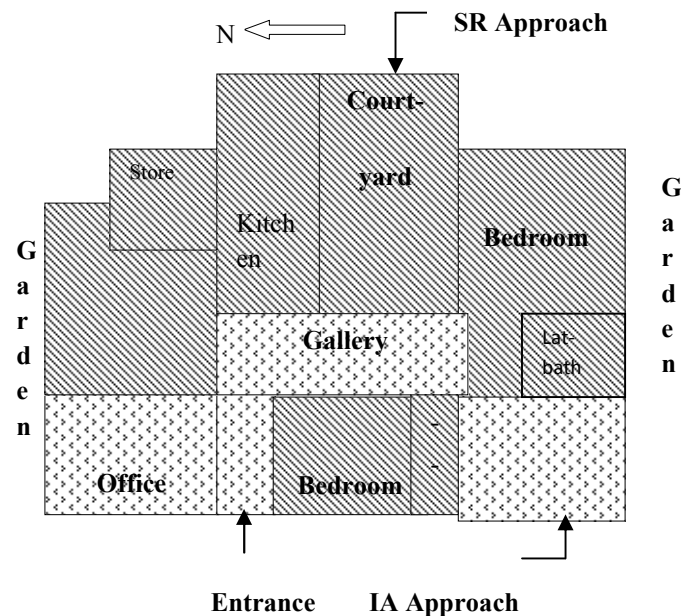
There are three bedrooms, drawing room and dining hall, office room, kitchen, store and two sets of lat-bath and a courtyard. The plan of the house is shown in Fig.1.

Fig. 1. Plan of house showing repair of floors by two approaches

**Soil Replacement (SR) Approach:** The removal of soil was planned in SR portion as shown in Fig.1. The damaged floors were removed and soil underneath the floor was taken out up to 1.5m depth. While removing the soil from the rooms the roots of the trees were found at many places. It may also be one of the reasons for moisture fluctuation under the floor resulting in uneven settlement. Locally available non expansive coarse grained red soil and the crusher dust was filled in small thickness and compacted to prepare the base for the floor. After the desired level of the floor base reached cement concrete of grade M15 was laid in 100 mm thickness and mosaic tiles were then fixed. RCC beams of width 20cm depth 30 cm were placed under the partition walls. The beams were resting on the main stable load bearing masonry wall.

**Integrated (IA) Approach** For repairing the IA portion (Fig. 1) following methodology was adopted:- The damaged floor was removed and the soil for about 500mm was also removed. Using hand auger and a vibratory needle rod, the holes of diameter 50mm in the black cotton soil was then made at every 750mm centre to centre. These holes were filled with stone chips size less than 8mm for about 300mm and followed by filling of Lime slurry up to the top soil level. Commercially available lime powder was used for this purpose. The depth of the lime pile was about 900mm. After all holes were filled in this way, the top of the soil was saturated with water. Stone dust / broken debris of the

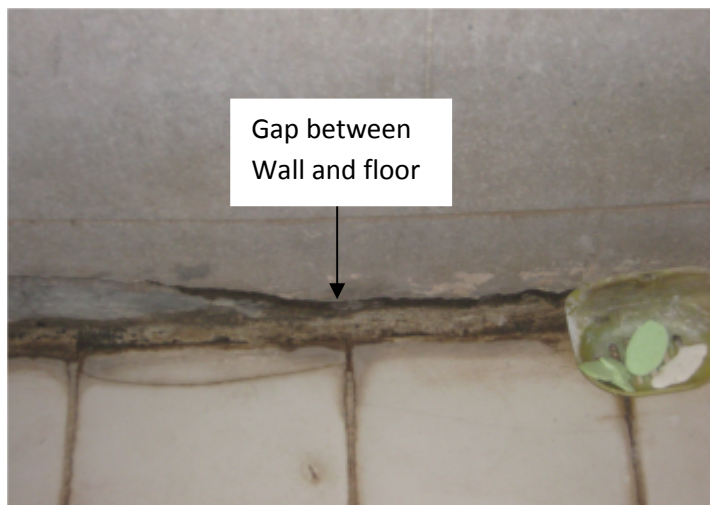
The house is having load bearing walls of stone masonry placed at about 1.5 m below the natural ground level. The floors of the house had been irregularly sunken and cracked nearly in all rooms and courtyard. On walking in the house, one could hear typical hollow sound at many places, perhaps due to the formation of cavity under the flooring. The floor was made up of cement concrete and was about 100 mm. As stated earlier the partition walls had also got severe diagonal cracks at many places and at some places the wall has gap with floor and / or to the roof slab. Figure 2 and 3 depicts the defects as stated here.

*Fig. 2. Gap between sunken floor and non load bearing wall*

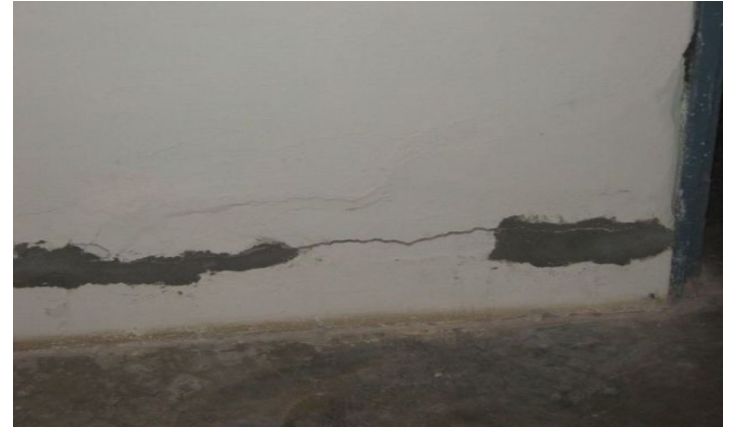
*Fig.3. Damaged wall of bedroom*
