## Sinkhole Dropouts Due to Underground Utility Installation on Construction Sites

Matthew A. Dettman

Paper No. 8.06

*This paper will document two case histories in Bowling Green, Kentucky, which is in Warren County, where dropouts have developed due to the combination of construction activity and underground utility construction.*

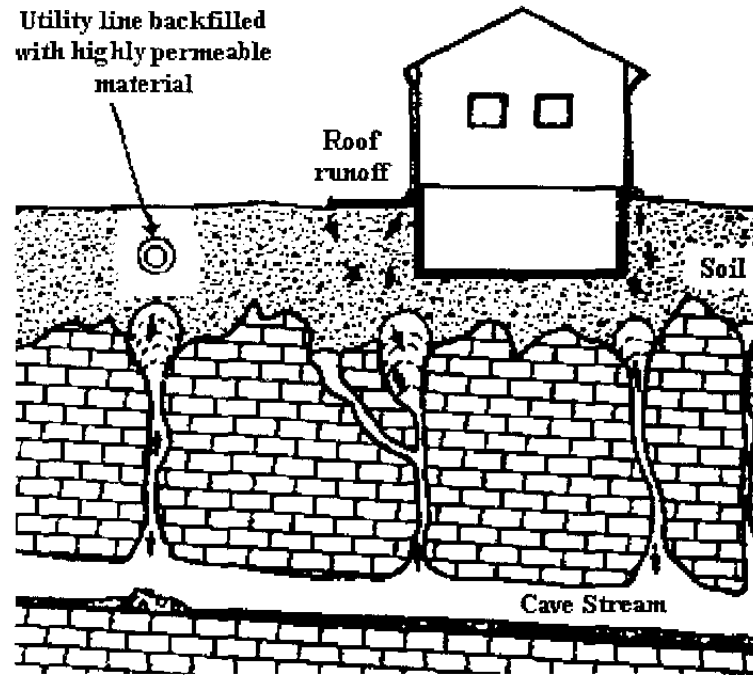
The second dropout was an example of utility lines causing a dropout and occurred further into the construction process. The site had been completely graded and the skeleton of the structure had been completed, including the roof. No paving had been completed but all parking areas and drives had been cut in and compacted smooth. This dropout occurred behind the building in the service drive area. The specific location of this dropout was directly underneath the intersection of two utility lines. One line was a forced water main running east-west and the other was a smaller water line running north-south. Both utility trenches were approximately 3 feet wide and were several hundred feet in length. The deepest line was approximately 5 feet deep and the other line was about 1 foot closer to the surface. In addition, there was a roof drain from the structure less than 100 feet away. Figure 2 below shows a schematic of the layout.

All of these factors combined to cause the dropout. The utility lines that were backfilled with highly permeable gravel served as a conduit to catch all the surface water and roof runoff and ultimately direct it to the regolith arch. Based on the fact that some heavy rains occurred shortly before the dropout, this regolith arch experienced a volume of water in a matter of days that would likely have taken many years. The dropout was observed immediately after it occurred and water was flowing

Fig. 2 Schematic of the cause of the Lowes dropout.

out of the gravel-filled utility excavations into the newly formed pit for approximately five hours. The rate of flow at the time the dropout was first observed was approximately five to 10 gallons per second and slowly diminished down to a trickle hours later.

As the sinkhole dropout was excavated so repairs could begin, the excavated soil was observed and had a sandy texture. This is typical in a regolith arch because most of the silts and clays have been washed down into the subsurface drainage system and the remaining coarser grained materials were acting as a bridge holding the surface in place. With this final piece of data, it became clear that excess water being diverted to an existing regolith arch via utility lines backfilled with gravel led to this sinkhole dropout.

While it is easy to document these occurrences and determine causes after the fact, preventive measures are as difficult as predicting locations. Consideration may be given to examining the process of utility installation. For example, one possible solution could be to use flowable fill to backfill utility trenches underneath the footprint of a building and 20 feet beyond. Flowable fill is a low strength, low-cost concrete that is slightly stronger than a stiff clay but has a much lower permeability than gravel. This would minimize the creation of a subsurface conduit for water that would be directed to an active regolith arch in the area of the structure, minimizing the potential for catastrophic failure.
