International Conference on Case Histories in Geotechnical Engineering (1984) - First International Conference on Case Histories in Geotechnical Engineering

Slide Stabilization With Gravel Trenches

Slide Stabilization with Gravel Trenches

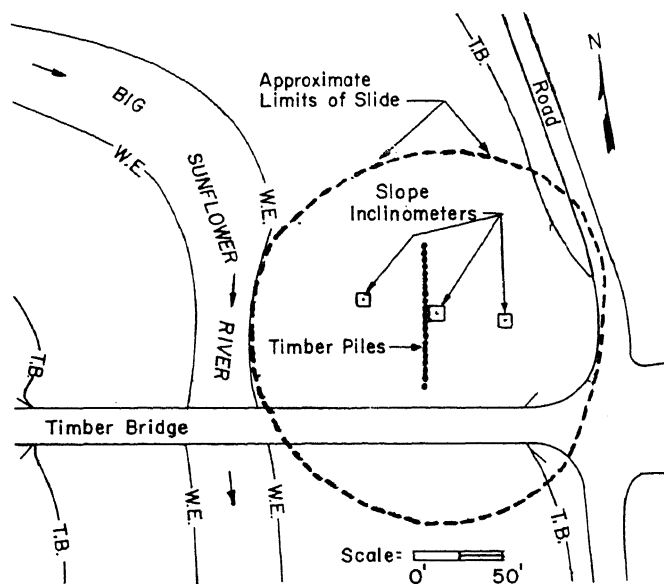
Fig. 1. Plan View of Slide Area

The slide is described as a long, shallow, translatory slide with an average depth to the slip surface of 10 to 12 feet. The slide had an areal extent of approximately 200 by 250 feet. The intermittent movement of the sliding mass had been perpetuated by the continual process of dumping debris at the top of the slide and subsequent erosion of the toe bulge by the river.

The slide had been active, with intermittent movement, for twenty years or more. The slide began to gather interest in the late 1960's as translational movements and upper bank subsidence affected a road located at the crest of the riverbank and threatened a timber bridge that had been in service at the slide site for several decades. The slide extended from about 150 to 200 feet upstream of the bridge to about 50 feet downstream of the bridge. Plan and

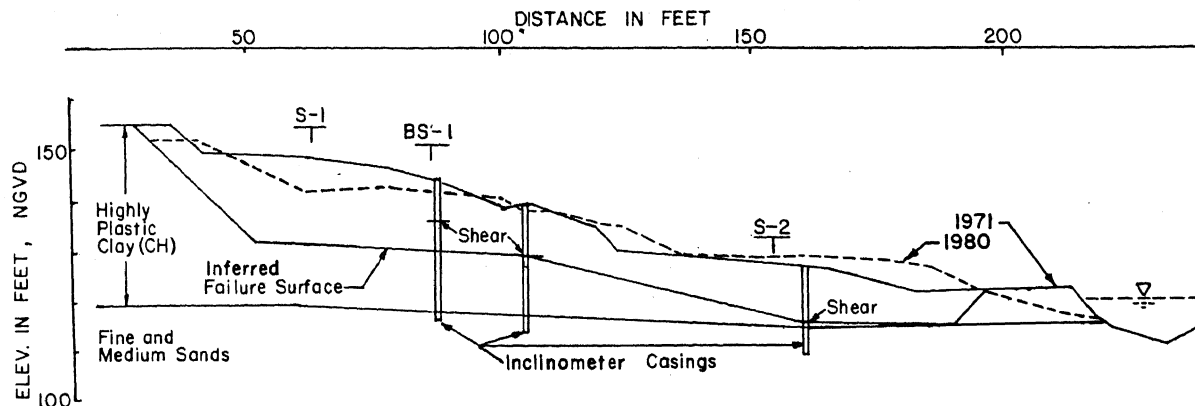
Fig. 2. Cross-Section of Slide

Investigation of soil conditions in the slide consisted of making two undisturbed sample borings and installation of three slope inclinometer casings in 1971 and one undisturbed sample boring in 1982. The borings indicated the abandoned channel deposits consist of highly plastic clays (CH) interbedded with occasional thin silt lenses. The top stratum deposits extend to a depth of approximately 35 feet below the elevation of top bank and are underlain by substratum fine to medium sands and silty sands with traces of gravel. The generalized soil and slide profile is presented in Figure 2. Also presented are the locations that the slope inclinometer casings sheared and the location of the inferred slip surface.

Design of the remedial measures required a detailed analysis of the existing conditions to determine the existing shear strength acting along the slip surface. Figure 2 shows in cross section the slide indicating boring logs, slope inclinometer casings and the inferred slip surface utilized in the analyses.

The sheared slope inclinometer casings showed the slide to be of the long, shallow, translatory type. The average depth to the slip surface was approximately 10 feet. Spencer's method of limit equilibrium analysis was used (Wright, 1974) to analyze the slip surface assuming the sliding mass to be in a state of limiting equilibrium and a piezometric grade line coincident with the existing ground surface. Drained strength parameters of $\phi' = 18^\circ$ $c' = 0$ psf were backfigured as the average strength acting on the slip surface producing a safety factor of unity.

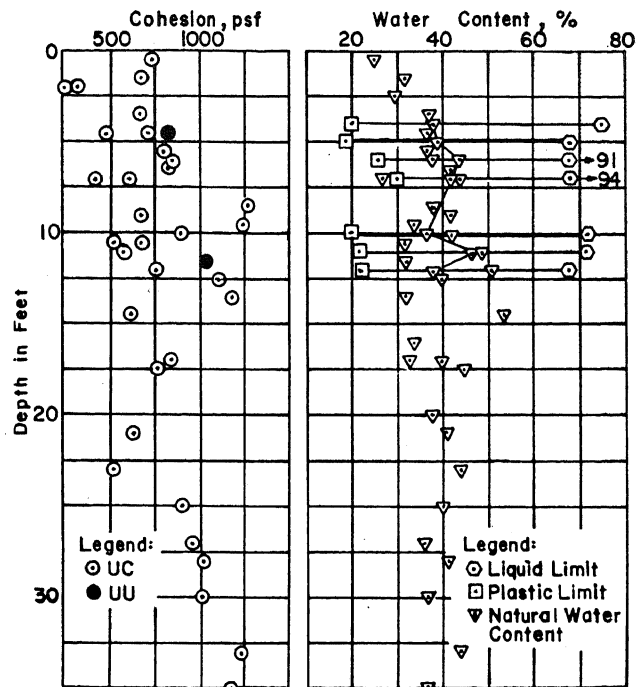
Fig. 3. Shear Strength and Water Content Data

Laboratory testing consisted of water content determinations, Atterberg limit tests, unconfined compression (UC) tests, unconsolidated undrained (UU) triaxial tests, consolidated-drained (CD) direct shear tests and consolidation tests. Plots of cohesion, Atterberg limits and water content versus depth are presented in Figure 3. The data was plotted versus depth because variations with depth below the surface of the slope were determined to be more significant than elevation. The UC and UU tests indicate considerable scatter in the shear strengths from the surface down to a depth of about 25 feet. The shear strengths range from a cohesion of 260 psf (pounds per square foot) to 1260 psf with an average value of 700 psf. Below 25 feet a trend of increasing cohesion with depth is indicated. The water contents also show considerable scatter, particularly in the upper 20 feet.

Three consolidated-drained, direct shear tests and two consolidation tests were run on samples from depths of 5 and 10 feet. Two of the consolidated-drained tests were run to determine peak strengths and provided average values for the applicable range of in situ stresses of $c' = 110$ psf and $\phi' = 23^\circ$. The third test was a repeated direct shear test performed to determine the residual strength of the soil. The residual strength was determined to be $c'_r = 80$ psf and $\phi'_r = 9^\circ$. The two consolidation tests indicate

The site investigation indicated the soils in the slide to be medium to stiff, highly plastic clays that exhibited an overconsolidated crust and fissured soil structure. Fissures and slickensides were evident from examination of the undisturbed samples and from observations during trenching for installation of the gravel trenches. It was noted that the slip surface was located at the lower extent of the heavily fissured and slickensided zone. The UC's indicated considerable scatter in shear strength down to a depth of about 25 feet. Observations of the specimens during testing indicated that fissures and slickensides controlled the strength of a large number of the specimens tested. The average liquidity index was 26 percent.

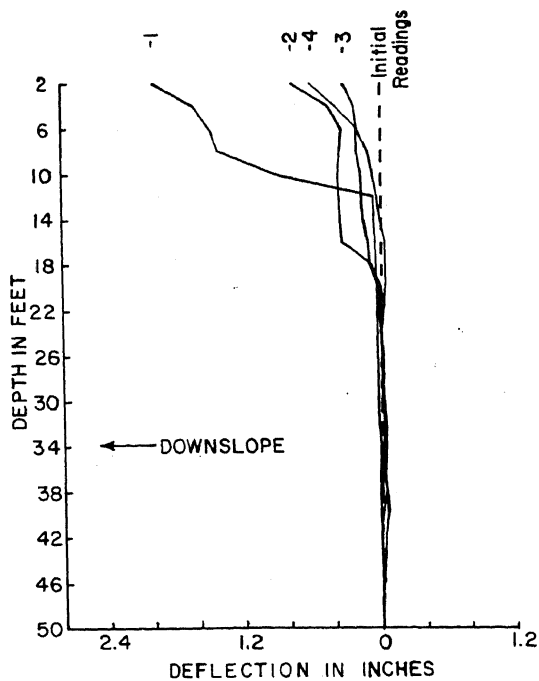
Fig. 6. Slope Inclinomometer Deflections

of installing 2.87-inch I.D., grooved, ABS plastic casing. The casings were installed in holes that fully penetrated the finer grained topstratum soils and terminated in substratum sands. Deflections in the casings were electronically measured using the Model 50308 Digitilt Mag-Tap Indicator. Initial readings on the plastic casings were taken in June 1982. Additional readings were taken in July and October of 1982 and April, July, August and November of 1983. Comparative plots are shown in Figure 6. These plots show movement of greater than 1-inch occurring in casing 1. However, casing 3 shows relatively small movements of less than 0.4 inches. This is interesting in that casing 1 is nearer the center of the slide and casing 3 is located near the toe of the slide, downslope from casing 1. The location of casing 1 is in an area of the slide in which the exact location of the slip surface was not determined. This movement may indicate that the gravel trenches did not fully penetrate the slip surface in the area of casing 1. Plastic casings 2 and 4 have deflections of approximately 0.5-inch and 0.6-inch, respectively. These deflections are considered to be strains associated with the mobilization of shear strength and densification of the gravel backfill.
