A Detailed Study on the Liquefaction-Induced Settlement of Timber Houses During the 2000 Tottoriken-Seibu Earthquake

A DETAILED STUDY ON THE LIQUEFACTION-INDUCED SETTLEMENT OF TIMBER HOUSES DURING THE 2000 TOTTORIKEN-SEIBU EARTHQUAKE

More than 100 timber houses settled and tilted due to liquefaction at a housing development during the 2000 Tottoriken-seibu earthquake in Japan. Among the damaged houses, 47 houses tilted more than 15/1000. Heavily tilted houses were necessary to restore to become horizontal after the earthquake, though several houses, that tilted slightly, were not necessary to restore. The authors studied the boundary of the angle of the restored and non-restored houses. According to the study by the authors, the critical angle of tilting to restore houses was about 10/1000. The authors studied soil conditions also, and found that groundwater level was shallower than about 1.7 m in the damaged zone. This implies that small structures such as timber houses have no damage due to liquefaction if the groundwater level or the bottom of surface non-liquefiable layer is deeper than about 1.7 m.

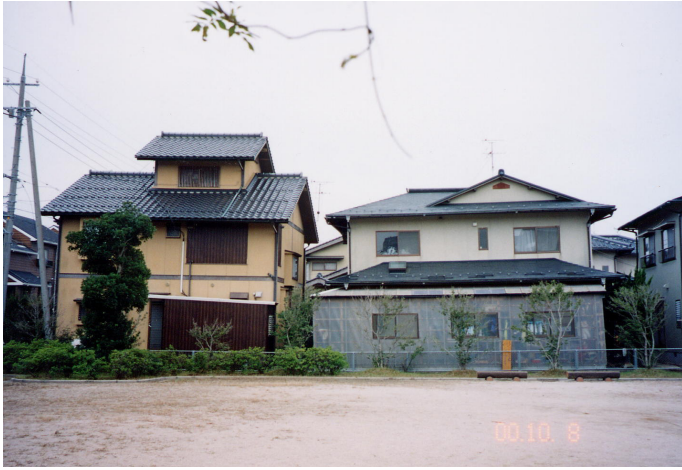
Photo 1. Settled and tilted houses due to liquefaction in Abehikona development

and tilting of residential houses. Photo 1 and 2 show the settled houses and boiled sands in Abehikona housing development. More than 100 houses settled and tilted in Abehikona housing development as shown in Photo 1. No severe cracks were observed on the walls of the settled houses. Figure 1 shows grain-size distribution curve of the boiled sand. The boiled sand was clean middle sand. This housing development was constructed by filling mainly granite-origin sand. Reclaimed and alluvial sand layers are deposited from the ground surface to the depth of about 7 m. Alluvial clay layer of about 5 m thick is underlay. SPT *N*-value of the sand is around 10.

In the heavily tilted houses, inhabitants felt giddy and nausea, and could not live in the houses after the earthquake, though walls, pillars and windows of the houses had no damage. Then heavily tilted houses had no choice but to restore to become horizontal. In the restore work, superstructures were uplifting by jacks, footings were repaired or reconstructed to become horizontal, then, the superstructures were replaced on the footings. Cost of the restore work for one house was about three to four million Yen (about US\$ 25000 to 35000).

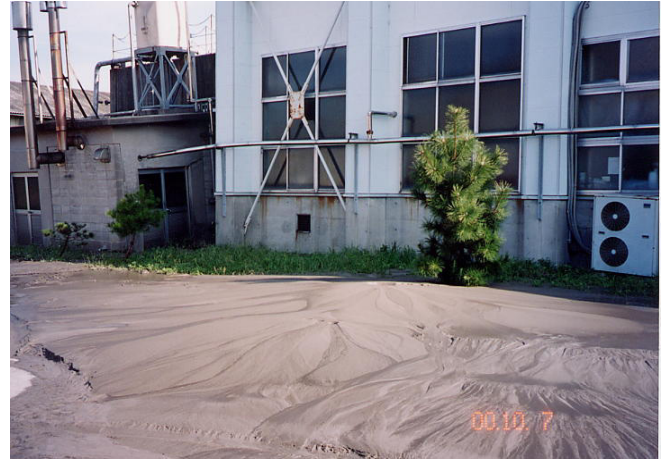
Photo 3. A big sand boil at an industry in Takenouchi industrial park

In Sakaiminato City, liquefaction occurred in a newly reclaimed land named Takenouchi Industrial Park, and brought severe damages to industrial facilities. Photo 3 shows a big sand boil in an industry. The ground was subsided about 30 cm shown in Photo 4 in the industry. River revetment near the industry tilted

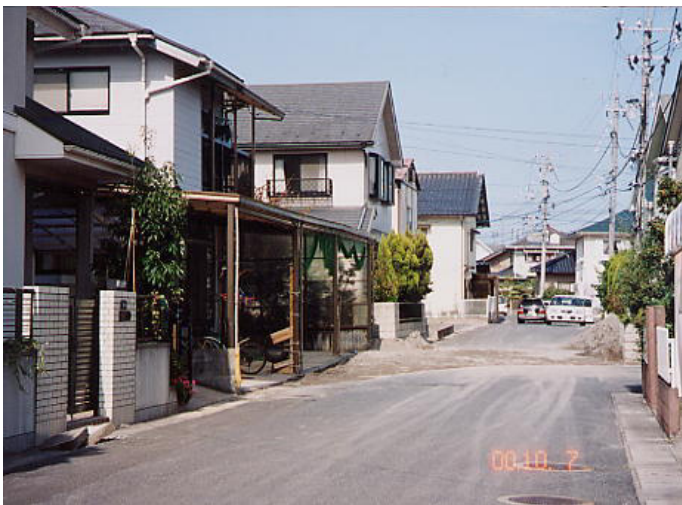
Photo 2. Boiled sands in Abehikona development

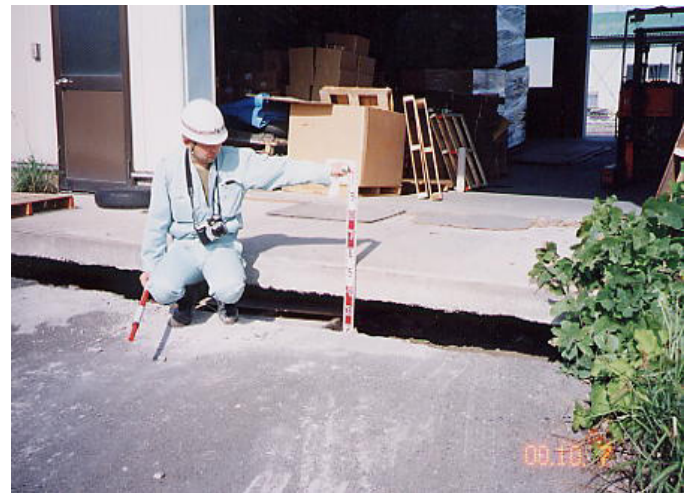
Photo 4. Ground subsidence at an industry in Takenouchi industrial park

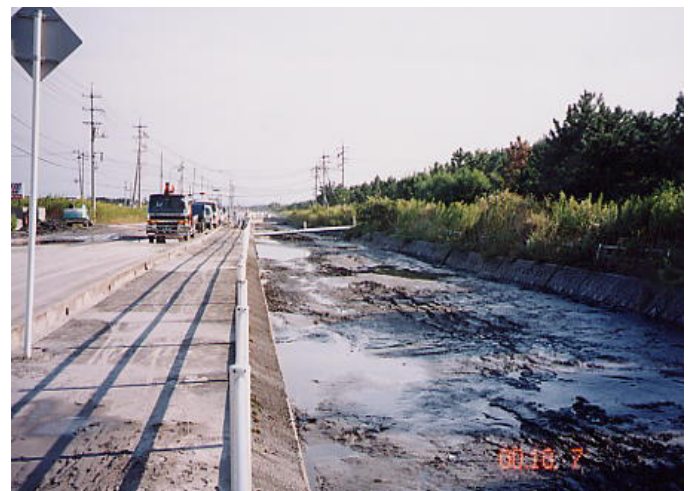
Photo 5. Liquefaction-induced flow toward a small river

towards the small river due to liquefaction-induced flow as shown in Photo 5. Boiled soil was very fine silt as shown in Fig.2. Sand boiling continued for about 8 hours after the earthquake because of low permeability of the liquefied silt. This area was constructed by the soil excavated from a channel near Takenouchi Industrial Park. According a boring data, very loose silt layer with SPT *N*-values of 0 to 3, is deposited from the ground surface to the depth of 11.75 m.

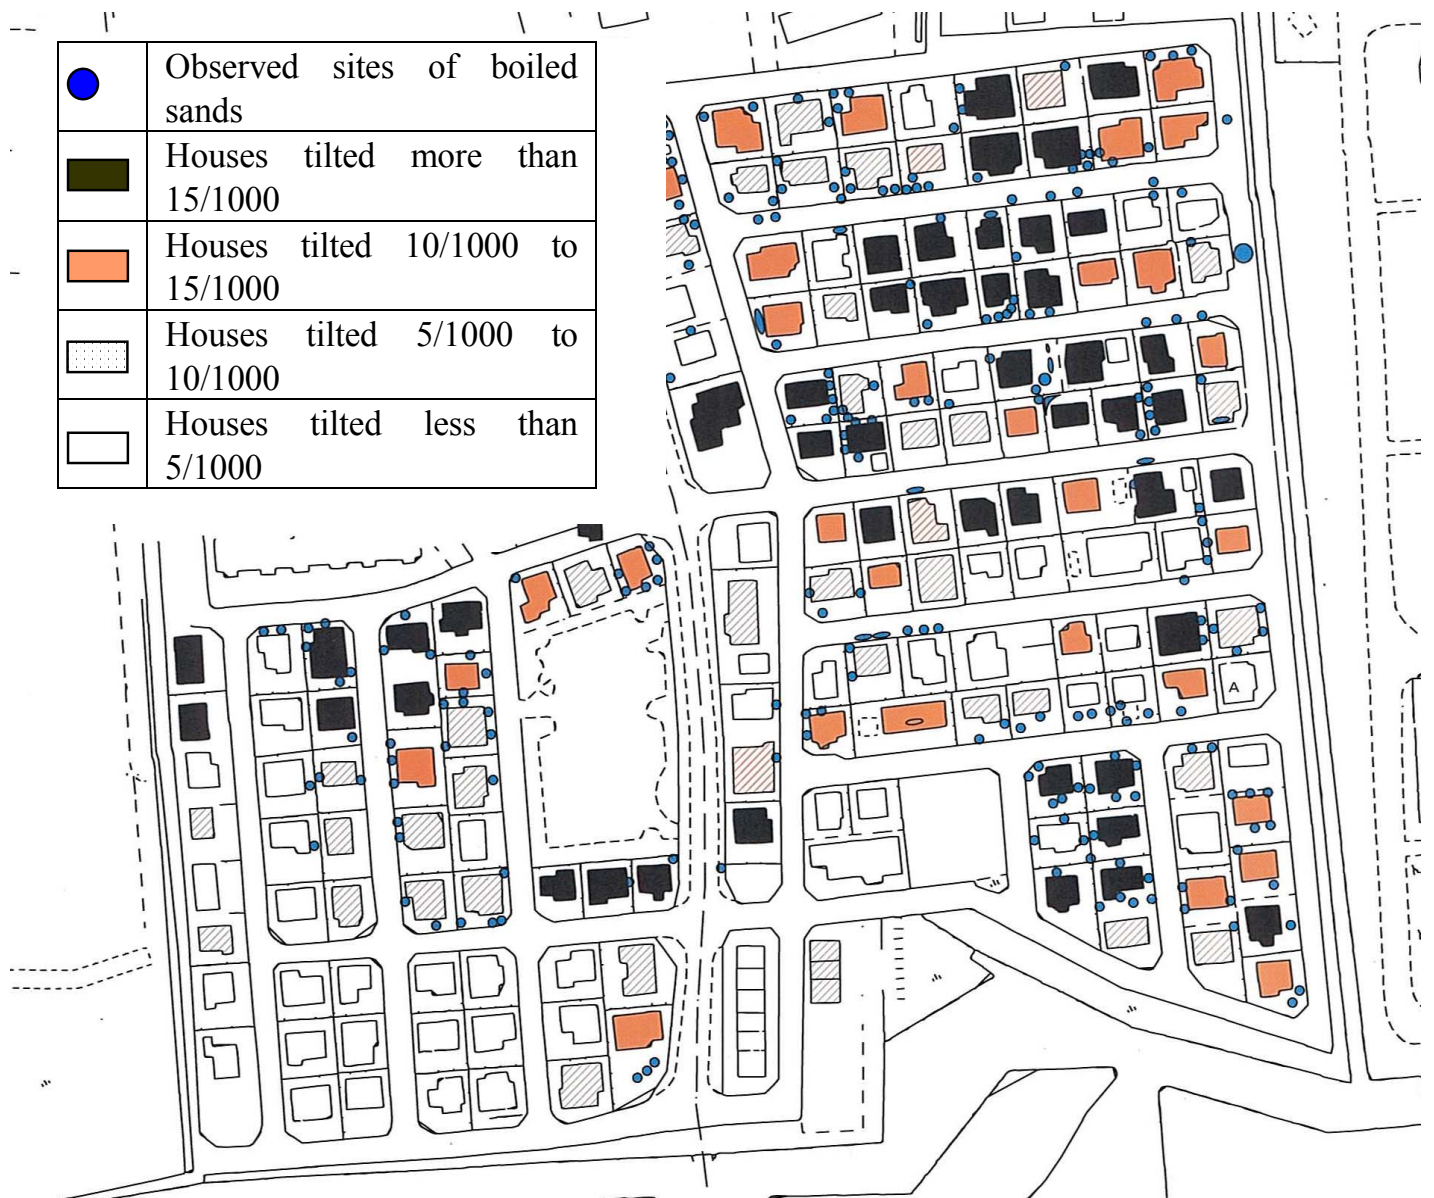
Angle of inclination was classified into four ranks, (a) more than 15/1000, (b) 10/1000 to 15/1000, (c) 5/1000 to 10/1000 and (d) less than 5/1000. Numbers of houses belong to the four ranks were 47, 30, 39 and 53. Figure 4 shows distribution of the rank of angle of inclination in Abehikona housing development. Heavily tilted houses distributed mainly in northeast zone. Observed sites

of sand boils are also shown in Fig.4. By comparing the angle of inclination and sand boils, it can be seen that sand boils were induced at severely tilted houses. This means that main cause of settlement and tilting of houses was liquefaction.

Fig.4. Distribution of the rank for angle of inclination of houses in Abehikona housing development

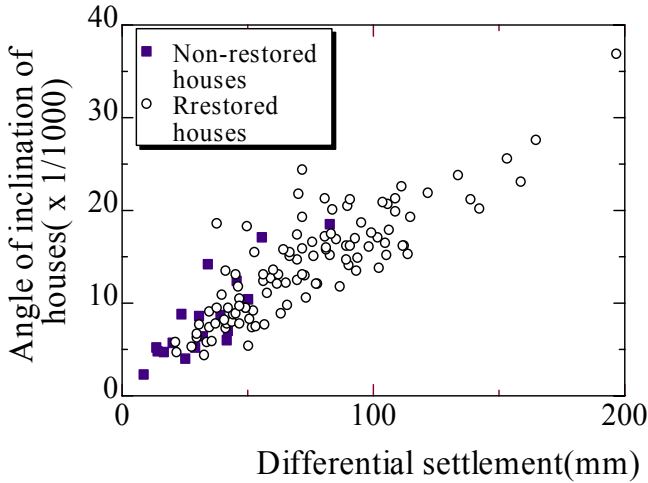
On the contrary, slightly tilted houses were not necessary to restore. The authors compared critical angle of inclination whether the restore work was necessary or not. Figure 5 shows relationship between differential settlement and angle of inclination of houses. In this figure, non-restored houses and restored houses were indicated in different symbols, closed square and open circle. It can be seen that the critical angle of inclination to restore was about 5/1000 to 15/1000.

Fig.5. Angle of inclination of restored and non-restored houses

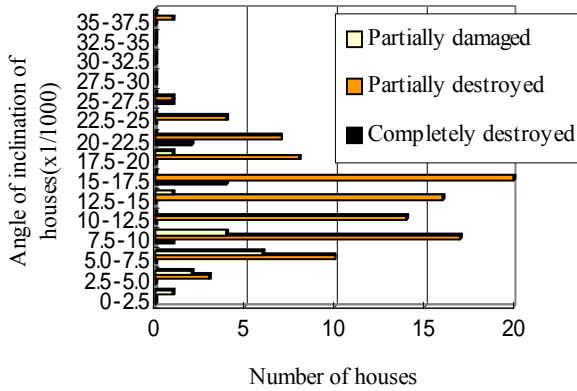
For each house, degree of damage was judged and classified into three degrees, (i) Partially damaged, (ii) Partially destroyed and (iii) Completely destroyed, by government after the earthquake. Figure 6 compares the judgment and the angle of inclination. The

angle of inclination of completely damaged houses was greater than 7.5/1000. Therefore, it can be said that the allowable angle of inclination of residential houses was about 10/1000.

Fig.6. Comparison of degree of damage of houses and their angles of inclination

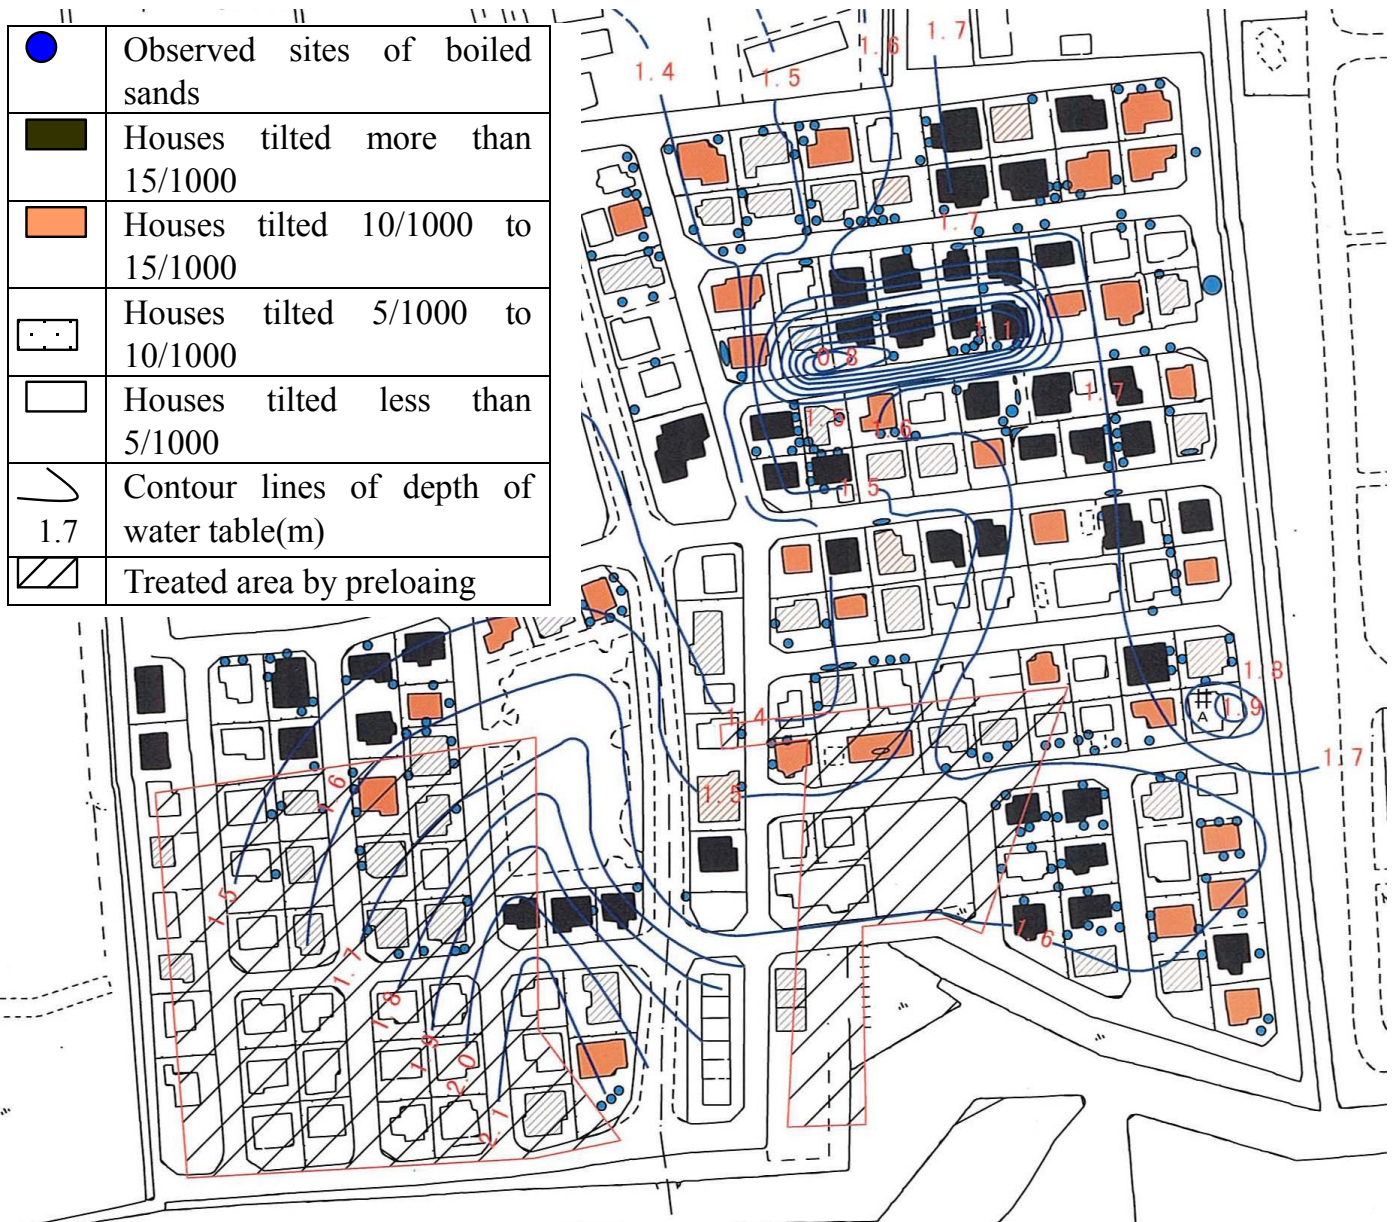
Fig.9. Contour line of the depth of groundwater level

Figure 9 shows contour lines of the depth of groundwater level. It is estimated that the ground surface subsided about 20 cm due to

liquefaction base on the differential settlement of pile supported structures as shown in Photo 7. By considering the subsidence of the ground surface, the real depth of groundwater level just before the earthquake was estimated and illustrated on Fig.9. As shown in the figure, depth of groundwater level in Abehikona housing development was shallow as GL-0.8 m to GL-2.1 m in whole area. Especially the depth of groundwater level at northeast zone was shallowest as about GL-1m. Special attention must be paid for

southeast zone because liquefaction and related damage did not occur in the zone. The reason may be that the zone was treated before constructing houses by surcharge (preloading method) to avoid the settlement of houses due to consolidation of alluvial soft clay.

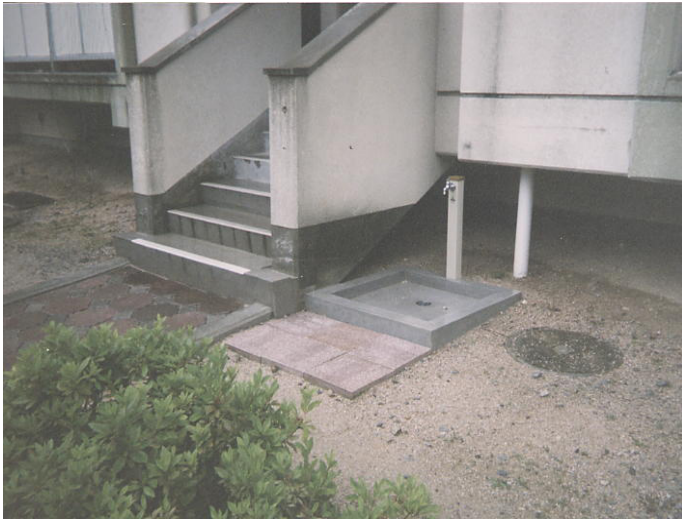
Photo 7. Evidence of ground subsidence due to earthquake observed around pile-supported apartment

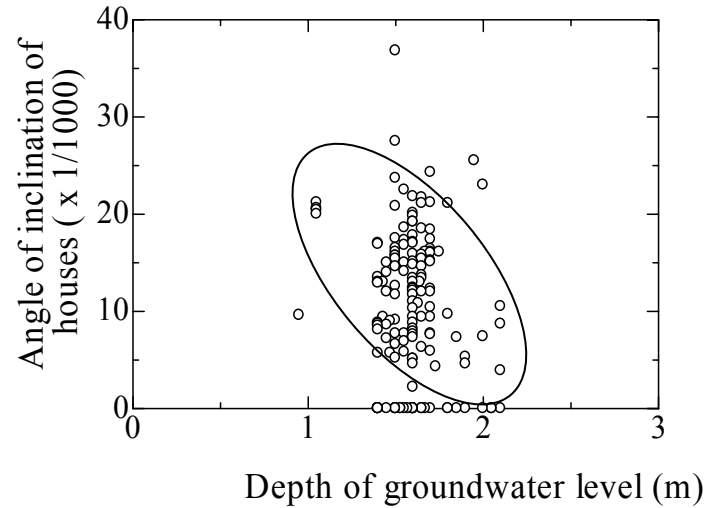
In Fig.10, the depth of groundwater level is compared with the angle of inclination of houses. Though the data are scattered, angle of inclination decreased with the increase of the depth of groundwater level. As mentioned before, the allowable angle of inclination was about 10/1000. Corresponding depth of groundwater level can be read as about 1.7 m in Fig.10. Therefore,

Fig.10. Relationship between depth of ground water level and angle of inclination of houses

it is estimated that the zones where groundwater level was shallower than GL-1.7 m were severely damaged in Abekona housing development during the Tottoriken-seibu earthquake. This implies that small structures such as timber houses have no damage due to liquefaction if the groundwater level or the bottom of surface non-liquefiable layer is deeper than about 1.7 m.
