## The Importance of Field Tests and Monitoring Activity for the Remedial Measurements Corresponding to Some Old Buildings in Bucharest

Anton Chirica  
*Technical University of Civil University, Bucharest, Romania*

## THE IMPORTANCE OF FIELD TESTS AND MONITORING ACTIVITY FOR THE REMEDIAL MEASUREMENTS CORRESPONDING TO SOME OLD BUILDINGS IN BUCHAREST

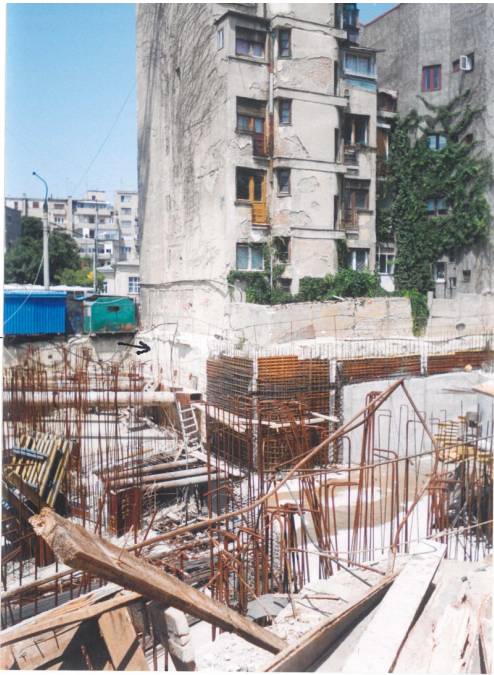
Photo 3. The old multi - storey building in Arcului 4 street

Analyzing the existing structure of the buildings in the close proximity of the site, it was decided to increase the safety of the old multi-storey building in Arcului 4 Street, by a screen of tangent micropiles of 180mm diameter drilled 8.00m deep (See photo 3).

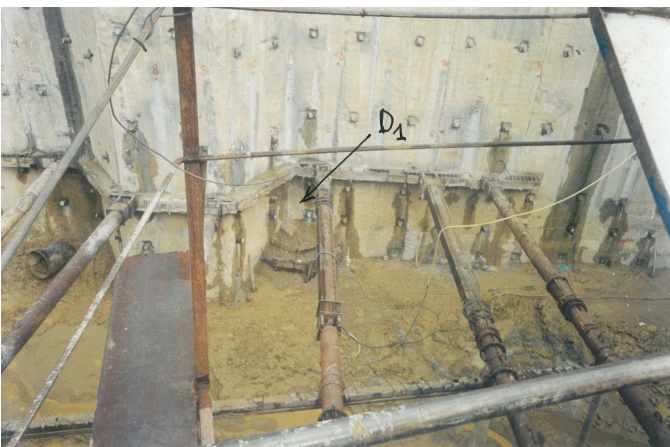
D2); because of the high hydraulic gradient and of the corresponding pressures of the saturated ground (about 100kPa) important volumes of water and soil material came into the excavation area; in photo 8 the  $D_1$  defect location is presented.

*Photo 8. Slurry wall defect situated adjacent to Armenian library at 16 m deep (D1 on the figure no 3)*

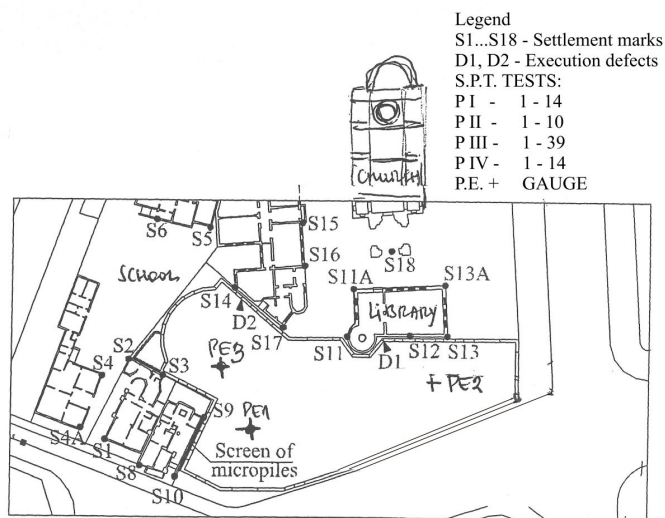
Fig. 3. Surveying marks and S.P.T. location

The most important technological incidents were (see fig 3):

- the execution of the anchors (5 levels A1-A5) under the underground water level was done with important losses of water and granular material (fine sand) during the drilling; it was approximated that volumes between 0.5 to 1.0 m<sup>3</sup> of lost material remained uncompensated for each anchor;
- defects in the slurry walls, located between 13.5 and 16.15m deep, consisting in openings (holes) 0.30m to 0.50m wide (D1,

Figure no. 3 shows the location of the principal settlement marks, installed on the most sensitive buildings. Also a lot of SPT tests by using a heavyweight hammer device were performed during four stages as below:

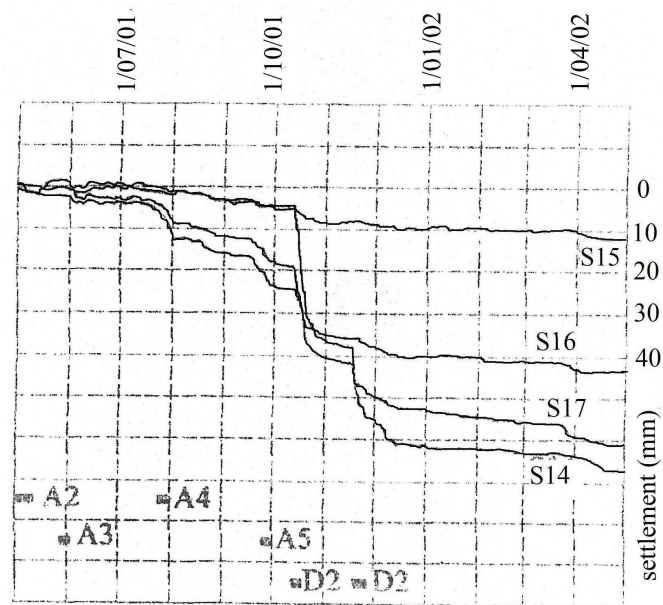
Fig. 6. Settlement evolution Armenian School

In figures 4, 5 and 6 is represented the evolution of the settlements related with the mentioned technological incidents, leading to the following conclusions:

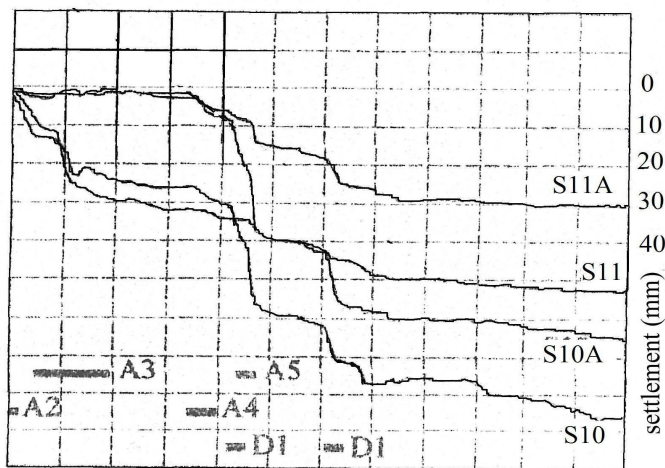
Fig. 4. Settlement evolution Armenian Library

- for the Armenian Library, the execution of the 3rd level of anchors (-10.55m) and of the corresponding excavation lead to settlements increasing of 2.5 to 3 cm; it is important to observe the strong influence of the defect in the slurry wall (D1), leading to an increasing of the settlement from 3.0 to 3.5cm (see fig 4);
- for the Armenian School, starting with the execution of the 3rd and 4th level of anchors some increasing of settlements have been registered, from 1.0 to 1.5 cm ; the defect (D2) in the slurry wall had a strong influence , the settlement increased with 6cm (see fig 5);
- for the American Church, situated at about 20m distance from the excavation , the major defect D1 in the slurry wall had an important effect, with settlement increasing of 2.5cm (see fig 6); the anchors execution had less effect (settlements recorded of about 0.5cm).

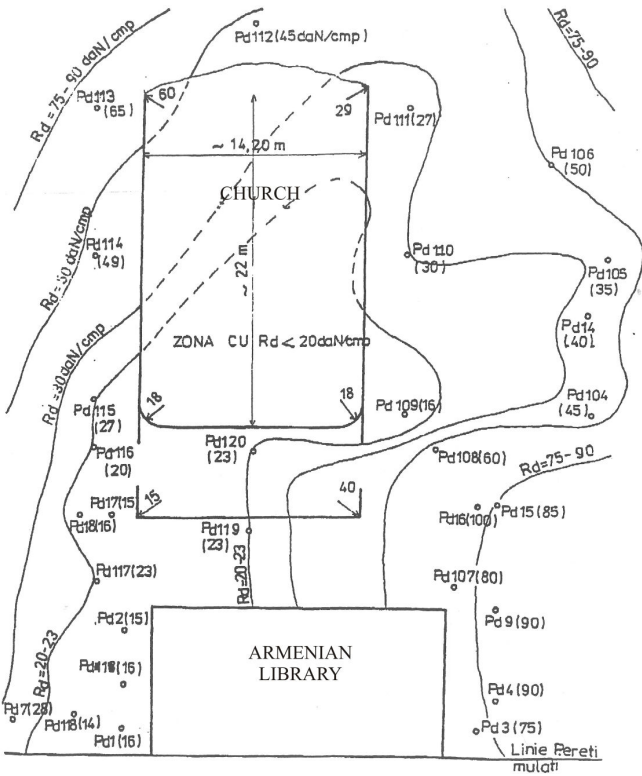
Fig. 7. Izocurves for dynamic penetration resistance of “Bucharest Clay” by processing S.P.T. results data

After the processing of the SPT results, it could be determined the horizontal and vertical extension of the influenced area of the foundation ground as a consequence of the flaws in the slurry walls, and also of those of anchoring.

- the result of the execution of the slurry walls was mainly the aeration of soil by  $\approx \Delta n=4\%$  on 8m deep and 4m behind the walls;
- by execution of the anchoring with high losses of material, the extension of the weak area from the foundation ground was up to 12 m deep and another 4÷6m wide;
- in the weak area the dynamic penetration resistance  $R_d$  has diminished from 200÷ 300 kPa to 50kPa. The above observations explain very well the increase in the settlements by 6cm (see figure 8) for the Armenian

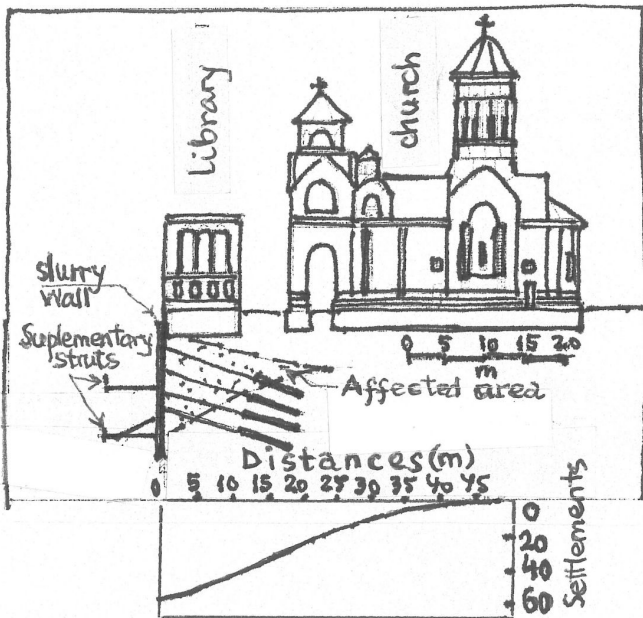
Fig. 8. Settlements values and affected area extension

Church and Library, and thus the spreading of structural flaws.

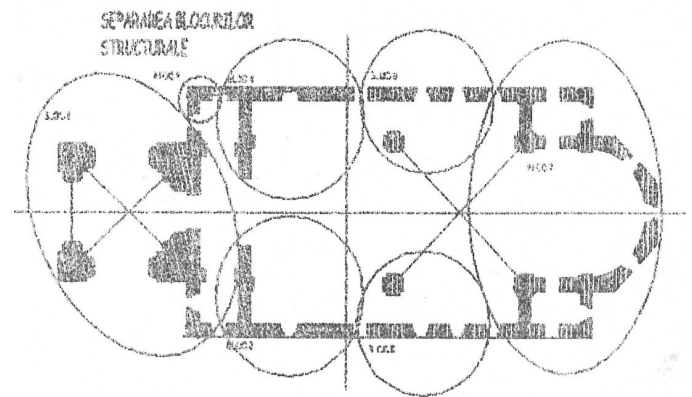
Fig.10. Structural blocks separation

In our case, the mechanism of failure of the Armenian Church was characterized by a dominant transversal component.

This particularity was determined by the fact that the reinforced concrete vaults have a smaller weight than the brick vaults, but the strength and the deformation modulus are significantly superior, which reduced the longitudinal degradation component to a continuous crack line from the west tympanum to the altar with openings of more than 1 - 2 mm.

On the other side, because of the airing of the foundation ground that lays on a longitudinal degradation gradient, the transversal component of the failure mechanism has developed more by the apparition of new cracks which by that time hadn’t been damaged, and the old cracks and fractures reached approximately 2.5 - 3.5 cm from 4 - 5 mm.

As a consequence to the failure mechanism developed in time and amplified by the uneven settlement phenomenon, the monument has been divided in 7 separate blocks that, in case of a major earthquake, were subjected to structural greater damage and even some collapses (fig. 10).

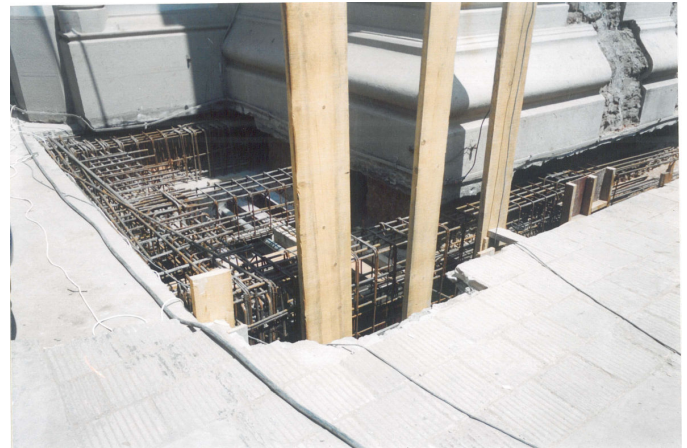
Photo 9 Supplementary foundations area near the church entrance

Photos 9 and 10 show details with the operation of reinforcement assembly for the supplementary foundations.

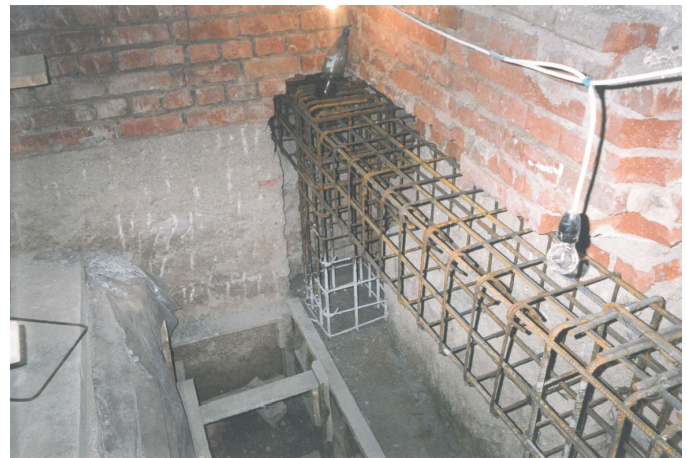
Photo 10 New foundation reinforcement inside the church
