International Conference on Case Histories in Geotechnical Engineering (1984) - First International Conference on Case Histories in Geotechnical Engineering

# The Pathology of Metal Culverts

**SYNOPSIS** Metal culverts are robust structures, but the very large number built every year entails, statistically, a rather high level of pathology. The various aspects of this pathology are analyzed below, first from a general point of view and then through an examination of three particularly instructive cases.

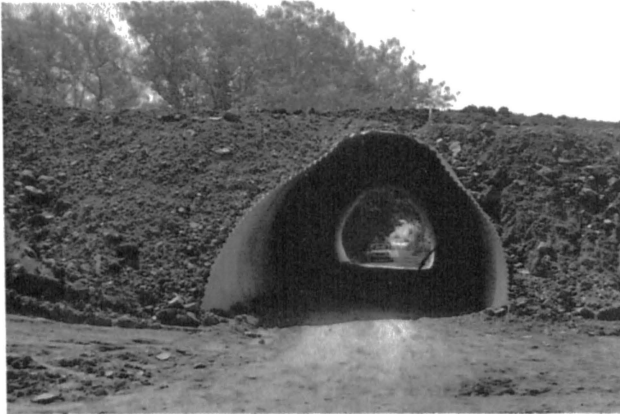
FIGURE 1

The most commonly encountered case is that of "pear-shaped" déformation of the ends of the structure. When they are cut slantwise, they are very flexible because of the highly marked anisotropy of the corrugated sheet metal. This is why, in the absence of stiffeners, deformation of the ends is practically inevitable as soon as the structure reaches a certain size. This effect is frequently aggravated by an excessive skewing of the structure, which substantially increases the cut length of the free end. In many

cases, this defect results in an ugly deformation of the end of the structure (figure 1), but in extreme cases the earth pressure is sufficient to reverse the curvature of the first few sheets, causing the end to collapse. We shall see, in case no. 1 described below, an especially instructive example of this type of failure.

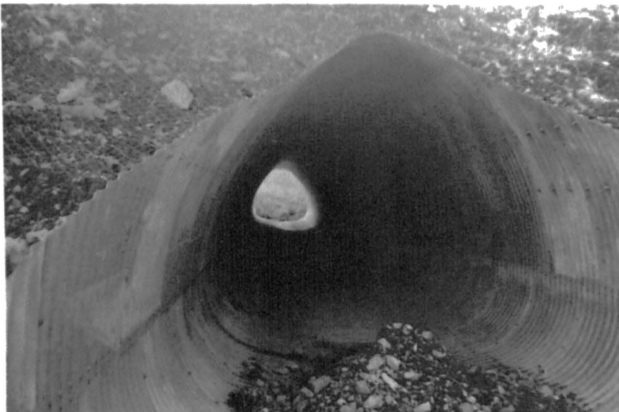
FIGURE 2

In certain relatively rare cases, when the wall of the structure has been under-engineered (inertia too low), there may result a type of deformation that is similar but extends to the whole body of the structure (figure 2); the pressure of the embankment, maximum in the transition zone between the haunches and the crown, may here again be sufficient to reverse the curvature of the corresponding plates. The structure is then quite unfit for normal use, and it would be extremely dangerous to continue filling, since this would most likely lead to collapse.

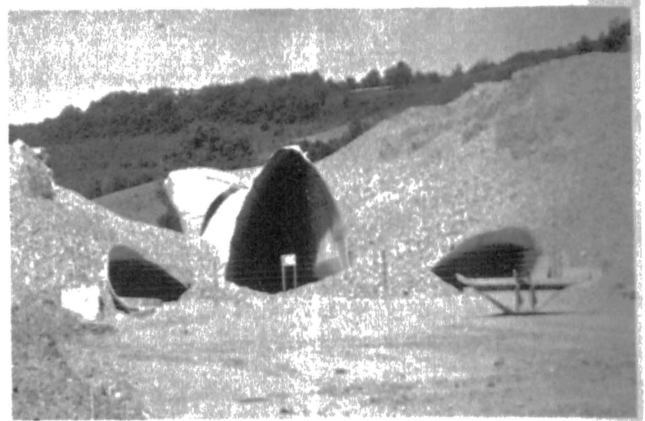
FIGURE 3

In the case of very large structures, the pear shape becomes unstable well before the functional filling is completed, and in one case the result was a complete "cloverleaf" collapse; fortunately, there were no victims (figure 3).

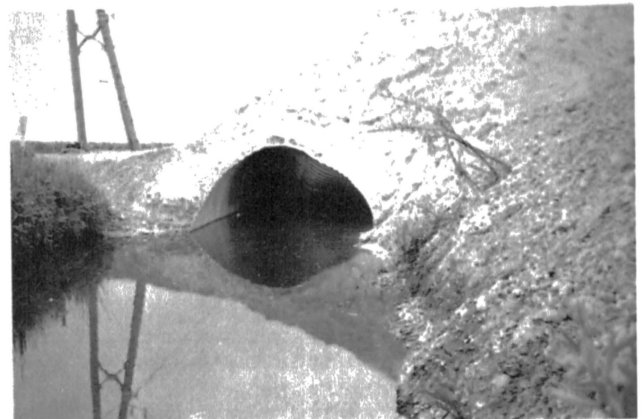
FIGURE 4

Such deformations generally have no effect on safety of the structure, but we have witnessed one extreme case in which the lateral yielding continued to collapse of the culvert (figure 4). Care should also be taken not to introduce such asymmetrical forces into a structure already built (as by digging a trench near it).

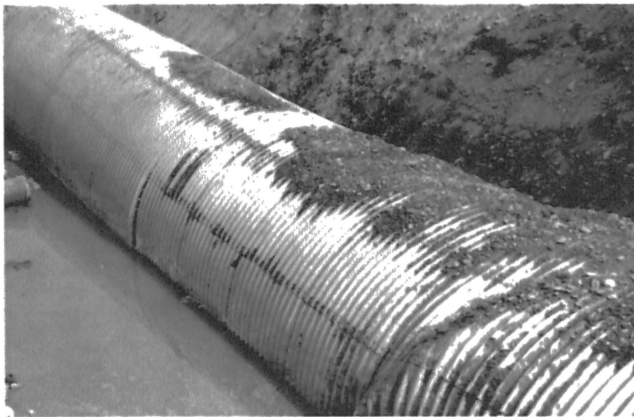
FIGURE 5

Less often, differential subsidence may be caused by a heterogeneity of the subsoil, such as the presence of faults bounding a strong stratum and a soft stratum. In extreme cases, the deformation may be such as to result in shearing of the culvert (figure 5). For this reason, there should be a sufficiently dense geotechnical survey along the centreline of the structure.

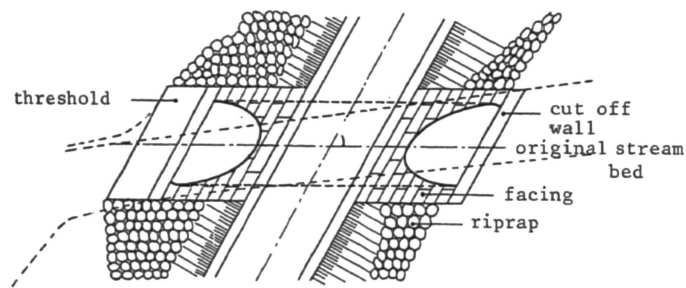
FIGURE 7

This is an arch culvert 5.25 mm thick having a span of about 9.20 m and a rise of 5 m. It is highly flattened ( $V/D = 0.54$ ) and highly skewed (65 gr) (figure 7).

The total length of complete rings (15 m) is comparable to the total length of the truncated chamfered slant-cut ends (2 x 7 m).

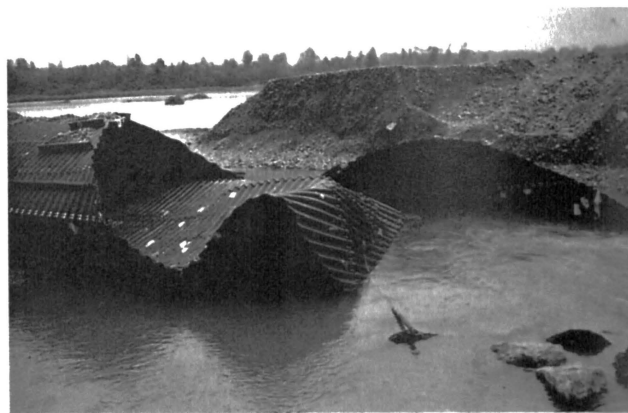
FIGURE 8

Failure occurred on the night following the completion of the filling work (the stream was then running in the culvert), during a rising of the waters caused by heavy rainfall, although the waterway did not reach a critical level (in fact, another culvert of half the span already built on the same stream did not suffer any damage). The culvert was found broken up in the stream bed, shifted bodily, and almost all of the fill surrounding it had been carried off by the water (figure 8).

The failure of the structure seems to have been caused by a number of factors working together. Mention should be made of the asymmetrical loading of the upstream end of the structure on the side projecting towards the bed of the waterway, caused by the greater height of the embankment and accentuated by the presence of a bulldozer in that zone.

The most plausible explanation assumes that the water acted preferentially on the projecting end of the culvert, which was protected by some riprap but not yet anchored in the cut-off walls. This end, highly deformable and overloaded by the asymmetry of the embankment and the presence of the bulldozer, probably then collapsed, taking with it the rest of the structure which was, too short for a state of equilibrium to be reached by a partial collapse. Once the bed of the stream was obstructed, one can readily imagine that erosion on either side of the culvert was very rapid.

The culvert was completely rebuilt; naturally, changes were made to make the construction safe.

- the skew was reduced to 67,30 degrees;
- the crown plates were "cap" cut at the ends to provide stiffening during the construction stage;
- the ends were given a truncated chamfered slant cut;
- the ends of the culvert were anchored along their entire perimeter in the cut-off walls and stone facings, built as the embankments were raised.

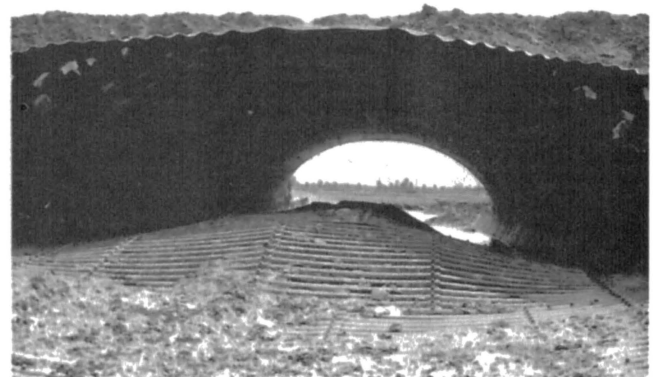
FIGURE 11

During a spring tide, at a time when the structure was embanked but the riprap not yet in place, the embankments were partially eroded around the culverts and the latter suffered serious deformation, essentially in the form of a reversal of the curvature of the floor (figure 11). No subsidence of the subsoil was observed.

It is difficult to establish the mechanisms of this incident, which occurred over a weekend with no eye witnesses present. It probably involves a conjunction of unfavourable circumstances. It was agreed when the matter was settled that the inadequate quality of the fills used was the primary cause.

than planned, creating a zone of very poor functional embankment around the ends of the culverts, but also the fill between the culverts (sand that had simply been sprinkled) was certainly not sufficiently compact. This explains why transverse deformations of the culverts could occur near the ends.

The culverts were rebuilt, after clearing and the recuperation of the usable portions, with the following changes made :

- the use of more rigid truncated ends, anchored in cut-off walls;
- the building of stabilizing banks and riprap protection as the embankments were built up;
- making the embankment impervious by means of a sheet of polyurethane lined with Bidim non-woven fabric, protected from the riprap by a layer of sand;
- new functional embankments made of 0/80 continuously graded quarry aggregate properly compacted by mechanical equipment on each side of the culverts;
- protection of the embankment around the culverts by the construction of a reinforced-concrete facing covered with quarry stones, cast on the embankment and with its base resting on the cut-off walls;
- the anchoring of the culverts to this facing by tie-backs.

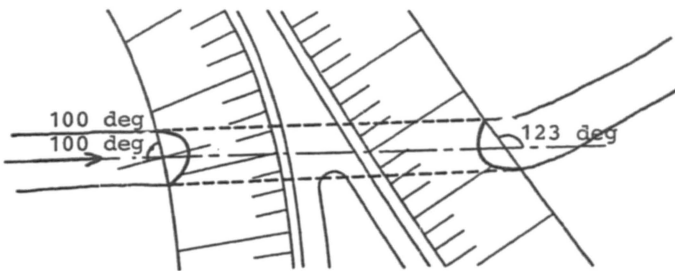
FIGURE 9

This is an arch culvert having a span of about 9 m and a rise of 6.50 m, made of galvanized steel 6.2 mm thick. It has a rather modest skew at one end (100 deg) and a very pronounced skew for this type of structure at the other end (123 deg) (figure 9).

When the culvert was in an intermediate stage of construction (about 1 m above the crown), the more skewed end collapsed over a substantial length about a quarter of the total length of the structure.

After the culvert had been cleared along about half its length, the end of the structure was rebuilt; the unusable plates were replaced and the changes necessary to assure the stability of the structure were made.

- to reduce to a minimum the portion of the highly skewed end not consisting of complete rings and not benefitting from the vault effect by allowing a large share of the crown plates to project to form a "cap";
- to reinforce both ends with reinforced-concrete facings serving as stiffeners.

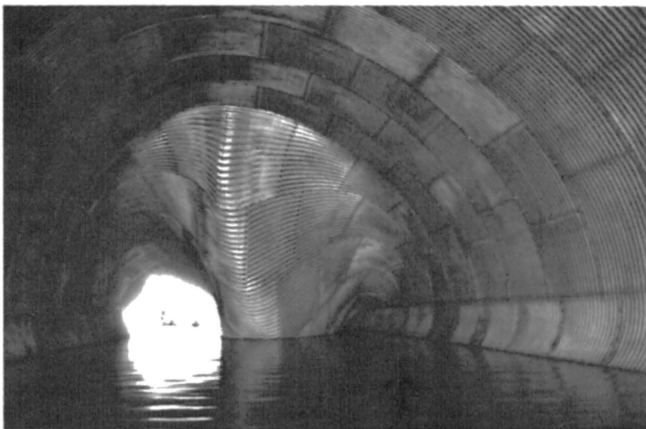
FIGURE 10

The asymmetrical collapse started from the projecting side of the end and propagated along the structure, ceasing only when the crown plates at the end were bearing against the floor (figure 10).

The asymmetry of the height of the embankment is not by itself sufficient to explain the failure of equilibrium, since most of the structure stood up normally. It would seem that most of the blame must be assigned to the excessive skew and inadequate stiffening of the end that collapsed.

The portion projecting farthest, not benefitting from any vault effect, yielded to the thrust of the earth, causing the partial collapse of the culvert.
