Stability of Slopes - A Case History

SYNOPSIS A Lecture cum-cinema hall was constructed on a terrace developed at the top of a hill-ock at a site located in the north-eastern part of India. At the time of development of the site, excavated soil was dumped on the slopes and retaining walls were constructed to retain the earth. After the first monsoon, the retaining walls gave way. Further distress in the vicinity of the building was noticed in the subsequent three years. The paper describes the details of the above failure, the investigations carried out and the remedial measures suggested.

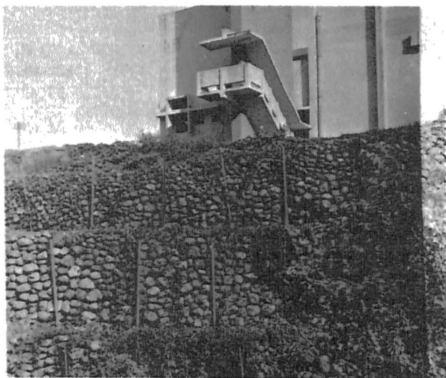
Fig.2 Crated Masonry Walls

During the monsoon of 1974, immediately after a heavy rain fall the retaining walls gave way. The northern and southern slopes adjoining the building failed and the retaining walls were carried almost to the toe of the slope. Subsequently, protective works in the form of crated masonry as shown in Fig.2 were constructed to protect the building.

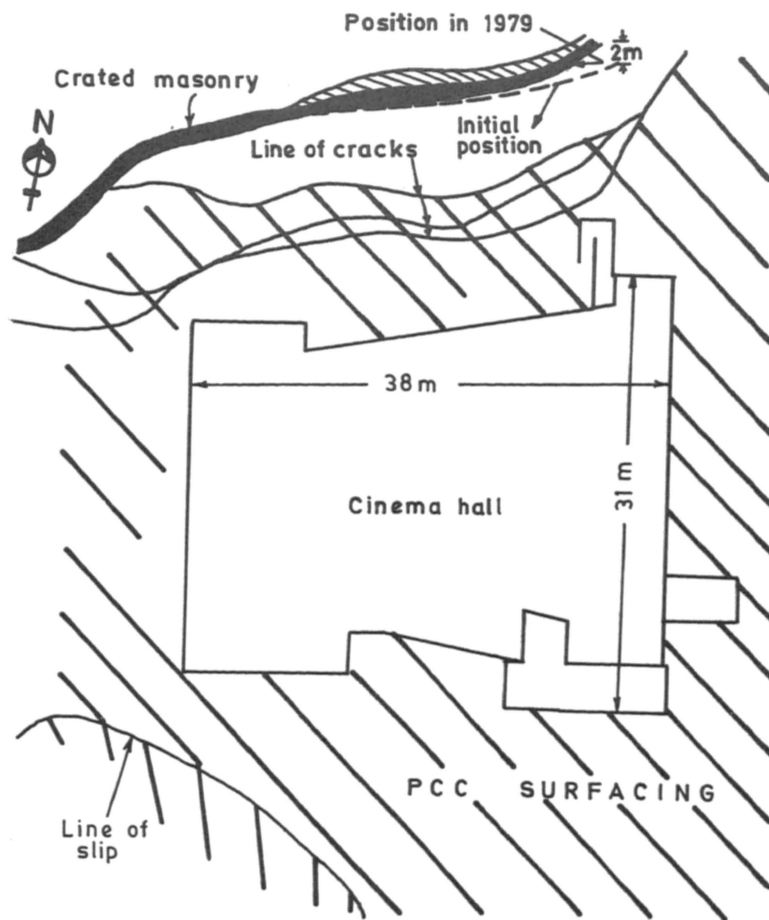
Fig.3 Some Details of Distress

The protective works and slopes experienced further distress during the period 1975-77. The crated masonry got bulged and was slightly displaced from its original position in 1975 (Fig.3). The plain cement concrete surface around the building sank at various spots resulting in cracks. Subsequently, the entire plain concrete surface was covered by a bituminous overlay. Surface drains were also constructed covering the plain concrete hard surface area. However, the discharge points of these drains were located on the slopes. Again in 1977, slips occurred on the southern side of the building after heavy rains. The slips resulted in subsidence of as much as 2.5m of the ground very near to the building as shown in Fig.4. On the northern side, the crated masonry bulged and got shifted by about a maximum of 2.0 m. Cracks appeared on the bituminous surface. The line of slip on the southern side and the line of cracks on the northern side are shown in Fig.3. At this stage, the problem was referred for detailed investigation to identify the causes of failure and suggest remedial measures.

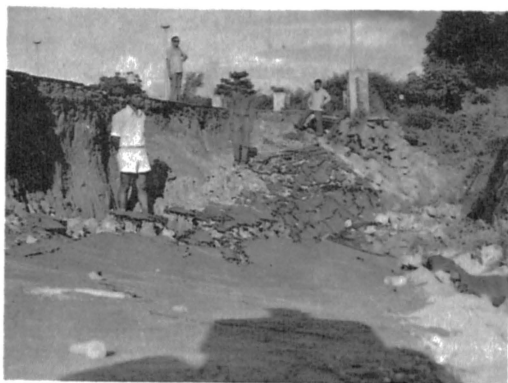
Fig.4 A View of the Slide

It is suspected that the soil excavated at the time of development of the site was dumped along the slopes of the hillock. Low values of SPT observed upto about 3.0 m particularly in bore holes located in the upper portion of the northern and southern slopes give evidence to above view. The failure that took place in 1974 could be due to the rain water seeping into the loose excavated material causing additional lateral pressure on the retaining walls. Subsequent distress observed could also be due to the inadequate drainage measures.

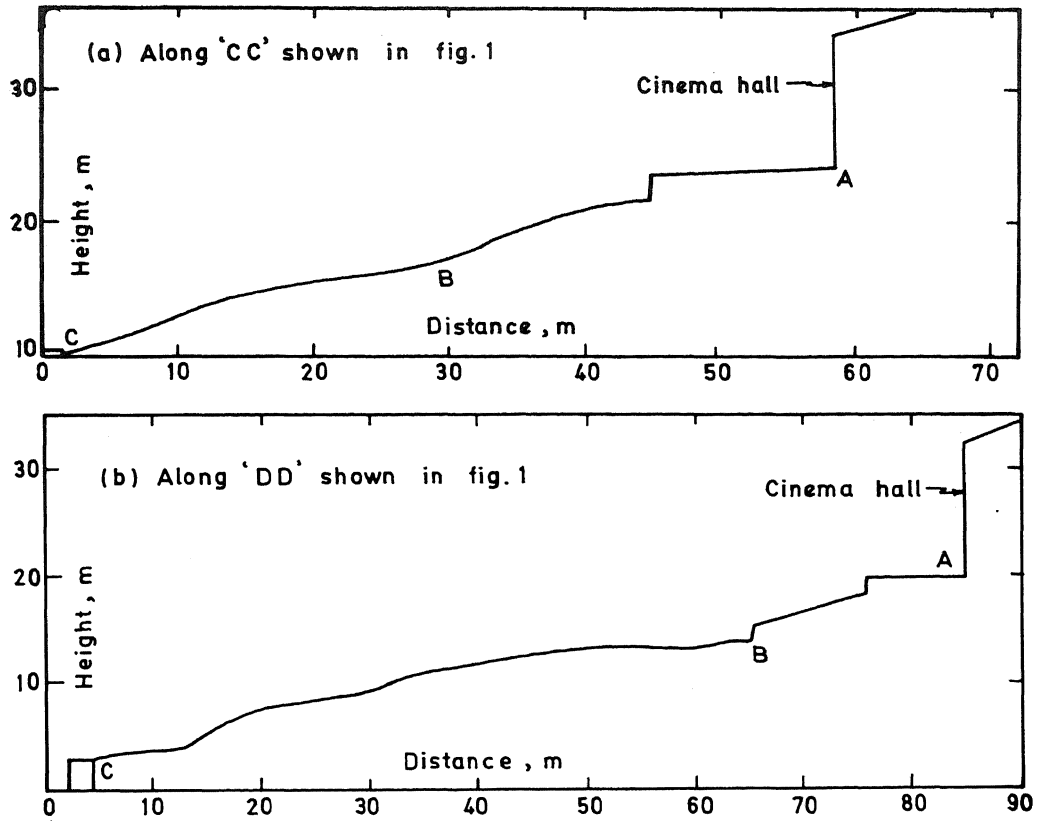
Fig.5 Cross-Section of the Slopes Analysed

The Indian Standards 1893-1975 recommends a value of $\alpha_h = 0.08$ for use in seismic analysis. However, considering the importance of the structure, $\alpha_h = 0.12$ and $\alpha_v = 0.06$ are used in stability computations. The cross-sections of the slopes 'CC' and 'DD' (Fig.1) are shown in Fig.5. This gives the ground

slopes as was existing in 1979, i.e. the time of investigation. Unfortunately, no detail was available regarding the ground slope that existed immediately after construction and the actual location and the dimensions of the retaining walls. Therefore, the analysis was carried out to examine the stability of the slope that was existing in 1979.

The upper parts of the northern and southern slopes had experienced slips. Therefore, the analysis was carried out separately considering only the upper part of the slope where the slips have been taken place (A to B in Fig.5) and the complete slope (A to C in Fig.5). The slopes were analysed assuming that pore pressures are absent in the sliding mass. The results of the back analysis are given in Fig.6.

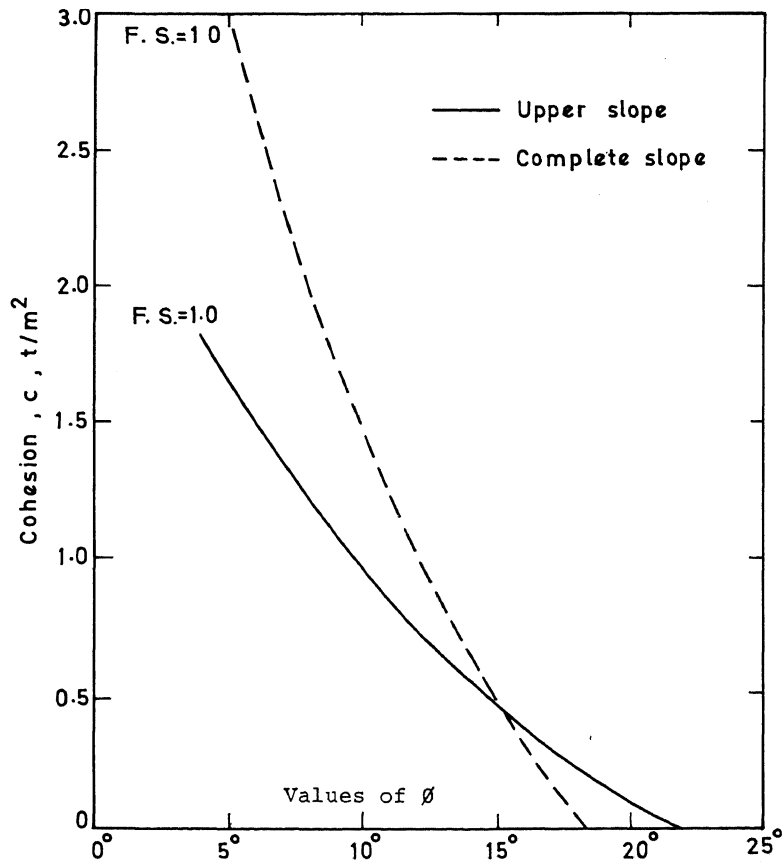
Fig.6 The Results of Back-Analysis

The results of the back analysis show that for the test values of c and ϕ obtained, the factor of safety should be more than 1.0 both for the upper slope and for the complete slope. Further, it was found that the critical slip circle is located much deeper than 1.5 m below the slope surface where it is likely that the values of c and ϕ are larger than test values in view of the higher SPT values observed at greater depths. Therefore, it was concluded that the existing slope is stable and the failure is confined only in the deposit of filled up soil.
